**HUNNEWELL FIELDS
ATHLETIC GROUNDS MASTER PLAN REPORT
WELLESLEY, MASSACHUSETTS**

**DRAFT #3 (FINAL)
NOVEMBER 5, 2003**

SITE ANALYSIS

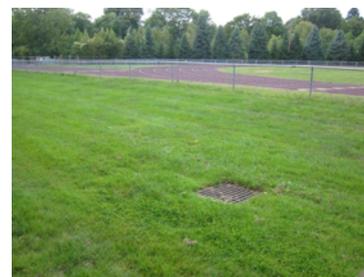
One section at the existing running track appears to be larger than necessary. A long portion of a straightaway extends farther than needed, according to high school track and field regulations (Figure 1). Although the area can be used by athletes practicing block starts, this extended length is taking up space which could be used for other track and field events to incorporate them into the stadium. The surfacing on the track is worn. Small chunks of resilient surfacing have peeled up and are missing from the track surface. The holes in the surfacing are a trip hazard for athletes competing or practicing on the track (Figure 2). The numbers along the track are also beginning to fade as are a majority of the markings and lane lines. The track drains into perimeter drains

Figure 1 – The track extends farther than necessary and takes up space which could be used for other track events.

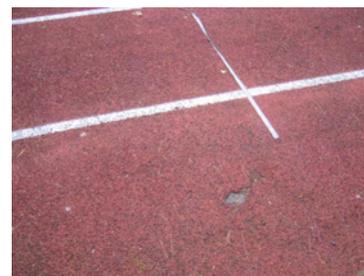
Figure 2 – Chunks of surfacing are missing from the track. These areas are a hazard for athletes.

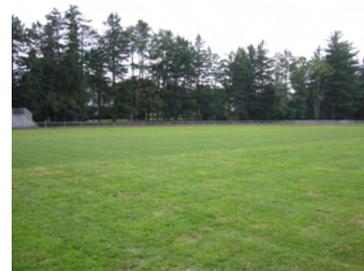
Figure 3 – The area that has been re-sodded in the infield of the track is very noticeable. The grass type is different when comparing the middle to the sidelines.

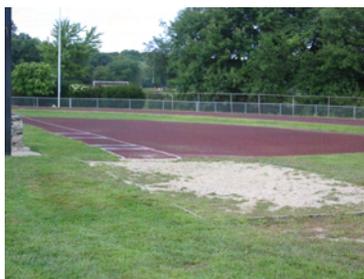
Figure 4 – The jump pits are overgrown with weeds and are uncovered all the time allowing the sand to become wet, contaminated and compacted.

Over the years, grass and weeds have grown over the edging and the pits no longer have a defined edge (Figure 4). The pits do not have any covers so rain and debris have mixed in with the sand making it dirty and compacted. The resilient surfacing at the high jump apron, long/triple jump runways and pole vault runway are also overgrown by weeds and grass. The straight edge of the runways has been lost due to the growth of grass and weeds. These areas look sloppy and take away from the pristine look that a stadium, as the focal point of an athletic complex, should have.

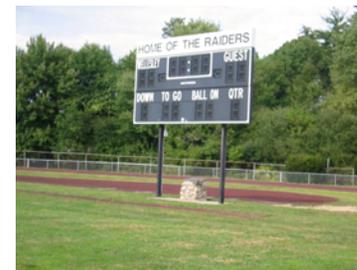
The scoreboard and a monument are located in the track infield. The scoreboard appears to be in very good condition although the location in the infield is not ideal (Figure 5). By moving the scoreboard and the monument outside of the infield there would be more space for the track and field events held behind the end zones.

Figure 5 – The scoreboard and monument are behind the east end zone in the infield of the track. This is an awkward location and should be relocated.

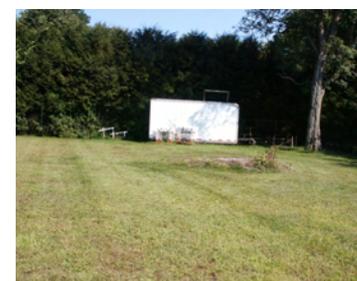
There are large grassy areas near the home and away bleachers currently used as gathering areas. At the visitors side of the field a large equipment trailer sits in the corner, but there is still track equipment strewn all over the area (Figure 6). Loose athletic equipment with weeds and grass growing over them takes away from the appearance of the stadium. Equipment should always be stored in an area that is protected from the elements. This will keep athletic equipment in good condition and prevent vandalism. A large swale is located at the opposite corner of the visiting side of the field. The swale is used to drain water from under the bleachers and the surrounding areas into a catch basin. Behind the visitor's bleachers is a slope vegetated with trees leading up to the road. A chain link fence encloses the area.

Figure 6 – An equipment trailer sits in the corner of the stadium, but equipment still is left outside and is overgrown by weeds.

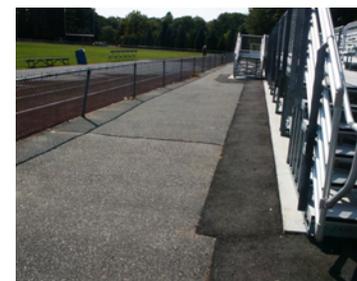
Figure 7 – The bituminous patch from the bleacher pad to the existing bituminous is not ideal. Also the existing pad is full of cracks and weeds.

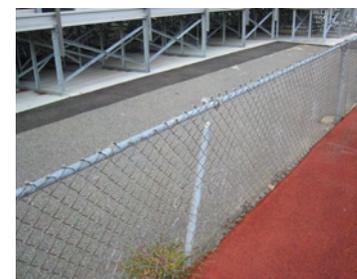
Figure 8 – The existing fence around the track is showing signs of wear with bent fabric and broken posts.

The condition of the fence around the track varies. Rust is forming on many portions of the fence and the fabric knuckles are bent in (Figure 8). Due to the previously mentioned drainage problems, the space between the fencing and the synthetic surfacing acts as a trap for trash and dirt. This creates an unattractive edge. Weeds growing in these areas are growing over onto the track surfacing. The perimeter fencing around the stadium site appears to have been recently replaced in some areas and not in others. The 6' galvanized chain link fencing is extremely rusted in some areas and is an eyesore when seen from the street or the gravel access road (Figure 9). Although some trees hide the fencing from the inside, the rust can be seen when looking into the site. The gates at the fencing all need to be replaced. They are rusted and extremely worn from years of use. The fence along the access road is sitting in grass which creates a difficult mowing edge. If the fence were placed in the gravel rather than grass, maintenance would be easier and long grass would not grow at the bottom of the fence.

Geller Sport recommends all fencing on the site be black fusion bond/powder coated fencing. This type of fencing is more aesthetically pleasing and has a longer life expectancy than galvanized fence. This type of fencing will not rust and can be easily touched up if there is a scratch or any other type of mark.

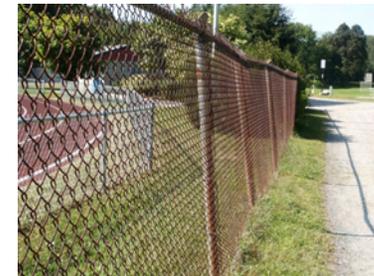
Figure 9 – The 6' perimeter CLF is an eyesore for the entire stadium and should be replaced with a fence that blends in with the landscape.

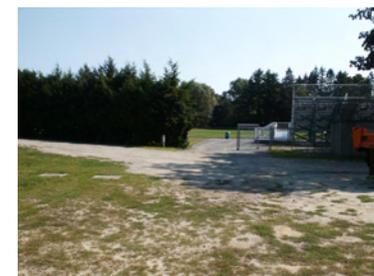
Figure 10 – The entrance is plain and unwelcoming. An entrance should make people want to go into the stadium. It should draw attention inside.

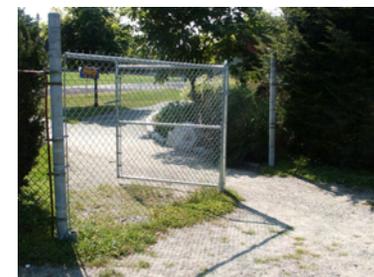
Figure 11 – The gathering area outside the entrance to the stadium is uninviting.

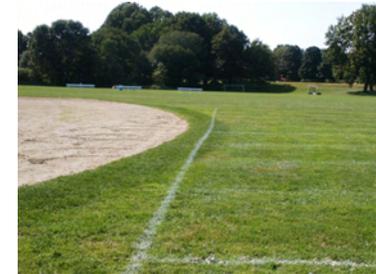
One end line sits about 1' off the edge of the Varsity baseball infield (Figure 13). The Varsity Boy's and Girl's soccer teams practice and play on this field every day of the week. With the two teams practicing and playing on the field everyday, the grass quickly shows signs of wear. At the center of the field and at the goalmouths dirt patches show up early in the season (Figure 14). If the athletic fields were properly rested and maintained it would be rare to see the fields with this amount of wear this early in the athletic season. All high traffic areas on the field will be extremely damaged by the end of the season due to the extensive use of the fields. The field drains out towards the sideline and down towards the aqueduct. The field does not have a subsurface drainage system to collect water or an automatic irrigation system to help maintain the field.

Figure 13 – The Varsity soccer field sits in right field of the Varsity baseball field. It does not infringe on the baseball infield, but comes very close.

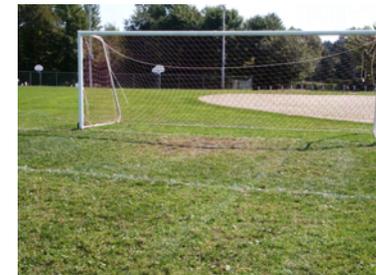
Figure 14 – The soccer goalmouths are already beginning to wear down. Later in the season this area will become more bare and dusty from all the use.

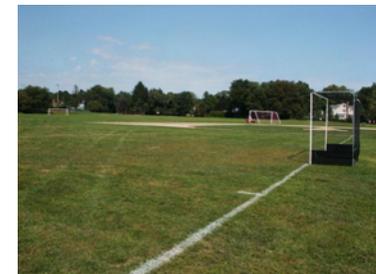
The Varsity field hockey game field is next to the soccer field and imposes on the third base side of the Varsity baseball infield. The field overlaps the infield of the baseball field to such an extent that an athlete dribbling towards the sideline must cross over grass to infield mix to grass again (Figure 15). The change in surface conditions and the lip that exists between the grass and the infield mix could cause injury to an athlete if the ball were to hit off the lip and fly into the air. If possible all multi-purpose athletic fields should be kept off the skinned infield areas of baseball and softball. Since this field is only used for games, the grass is in relatively good condition. Wear around the goalmouths is not that apparent, but the middle of the fields does appear more worn than the rest of the field (this is to be expected). The field drains towards the JV field hockey field and eventually to the ponds surrounding the area. There is no subsurface drainage system or automatic irrigation system in this field.

Figure 15 – The Varsity field hockey field overlaps onto the Varsity baseball field at the third baseline. The field overlaps onto the infield grass.

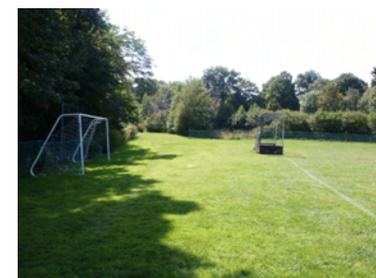
Figure 16 – The JV field hockey field is not regulation size. The slope down towards the water channel keeps the field from being larger.

The field hockey practice field, which is also the JV field hockey game field, is tucked in the southwest corner of the site. One end line of the field is about 10 to 15-yards away from the brook and the other end line aligns with the slope at the aqueduct (Figure 16). The surface of the field undulates severely. Throughout the field, high and low points are very obvious. A playing field this uneven can be detrimental to an athlete. The uniformity of a playing surface is essential in preserving the health of athletes. The field area slopes down gradually towards the brook. If the grades were slightly raised near the brook with Conservation Commission approval, the field could be enlarged. Currently it is not regulation size. At the western sideline of this field there is a 4' chain link fence with green PVC coated fence fabric. The fence is old with many dents in it. The fence provides a poor mowing edge and the bottom of the fabric has long grass and weeds growing up through it (Figure 17). There are permanent team benches at the field's sideline. Since most of the other fields in the area drain towards this field, it appears to receive an adequate amount of water even though the field does not have an automatic irrigation system. The grass remains green through the summer months when conditions are dry.

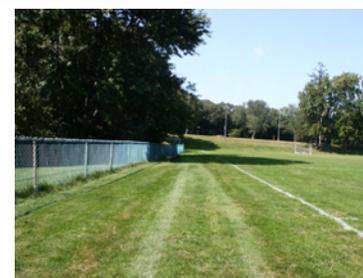
Figure 17 – The fence at the JV field hockey field is a poor mowing edge with grass growing up into the fabric.

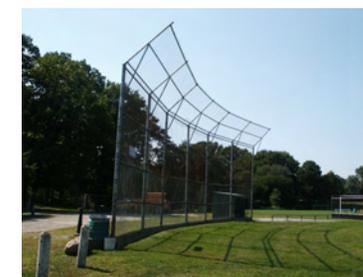
The equipment at both baseball fields needs to be replaced. The backstop at the Varsity baseball field is a galvanized chain link fence backstop with a wooden baseboard. Although the backstop is of adequate size and height, it is old and rusting (Figure 18). The fence fabric has many dents in it from years of use and should be replaced. The wooden baseboards are not properly attached to the backstop and could be a hazard for catchers going after a passed ball. The team bench areas consist of a bench on a bituminous concrete pad. The bleachers sit on the same pad and

Figure 18 – The Varsity baseball backstop is regulation size, but is completely rusted with huge dents in the fabric and a baseboard that is falling apart.

- Pull back the existing Varsity baseball infield so it is 40' in front of the backstop.
- Replace the existing backstop with a new fusion bond/powder coated backstop with a baseboard.
- Construct new team areas with new benches on concrete pads at both sides of the field.
- Renovate the existing JV baseball field and push the backstop towards the home plate area so it is 40' away.
- Construct new dugout areas complete with benches and an overhang.
- Make this baseball field into the Varsity baseball field and the other field the JV field (the other field cannot have dugouts due to space constraints).

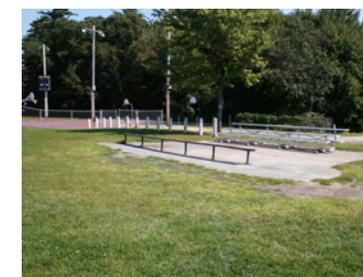
Figure 19 – The team bench areas are not protected from foul balls nor separated from the spectator seating.

are located about 10' behind the benches (Figure 19). There is no protective fencing in front of the team areas. The infield of the Varsity baseball field appears to be in good condition. Since the outfield of the baseball field is used by so many other sports, the grass is damaged especially in left/center field where the soccer field is in the fall. Along the right field foul line there is a batting cage which is in fair condition. The Varsity baseball field appears to drain properly out of the infield towards the first and third baselines. At the first baseline, water sheds down towards the basketball courts to the outlet area beyond. At the third baseline, the water sheds over towards the Skating Pond Field and to the pond. There is no automatic irrigation system in the infield or the outfield to help maintain the field.

The team areas need to be repaired. The home and visiting team bench areas should be comparable. Team areas should be fenced in to protect players from foul balls or overthrown balls. Geller Sport recommends an 8' fusion bond chain link fence extending from the backstop to the end of the infield with gates for players to pass through. This also allows for a clearer designation of dead ball areas. It is recommended that the outfield have a permanent fence, but due to the outfields being multi-purpose fields, semi-permanent fence could be considered in this situation.

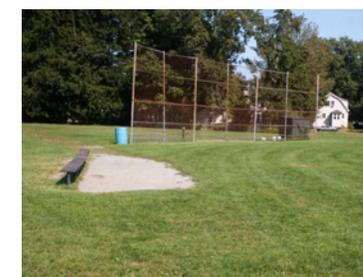
Figure 20 – The JV baseball backstop is not regulation and is totally rusted. The team areas are dirt patches that have been worn in by use.

The backstop at the JV baseball field is in poor condition and is not the regulation size or height (Figure 20). The backstop does not have an overhang and the galvanized chain link fencing fabric is rusting and has many dents throughout the fabric. The team areas consist of a team bench and a worn dirt spot in front of the area rather than a concrete pad. There is also no protective fencing in front of the team benches. The infield of the JV baseball field is also in poor condition and the skinned infield is infested with weeds (Figure 21). In the outfield, since fall teams use the area, the grass tends to be worn and the soil compacted, especially in left field where the football team practices. There is a wear path in the grass, in the corner of the site near the aqueduct, leading to the team area located at the first baseline. The JV baseball field is not handicap accessible and the field does not have designated areas for fans to sit. The field drains out towards the first and third baselines. At the third baseline, water sheds towards a neighboring yard. At

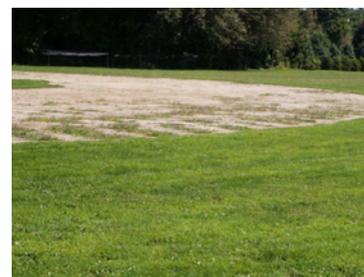
Figure 21 – The infield of the JV baseball field is overgrown with weeds. This can create an unsafe playing surface.

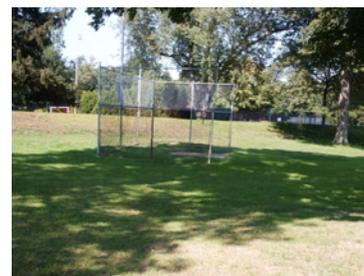
The track and field events held at these fields are javelin, shotput and discus. The discus cage is set up to the north of the brick building by the Cochituate Aqueduct (Figure 22). Whether it be on the softball field or the JV baseball field, javelin is thrown wherever there is not a game or practice being played. Having these events so far from the stadium can be a nuisance for coaches. The cages and pads at the event areas are in need of replacement.

Figure 22 – The discus cage is in poor condition and far away from the track. It is a headache for coaches during meets to come and watch events away from the track.

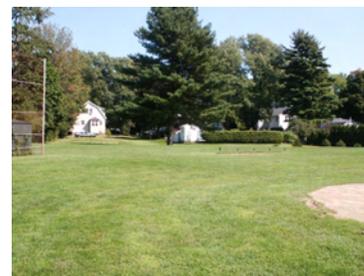
Figure 23 – There is no fence to keep foul or overthrown balls out of the neighbors yard at the JV baseball third base line.

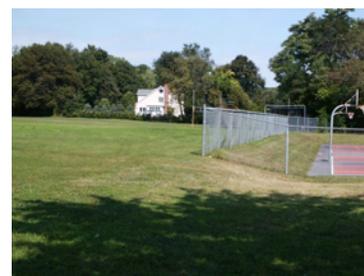
The fencing around the perimeter of the site is inconsistent. There is fencing near the basketball courts, at the west and south sides of the Skating Pond Field and at the southeast side of the Baseball/Multi-Purpose Field, but nowhere else. At the JV baseball field there is no fence at the third baseline area to keep balls from going into an abutter's yards (Figure 23). The slope at the aqueduct provides a barrier to keep balls on the site, but it does not limit access to the fields. The fencing at the basketball courts is 6' galvanized chain link fence and it follows the contours around the courts (Figure 24). The fence

Figure 24 – The fence around the basketball courts acts as a barrier for athletes from the slope and so balls from the fields will not disturb people playing basketball.

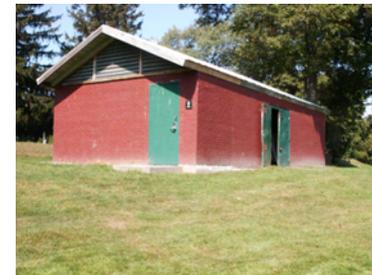
Figure 25 – The building has bathrooms, but is not HC accessible. Since the building is in a central area many teams can store equipment in the shed.

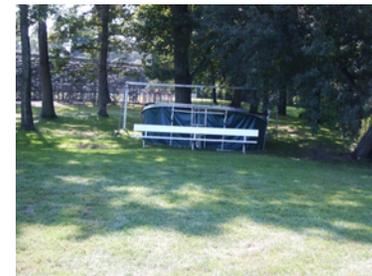
Figure 26 – Equipment that is not stored is going to last a shorter time than equipment that is stored, especially metal benches.

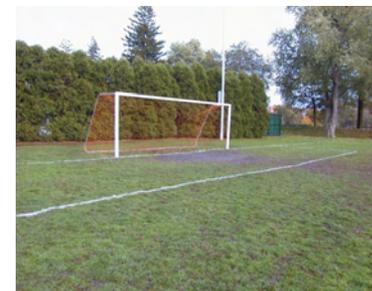
Since this field is the only lighted field in the area, it receives significant use. Both soccer and softball are playing on the field non-stop although currently the soccer field is not regulation size so it cannot be used for Varsity games. With the use the field receives, the outfield/multi-purpose field turf becomes easily worn out in high traffic areas such as the middle of the soccer field and at the goalmouths (Figure 27).

Figure 27 – The grass is almost completely worn away in high traffic areas such as at the soccer goalmouths.

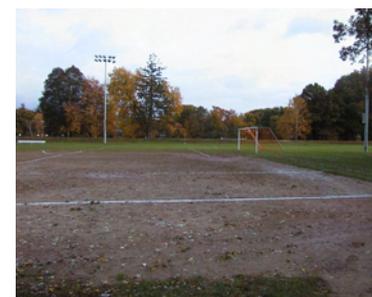
The softball field has a fully skinned infield. Since the outfield is bound by the aqueduct, the tennis courts, the Little League Field and Washington Street, a large corner of the soccer field runs onto the softball infield to make the soccer field as large as possible (Figure 28). Whenever possible, a change in surface should be avoided for soccer fields. The change in surface to a skinned infield can be a tripping or slipping hazard for a soccer player, especially during

Figure 28 – A large area of the soccer field runs onto the softball infield. This can be unsafe for athletes tripping over the lip of the infield.

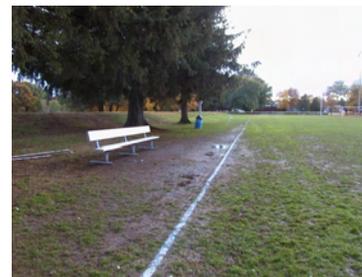
The team areas which are located near the aqueduct, are shaded by the large trees behind them. Due to the shade these trees create, grass does not grow well in this area. With the teams using this sideline during the game, the area also become extremely muddy during the soccer season (Figure 29). The team area is generally not a hazard for an athlete, but takes away from the aesthetic quality of the area.

Figure 29 – The team areas do not grow grass well due to the shade in the area. The area becomes extremely muddy due to teams using the sidelines during games.

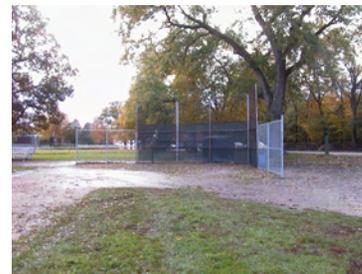
The equipment at the softball backstop is in fairly good condition, but locates the team areas in the wrong position. There should be protective fencing in front of the team areas (Figure 30). Team areas should be centered on the respective baseline between home plate and the base. Team areas should always have 8' fencing in front to protect players and coaches from foul balls.

Figure 30 – The softball backstops are in fairly good condition, although the protective fencing does not extend in front of the team areas.

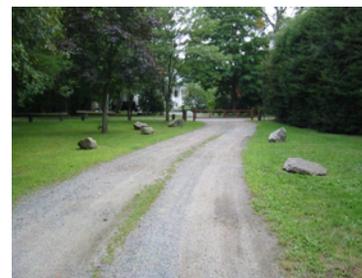
blocked off by large boulders and by a swinging gate to allow maintenance and emergency vehicles through (Figure 31). As the site is entered, there is a water channel to the right of the gravel road and the stadium fence to the left. The road continues it curve around the stadium fencing towards the storage area just outside the fence. There is a gravel space outside the basketball courts that appears to be a turn around or possibly a place to park (Figure 32). Concrete bollards and the bleachers at the Varsity baseball field's first baseline are located adjacent to the road to keep cars from driving onto the fields. The bollards are old with paint chipping off and are an eyesore. The gravel road terminates behind the baseball backstop and there is no clear definition between the end of the road and the grass. Since the access roads do not continue throughout the site, maintenance vehicles must drive across the athletic fields. The access drive also connects with a nature path which runs throughout the property and crosses over Rice Street.

Figure 31 – The entrance to the site from Rice Street is blocked with a gate and by boulders.

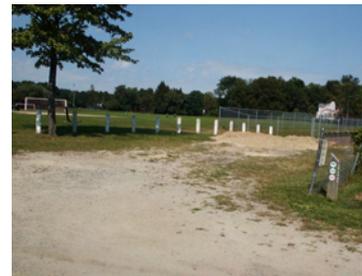
Figure 32 – The area near the basketball courts could be used for HC parking. The bollards are used to keep cars off the fields, but are in poor condition.
