Fuller Brook Park Preservation Project
Executive Summary
Phase 2 Preliminary Design Report

Prepared for the
Fuller Brook Park Coordinating Committee
Wellesley Natural Resources Commission
Wellesley, Massachusetts
January 2011

Fuller Brook Park Preservation Project Phase 2: Preliminary Design Report

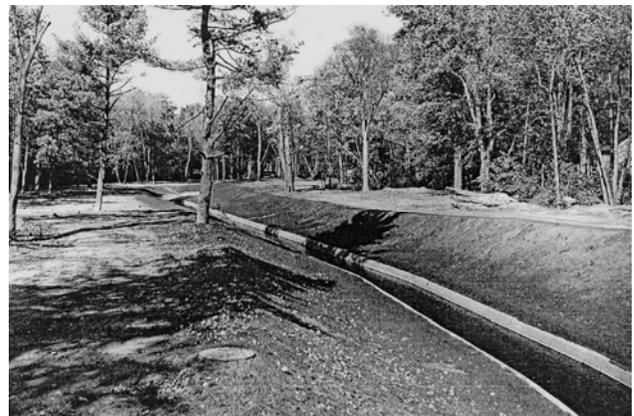
Concrete curbs and steep turf banks considerably altered the naturalistic character of Fuller Brook Park in the 1950s.

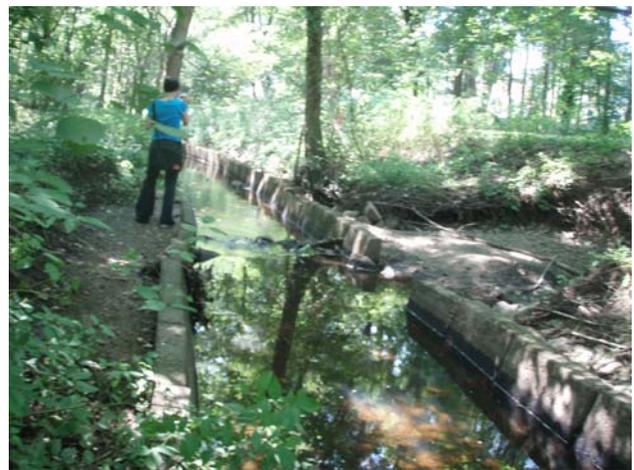
Collapsed concrete liners now impede water flow throughout Segment 1 and contribute to bank erosion.

The Fuller Brook stream course and bank is the most deteriorated in Segment 1, largely because of the displaced and broken concrete curbing that impedes water flow, concentrating the stream flow behind the curbing and hastening bank erosion. Because the curbing is dislodged in several places, the channel size is inadequate to effectively convey water during storm events. The stream bank is highest in this segment at an average of 6’.

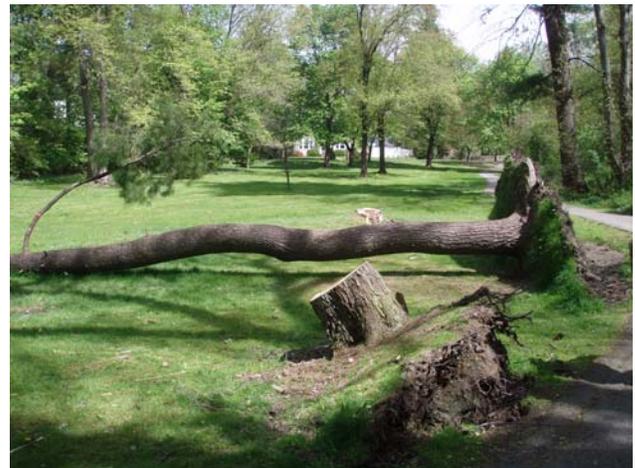
Uprooted trees in wet area near the bituminous path southwest of Wellesley Avenue.

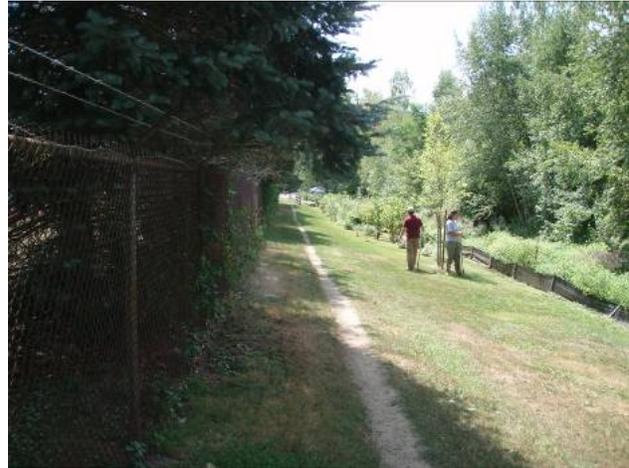
Existing narrow beaten footpath along the chain-link fence and fir hedge bordering the football field in Segment 3.

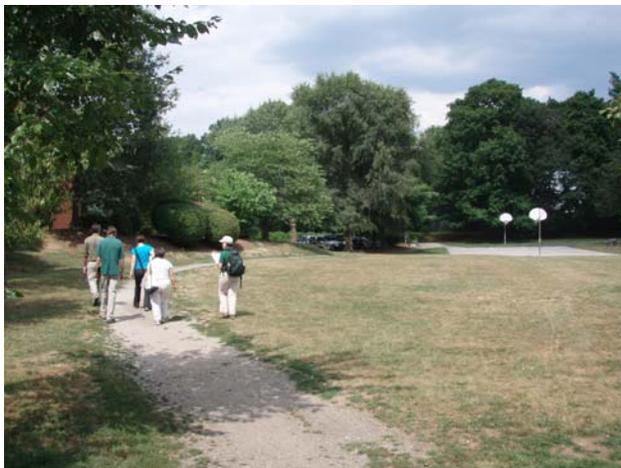
Stonedust path at Phillips Park.

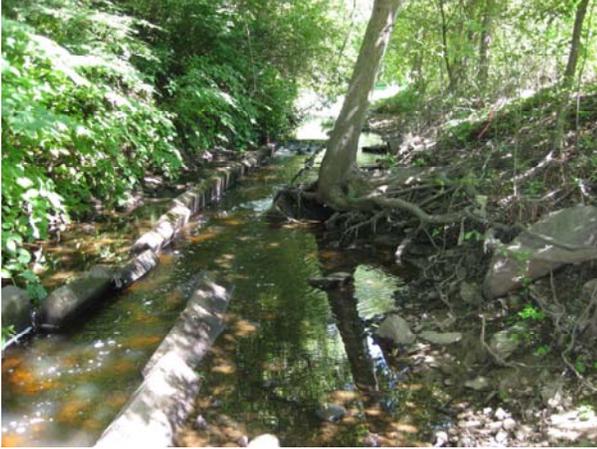
Collapsed concrete liners in Fuller Brook, Segment 1.

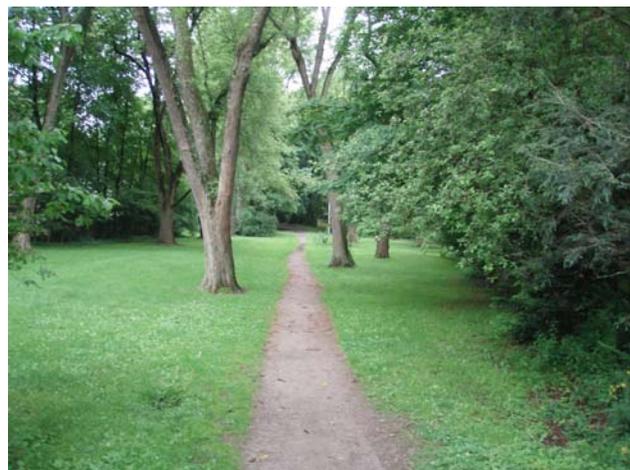
Narrow section of dirt path in Fuller Brook Park, Segment 4. This is an example of a path that does not meet universal access standards due to width and surface material.

A few existing areas along the path exceed the recommended grade for universal access (5%), most of which relate to the slopes approaching street crossings. However, with the exception of the bituminous path in Segment 2, most of the path in the Park does not meet current universal design standards for slip-resistant surfaces. Since one of the design criteria for Phase 2 is improving universal access, the alternatives considered a range of access from no change to full compliance with the Americans with Disabilities Act (ADA).

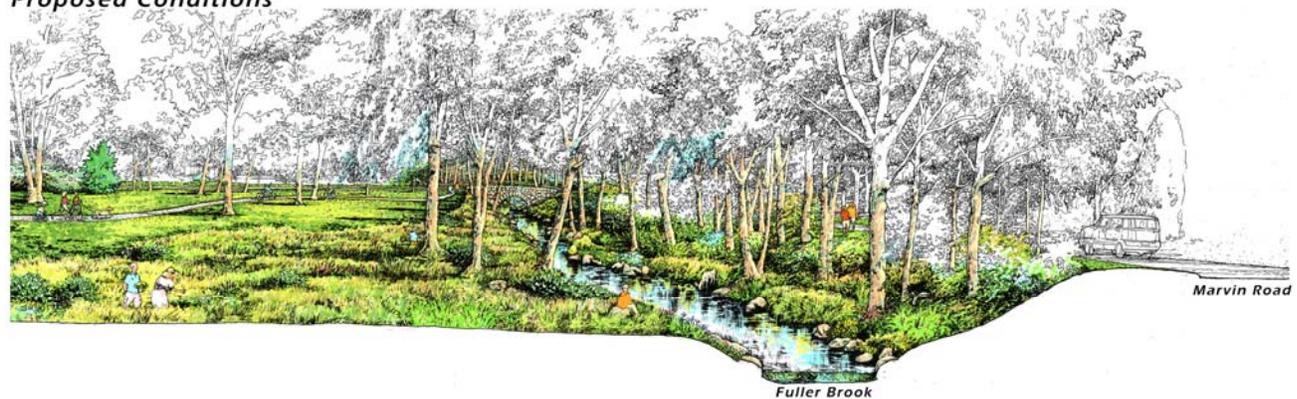
Proposed Conditions

Conceptual sketch showing the character of proposed changes to Fuller Brook Park, reflecting the desire for naturalistic character, enhanced floodplain function, and open views to historic bridges. In this instance, the path has been re-routed to create the opportunity for a wet-meadow in a location that is subject to seasonal flooding.

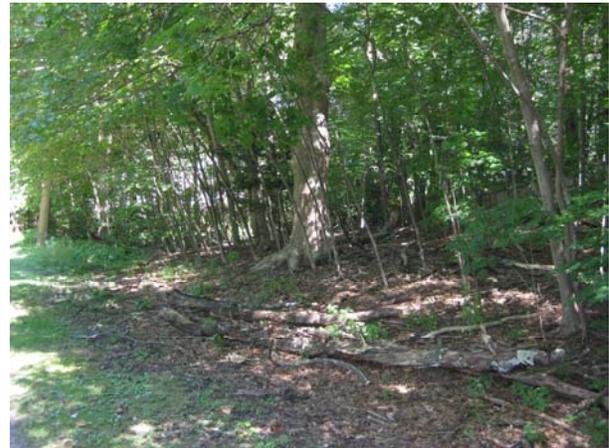
Invasive Norway Maple seedlings in Segment 4.

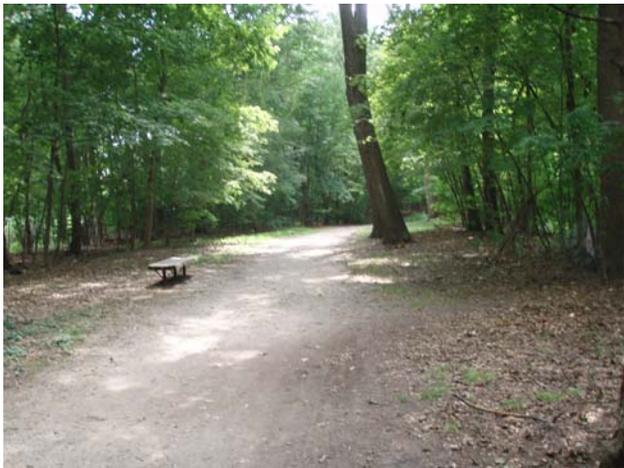
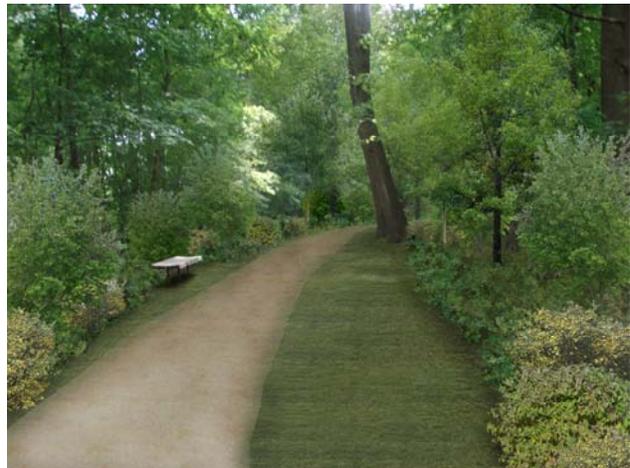
Photo simulation showing vegetation management in Segment 4. After removal of Norway Maple saplings, install native shrubs and trees to retain a lush, green corridor.

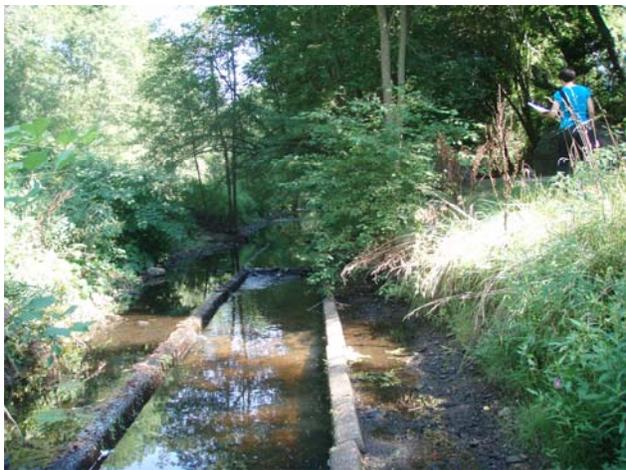
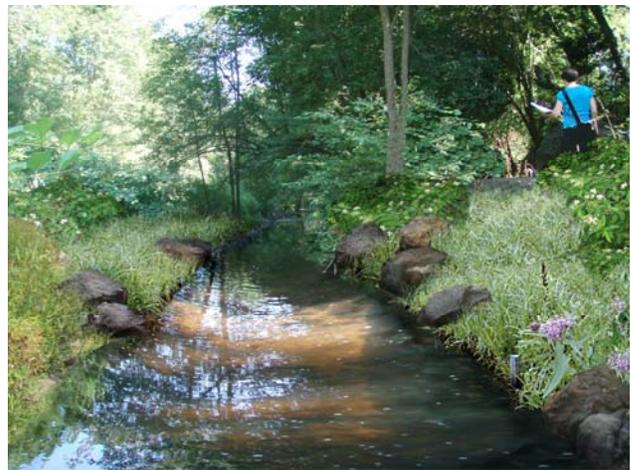
Photo simulation showing stream restoration and bank stabilization using boulder toe, natural coir logs, and live stakes in Segment 1.

The stream banks along both Fuller Brook and Caroline Brook are commonly undercut or eroding, often under large trees or areas where there is a lack of stabilizing vegetation. The concrete curbing also contributes to the instability of the bank in Segment 1 because the channel flow is forced against the bank by the curb. After evaluating the range of solutions to stabilize the stream bank, the final recommendations include a combination of natural boulders (30%) and fiber coir (70%) at the toe of the bank with live stakes used on the re-graded slope to prevent erosion. This technique can be used throughout the Park, and could be combined, where appropriate, with a diverse designed planting in areas where a specific visual or aesthetic effect is desired.

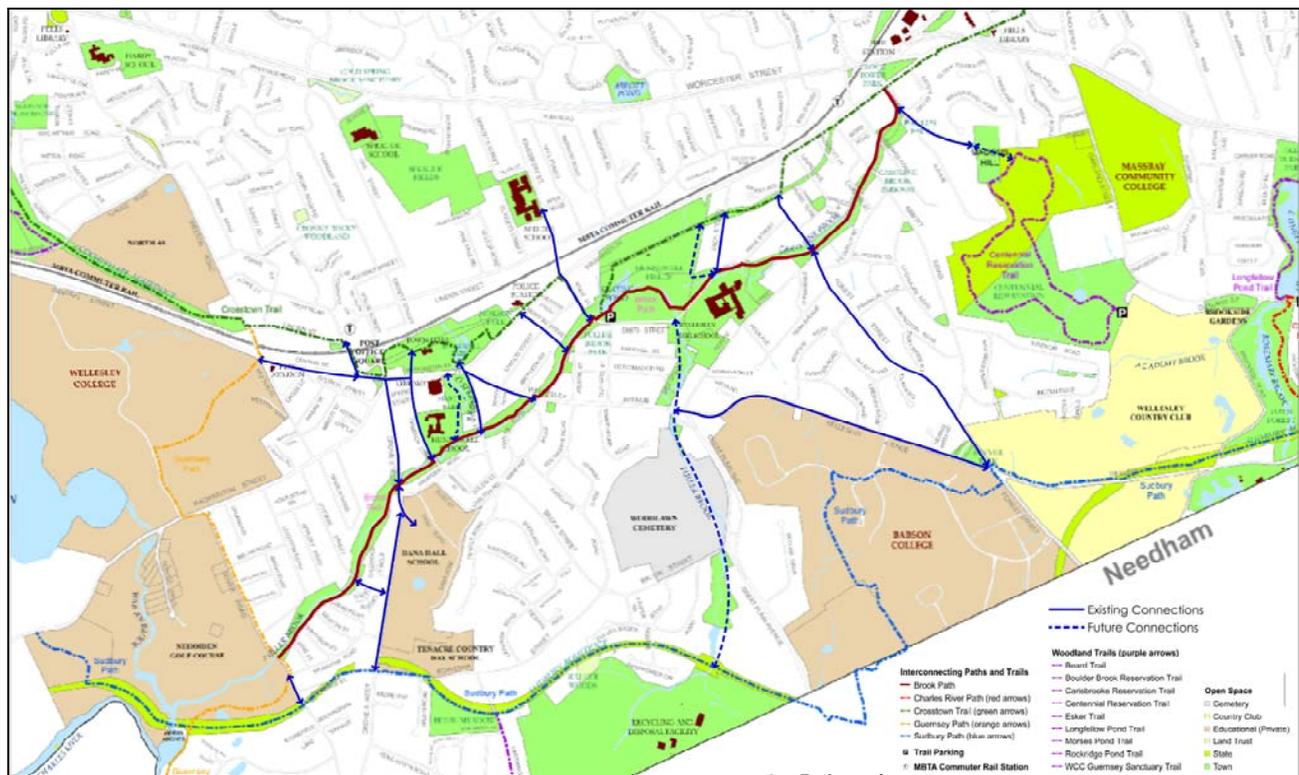
Strengthen Path Connections to and from Fuller Brook Park

Phase 2 examined options to strengthen path connections to and from Fuller Brook. The diagram below shows some of these existing or potential connections. These improvements are not included in the cost estimate.
