Fuller Brook Park

Wellesley, Massachusetts

Preservation Master Plan

November, 2009

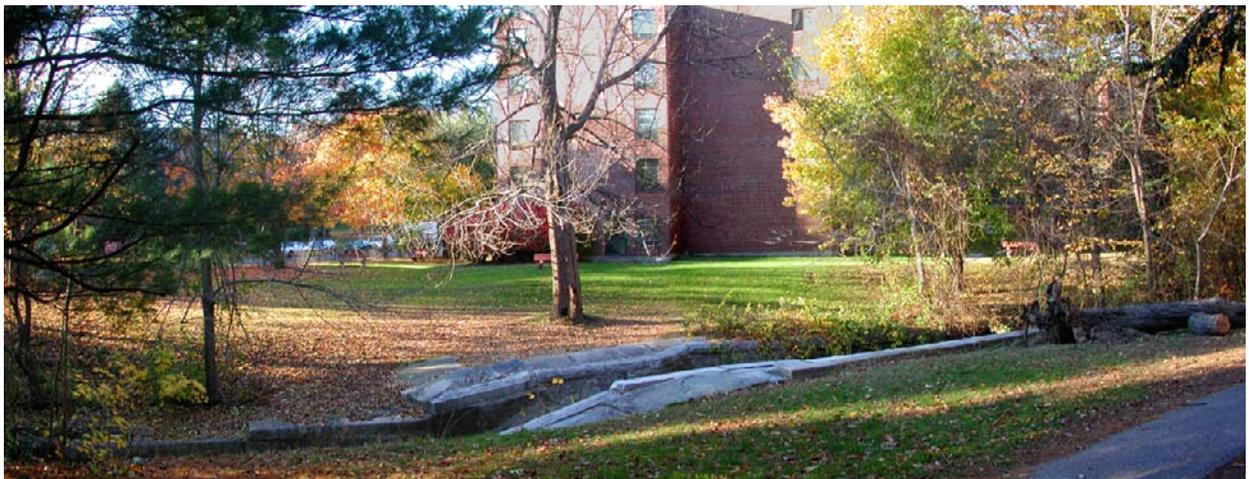
The "Grove Street Flume," a granite and concrete channel, through which Fuller Brook flows. Its original purpose and history did not come to light during the research for this plan.

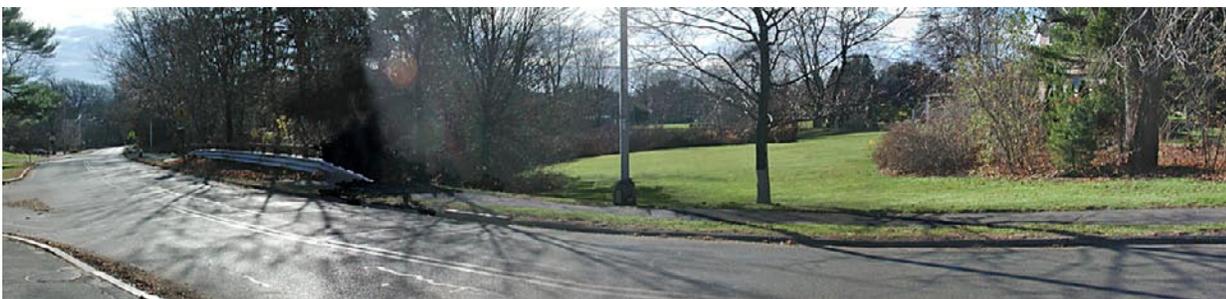
Hunnewell Field connects the Caroline Brook Section to the Fuller Brook Section, but today across from the High School no path is clearly evident.

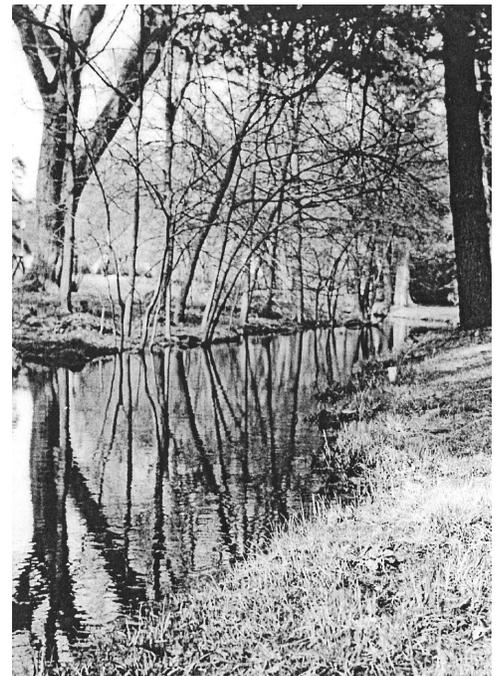
BEFORE: Pre-construction view of Fuller Brook near Grove Street, 1958. (NRC files)

The work was directed by the Massachusetts DPW's Division of Waterways. The primary focus was on straightening, deepening and widening the brook to drain flood waters away from developed sections of town into the Charles River. Full engineering treatment took place mostly in the western section of the park, from Dover Road to Grove Street. Stream-edge vegetation was removed; the banks were cut back to a 1:1 slope and turfed; the stream bed was lowered; new larger culverts were installed at a lower elevation; concrete channel liners were placed along the edges of the brook; and new

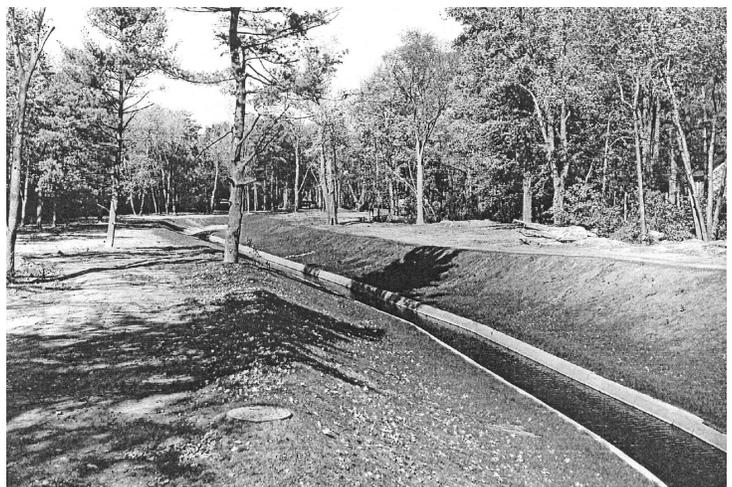
AFTER: Post-construction view of Fuller Brook near Denton Road, circa 1958. (NRC files)

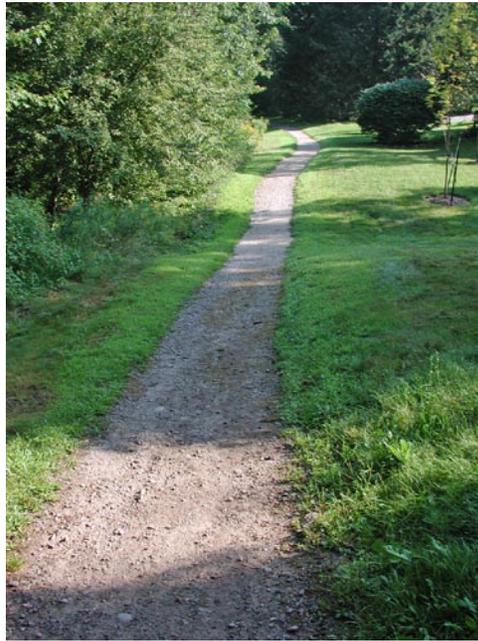
The dirt and gravel path near the Dover Road entrance to the park, illustrates grading and accessibility issues.

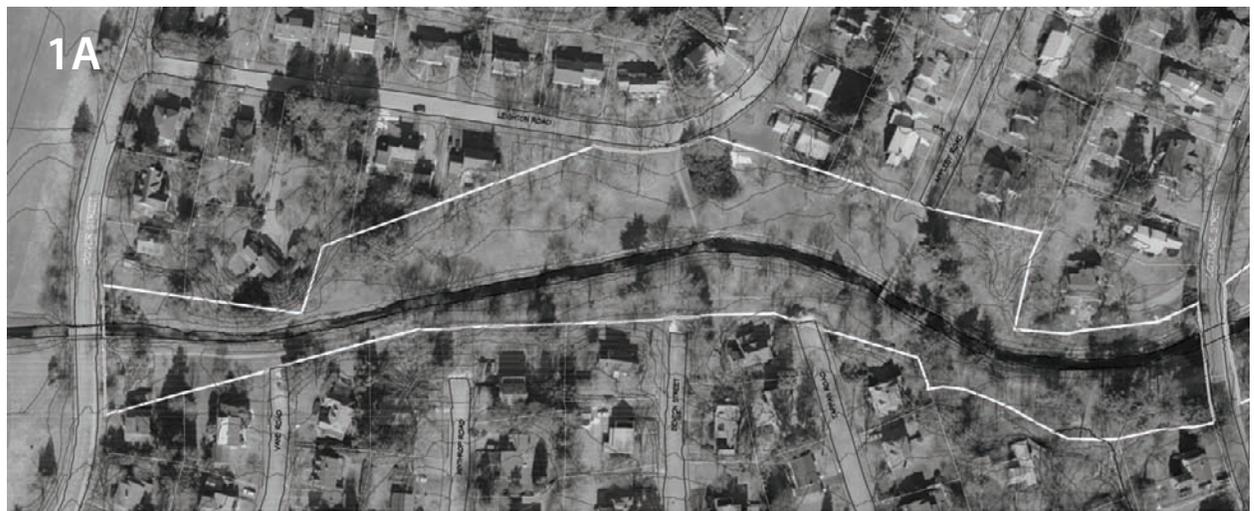
Map of Segment 1A. Dover Road is to the left, Cottage Street is to the right. The white line marks the boundaries of the park. This segment of Fuller Brook Park is wider than many of the other segments. All segment maps are at approximately the same scale.

The portion of Fuller Brook from Dover Road to just east of Grove Street was lowered and lined with concrete curbing (photo 1A-2) in the late 1950s. In general this section of the stream bed is narrow and deep with steep sides. Most of the curbing still exists but it has shifted over time and is no longer effective in channeling the watercourse. There is minor erosion in some areas.

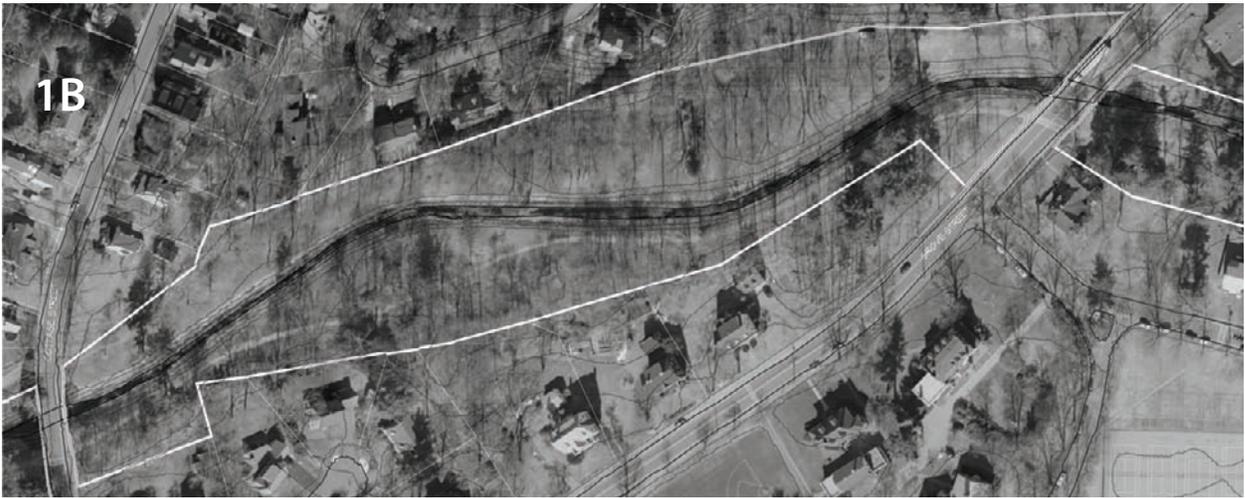
Map of Segment 1B. Cottage Street is to the left, Grove Street is to the right. The path is faintly visible running south of the brook.

Cottage Street marks the western edge of Segment 1B and Grove Street marks its eastern edge. There are no intersecting roads in this segment, but Denton Road dead ends just north of the park and there is a pedestrian right-of-way from the end of the road to the park. The main park path, which is gravel-surfaced and about 4' wide for most of Segment 1B, runs south of Fuller Brook.

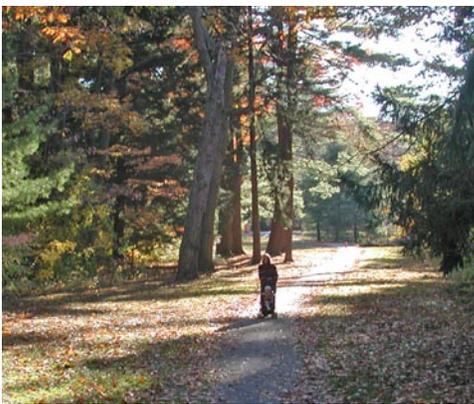
This section of the park has a wide path and poor drainage.

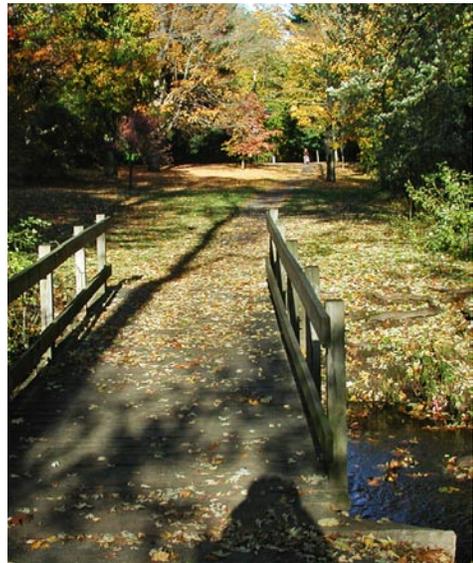
The main path crosses Cold Spring Brook at this bridge.

There is a late twentieth century pedestrian bridge over Cold Spring Brook with wooden structure and rails and concrete abutment. It is similar to the Leighton and Appleby footbridges, although the rails are more widely spaced. Near the Hunnewell School, three large stones function as informal benches. There are small trail posts at Grove and Cameron Streets.

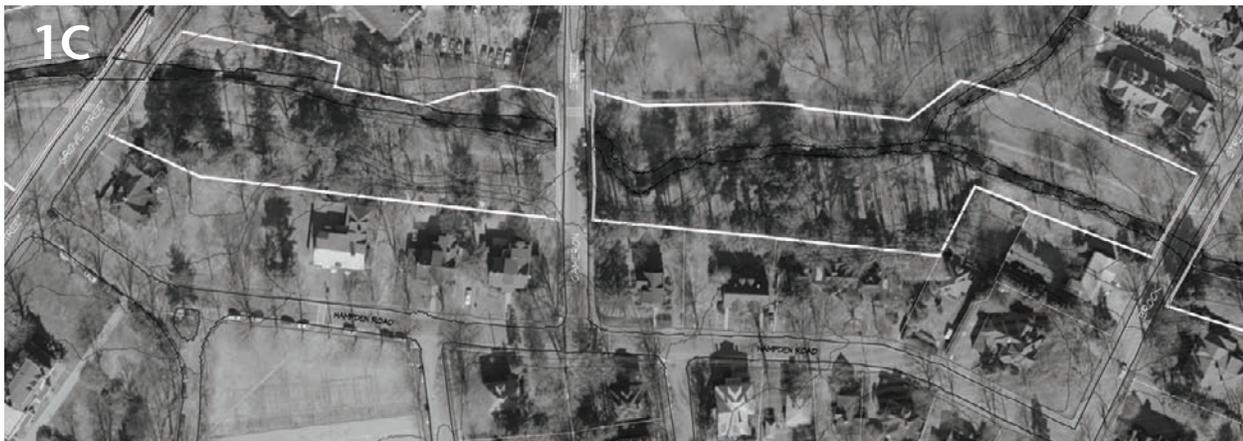
Map of Segment 1C. Grove Street is at the left, Cameron Street is in the center, Brook Street is at the right. Dana Hall School is at the lower left. Hunnewell School is just off the map at the upper right. Cold Spring Brook enters Fuller Brook from the top (north) near the right edge of the map.

In Segment 1C, the stream bed is narrow and deep at its western end, and wide and meandering at its eastern end. It has a more natural appearance than Segments 1A and 1B because it does not have riprap or curbing. East of Grove Street there is a change in grade marked by a flume. There is erosion east of Grove Street and sediment deposit and erosion east of Cameron Street. East of the Hunnewell School, Cold Spring Brook enters Fuller Brook from the north. The Grove Street flume is a narrow structure creating a channel about 30' long and 8-10' wide with granite block side walls reinforced with concrete at the bottom and outer edges. The concrete bottom creates a small waterfall at the west end.

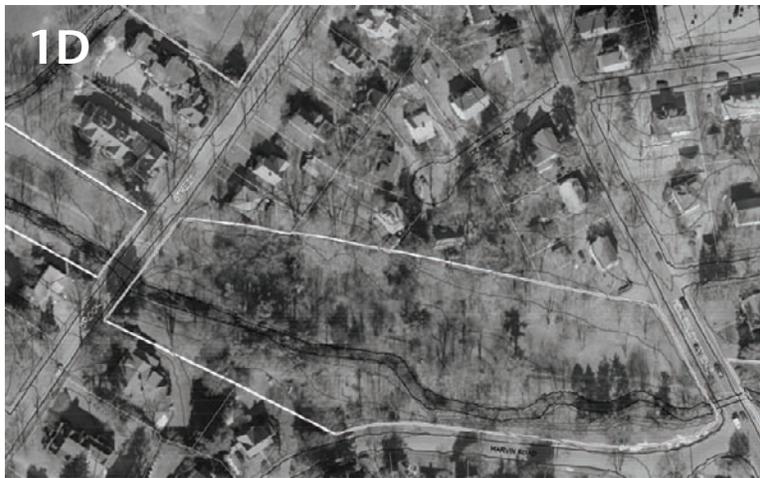
Map of Segment 1D. Brook Street is to the left, Wellesley Avenue is to the right. Note: This map is at the same scale as the other aerial views of Fuller Brook Park. It is smaller because this segment is considerably shorter than the other segments.

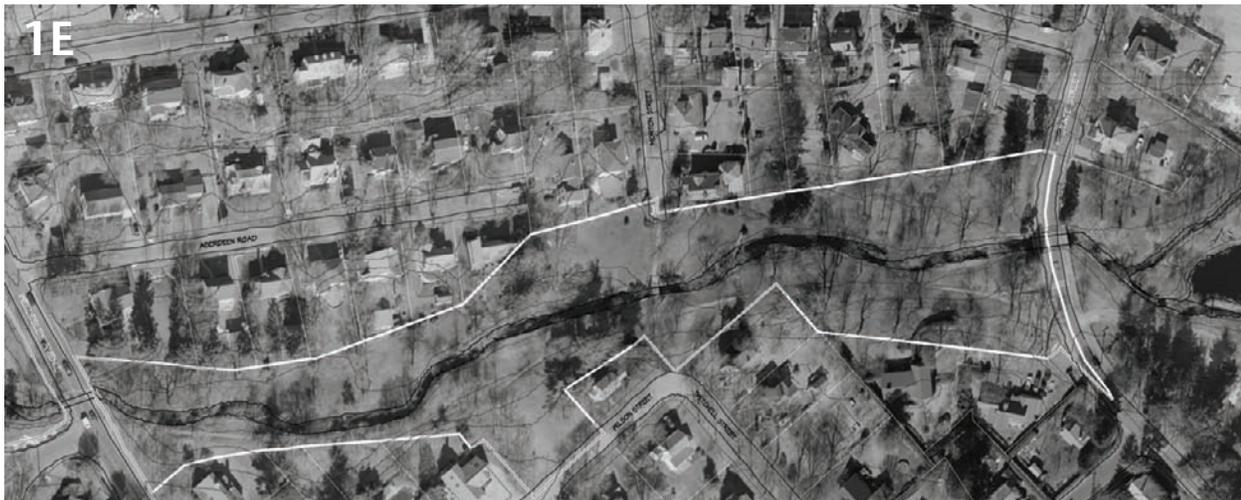
Map of Segment 1E. Wellesley Avenue is at the lower left and State Street is at the right. Part of Hunnewell Field is visible at the far right.

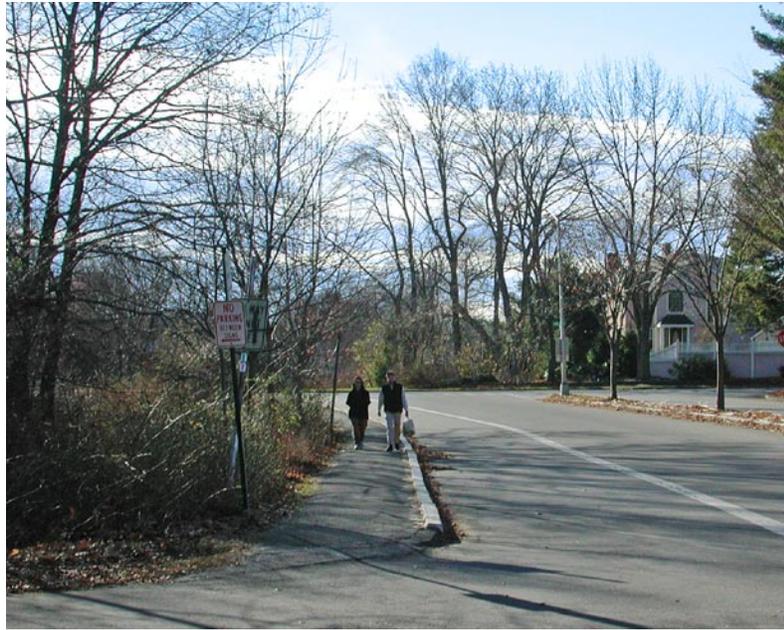
Between the wetland next to the High School and Hunnewell Field the Fuller Brook Park route follows this Paine Street sidewalk.

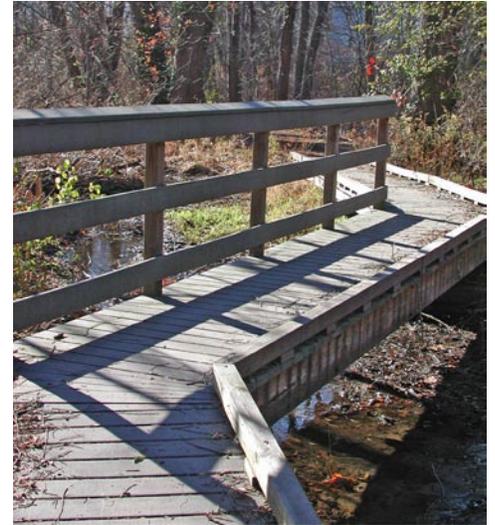
A narrow boardwalk bridge over Caroline Brook provides an environmentally appropriate stream crossing in this classic New England red maple swamp.

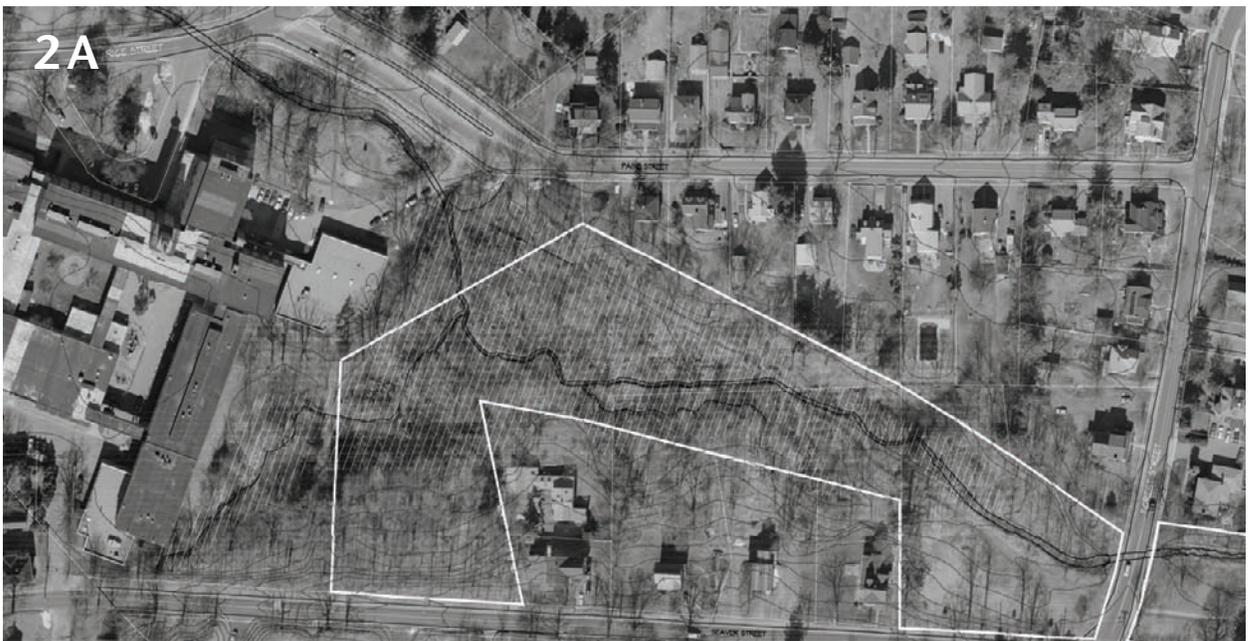
Map of Segment 2A. Wellesley High School is at the left, Paine Street is at the top, Forest Street is at the right, Sever Street is at the bottom.

ends at Forest Street. The path through the swamp is about 4' wide and earthen, with wood chips in wetter areas. As it approaches Forest Street it becomes a single track that is far narrower than the rest of the Fuller Brook Park trail system.

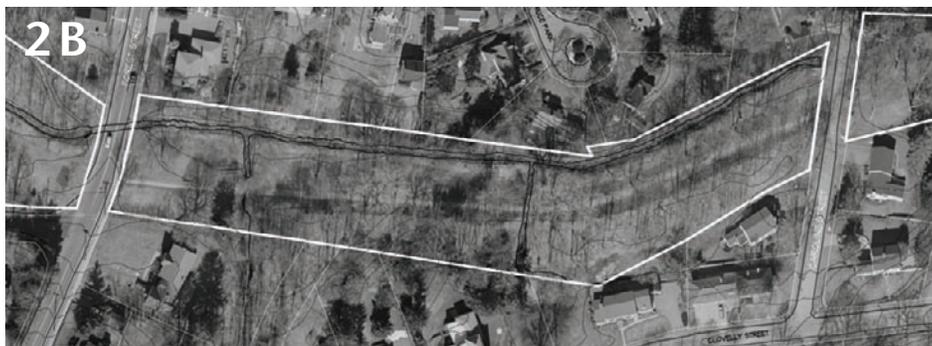
Map of Segment 2B. Forest Street is on the left, Caroline Street is on the right. There are no intersecting roads. The path is visible in the center of the park while the brook runs along the northern (top) edge. The upper right corner of the segment is where Caroline Brook emerges from underground pipes.

edge of the park, emerges from a culvert just west of Caroline Street, but is underground east of that. Two small channels run north/south across the park, emptying into Caroline Brook. There is some erosion and some wooden cribbing along parts of Caroline Brook.

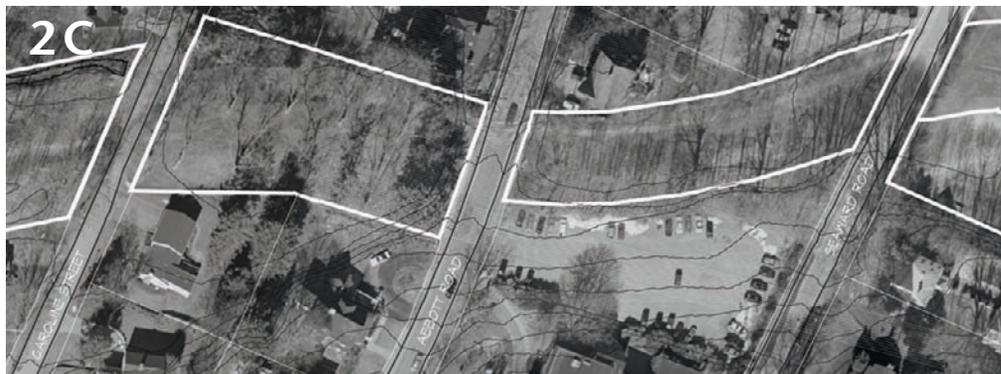
Map of Segment 2C. Caroline Street is on the left, Abbott Street is in the middle and Seaward Road is on the right. This segment is relatively short and is broken in the middle, making it seem even shorter.

Segment 2C begins at Caroline Street. It is bisected in the middle by Abbott Street, Seaward Road forms its eastern edge. For the entire length of this segment, the path is narrow and is surfaced with dirt, gravel or stone dust.

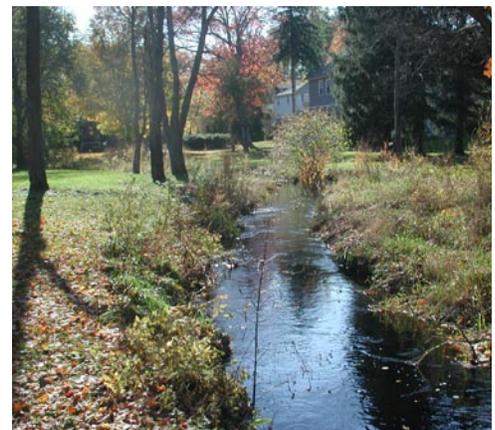
Invasive riparian species need to be controlled at numerous locations along the historic course of the stream.

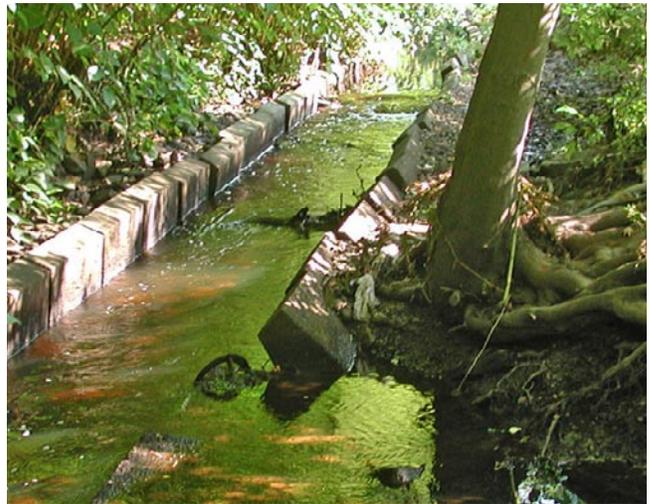
Derelict concrete stream channel liners, near Dover Road.

These problems consist primarily of bank erosion and stabilization issues, water channelization, invasive plant infestations and a lack of visual character. These issues are impacting the Brook's ability to treat and convey stormwater, act as a major flood control mechanism, provide viable wildlife habitat and serve as an interesting scenic resource.
