MORSES POND ANNUAL REPORT: 2019

PREPARED FOR THE TOWN OF WELLESLEY

BY WATER RESOURCE SERVICES, INC.

JANUARY 2020

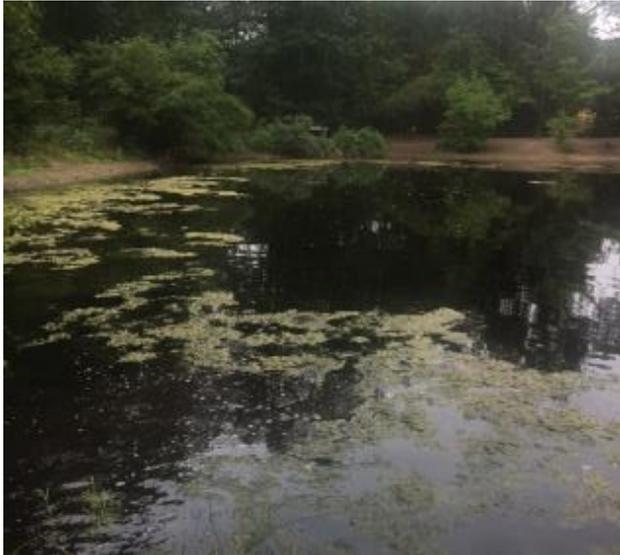
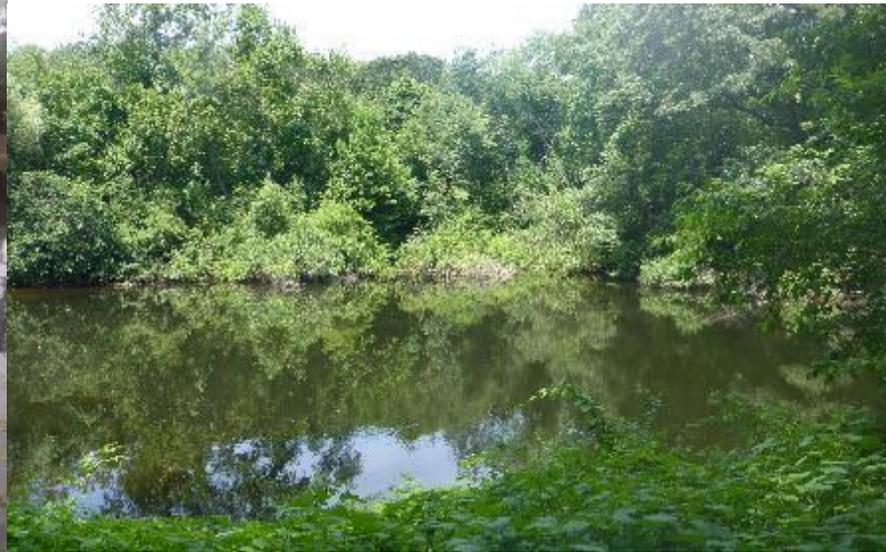
Figure 12. Photographic documentation of improvement in two Wellesley Ponds

Bezanson Pond August 2016

Bezanson Pond August 2019

The phosphorus inactivation program for these smaller ponds showed promise in 2018 and 2019. Bezanson and Farms Station Ponds exhibited markedly better conditions in 2019 than in past years and this may be all that is needed to keep those ponds in a condition appropriate for their intended uses. Use

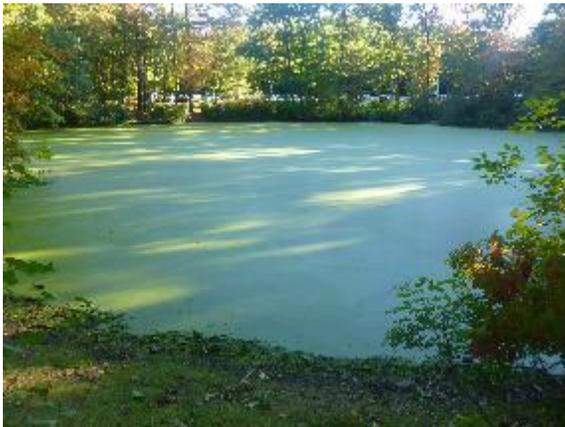
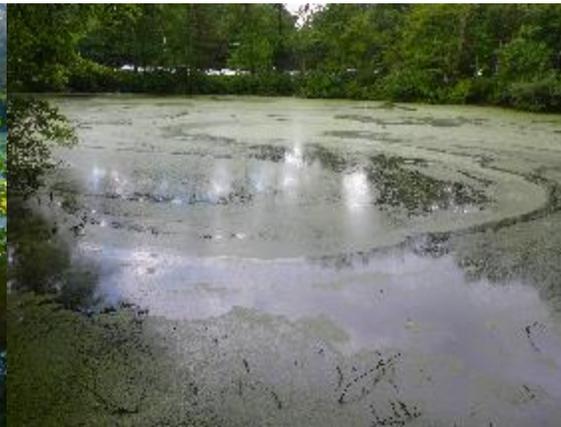
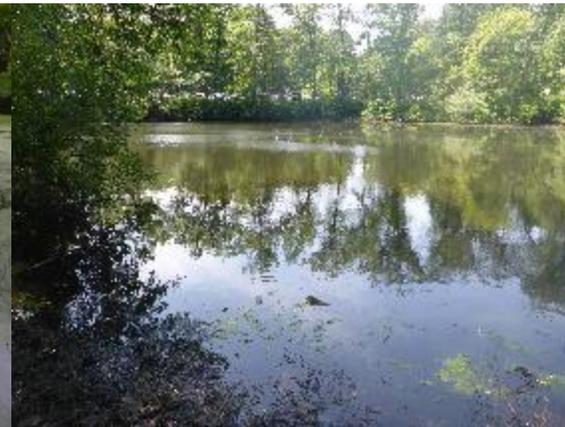
Farms Station Pond Sept 2016

Farms Station Pond Aug 2018

Farms Station Pond Aug 2019
