MORSES POND ANNUAL REPORT: 2013

PREPARED FOR THE TOWN OF WELLESLEY

BY WATER RESOURCE SERVICES, INC.

NOVEMBER 2013

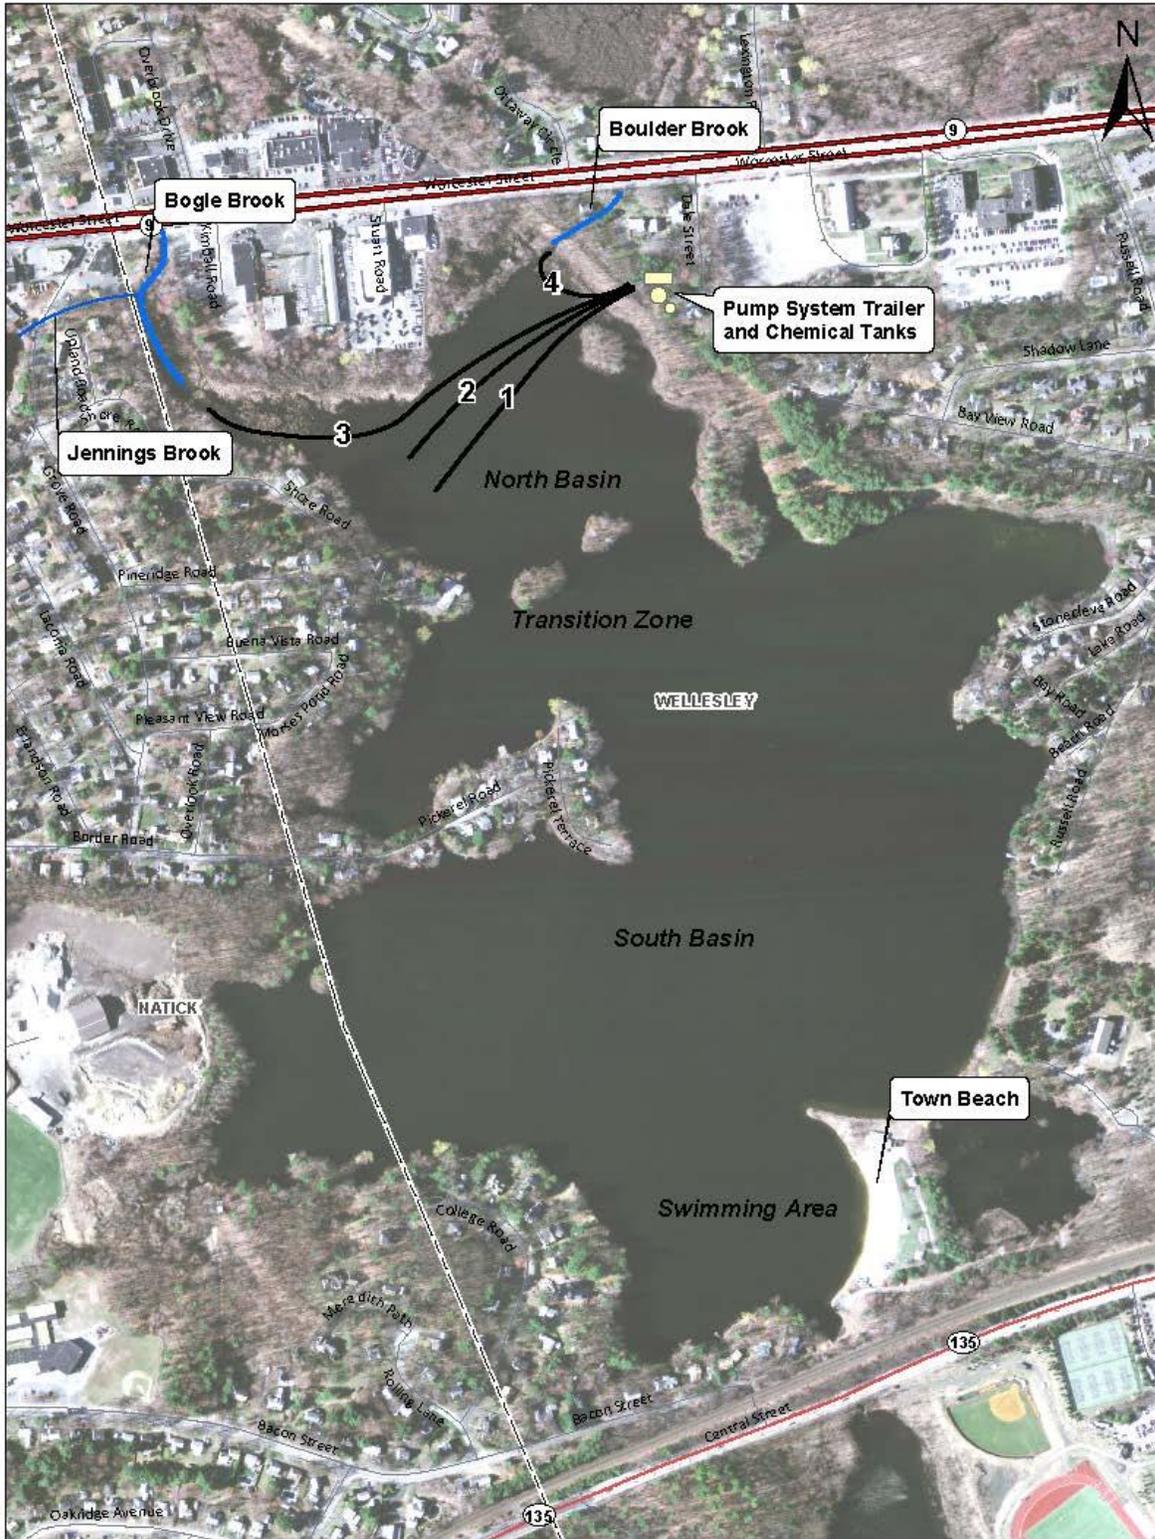
Figure 1. Phosphorus Inactivation System for Morses Pond

A phosphorus inactivation system was established in the spring of 2008, in the north basin of Morses Pond. After testing and initial adjustment in 2008, the system has been operated in the spring and early summer of 2009 through 2013. The chemical pump station is portable, but is stationed for the treatment period at the Town of Wellesley Dale Street Pump Station. Four sets of lines run from the pump station into the north basin (Figure 1), each set consisting of an air feed line and two chemical feed lines. The phosphorus inactivation chemicals used for the treatment are aluminum sulfate (alum) and sodium aluminate (aluminate). Both are flocculating agents responsible for the inactivation of phosphorus, with alum creating acidic conditions and aluminate shifting the pH to a more basic level; both are added at a roughly 2:1 ratio (alum to aluminate, by volume) to balance the pH of treatments.

Two lines with single diffusers and sets of chemical ports near the end of each line run within the north basin to the mouths of Boulder Brook and Bogle Brook. This facilitates inlet treatment, generally considered the most effective means of inactivation, given mixing and settling as the streams proceed into the north basin. The other two lines, each with four diffusers and corresponding chemical ports, are spaced within the north basin itself to allow treatment of water in that basin. This allows treatment if operation is not possible from the start of a storm, or if additional treatment in the basin appears necessary. However, as spring progresses, dense vegetation within the north basin limits horizontal mixing and overall system efficiency, and these lines were removed in 2013.

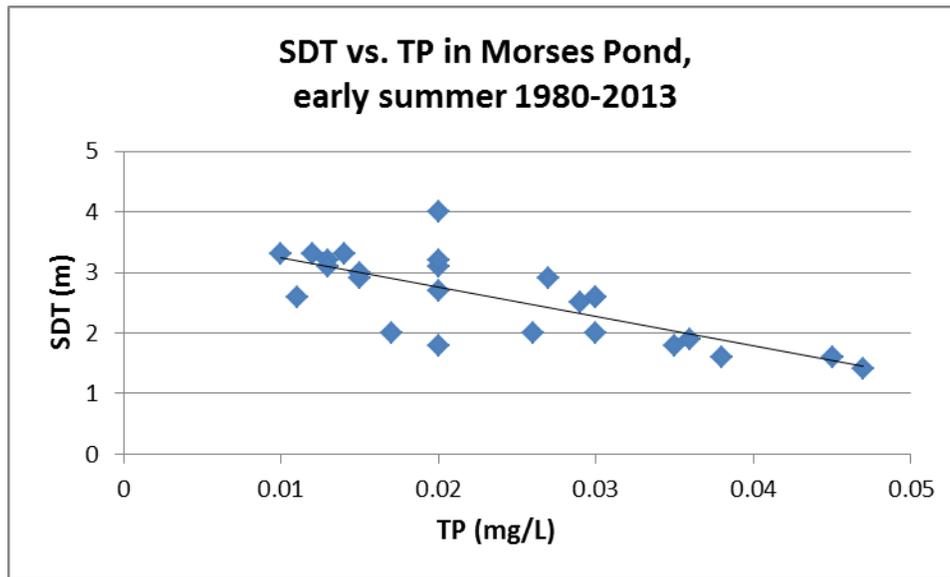
Figure 2. Relationship between water clarity and total phosphorus in Morses Pond, 1980-2013.

Water quality is assessed prior to the start of treatment, normally in May, early summer, and later in the summer in up to three areas: the north basin, the transition zone to the south basin just south of the islands, and near the town beach at the south end of the pond. Visual and water quality checks are made on an as needed basis, as part of normal operations or in response to complaints, major storms, or town needs. The complete water quality record for 2013 (Table 2) incorporates field and laboratory tests at multiple sites. A summary of phosphorus data for key periods since 2008 is provided (Table 3) to put the treatments and results in perspective. It is intended that total phosphorus will decrease through the treatment, such that values in the south basin, assessed in the swimming area near the outlet of the pond, will be lower than in the north basin, with the transition zone exhibiting intermediate values. Based on data collected since the early 1980s, total phosphorus in the south basin in excess of 20 ug/L tends to lead to algal blooms, while values <20 ug/L minimize blooms and values near 10 ug/L lead to highly desirable conditions (Figure 2).

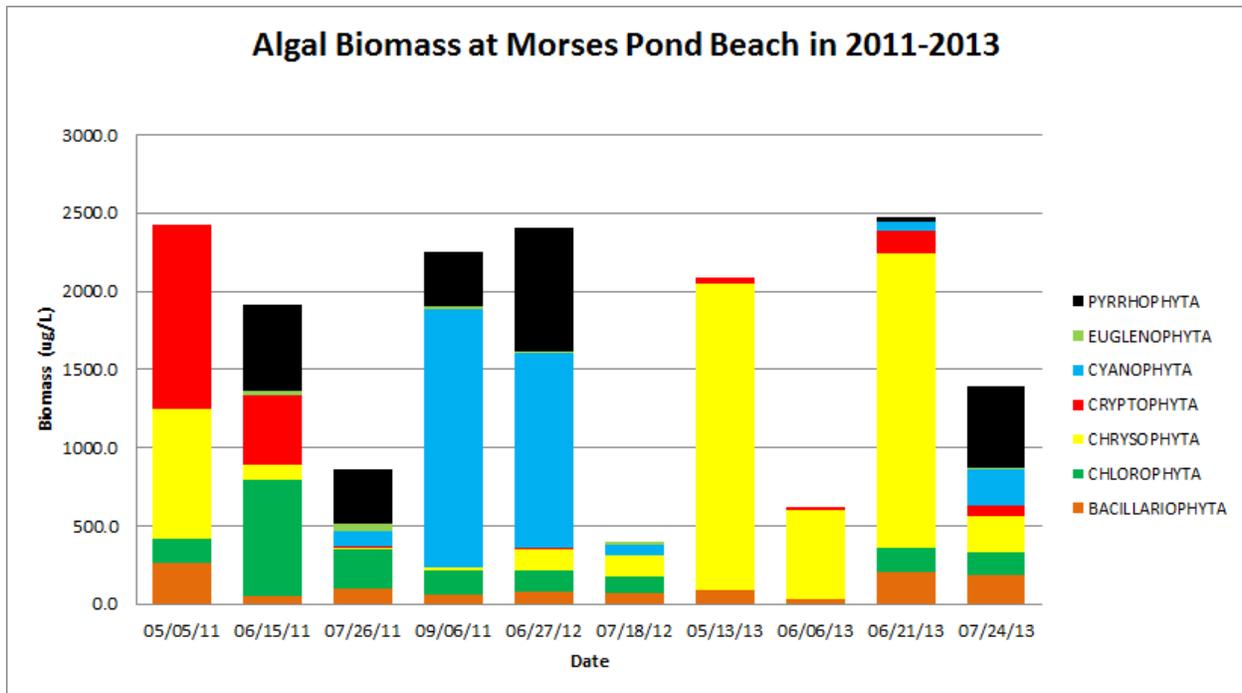
Figure 3. Algal Data for 2011-2013

Algal data for 2011-2013 illustrate processes in Morses Pond over the summer (Figure 3). Moderate densities of mainly coldwater forms in spring give way to lower densities more typical late spring forms such as green algae in June, with those densities further reduced and species composition further altered by the aluminum treatments, such that relatively low biomass of largely innocuous forms is observed in July of 2011. Lack of treatment allows algal densities to rebound over the rest of the summer, with blue-greens becoming dominant by September 2011. In 2012, conditions at the end of June were already similar to those in September of 2011, and algal density increased for the next two weeks, resulting in a bloom (there is no strict definition of a bloom, but biomass in excess of 5000 ug/L would be a reasonable threshold). No sample was collected during the mid-July 2012 bloom, as there

was a major storm just before we arrived at the lake, and it was thoroughly flushed. This resulted in low algal biomass on July 18, 2012, and was not the result of treatment. Biomass remained below late summer 2011 or early summer 2012 values for the rest of the summer of 2012, which may be due to the treatment of storms during summer of 2012. However, those treatments were not as efficient as they should have been, owing to frequent equipment malfunctions. Maintaining the algal assemblage features of mid-July 2011 is an appropriate goal for the phosphorus inactivation project.

Algae in 2013 were dominated by golden algae through June at concentrations no higher than 2500 ug/L, a desirable target. There was a shift in July to a more mixed assemblage that included greens and blue-greens, but still at acceptably low overall biomass levels. Treatment may have helped keep nutrient ratios in a zone that does not favor blue-greens (higher N:P ratios by virtue of P inactivation), but flushing is more likely to have been responsible for maintenance of desirable biomass levels. Additionally, completed dredging of the north basin enhanced detention capacity and should aid phosphorus reduction in the south basin. However, phosphorus levels exceeded the targeted 20 ug/L threshold most if not all of the time, which was not surprising in light of the frequent and intense storms in 2013.

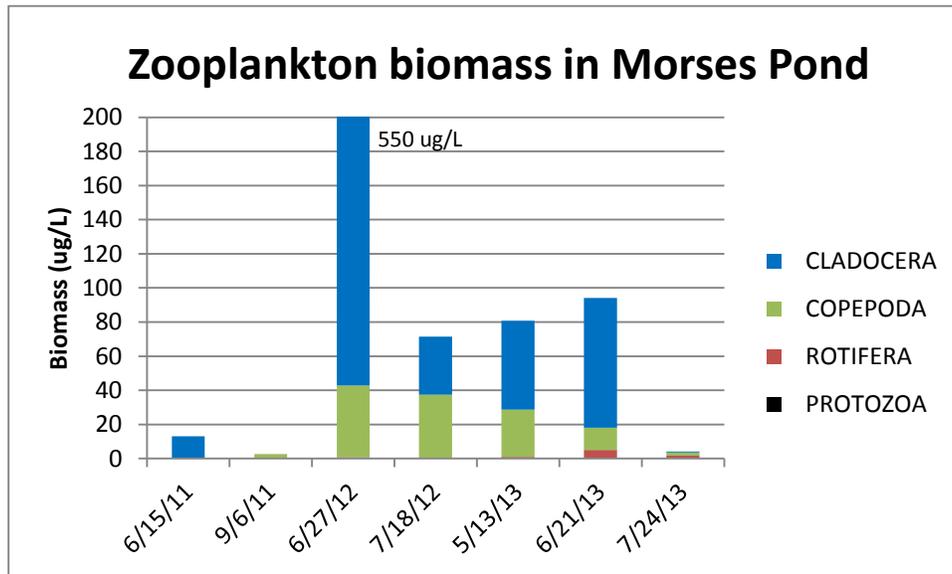
Figure 4. Zooplankton data for 2011-2013.

Zooplankton have also been sampled, and while not as tightly linked to nutrients, provide important information on the link between algae and fish (Figure 4). Zooplankton biomass varies strongly between and within years. Values <25 ug/L are low and values higher than 100 ug/L are high; Morses Pond values span that range and more. Values in later summer are expected to be lower than in late spring or early summer, as fish predation by young-of-the-year fish (those hatching that year) reduces populations of zooplankters. Spring levels will depend on water quality, predation by adult fish, and available algae,

which are food for zooplankton. The dominant zooplankton tend to be cladocerans and copepods, both groups of micro-crustaceans. *Daphnia*, among the larger cladocerans, filters the water to accumulate algae as food, and can increase water clarity markedly. *Daphnia* abundance was elevated in late spring of both 2012 and 2013, but not in 2011, but it was present in all three years, a good sign. The late summer zooplankton population was very low in 2011 and 2013, but was substantial in 2012. Variation does not appear to relate to aluminum treatments, which could be toxic at high concentration and high or low pH; the treatment protocols minimize this probability. Variation in fish reproduction and predation are suspected as the main causes of zooplankton variability, although flushing rate may have some influence as well.

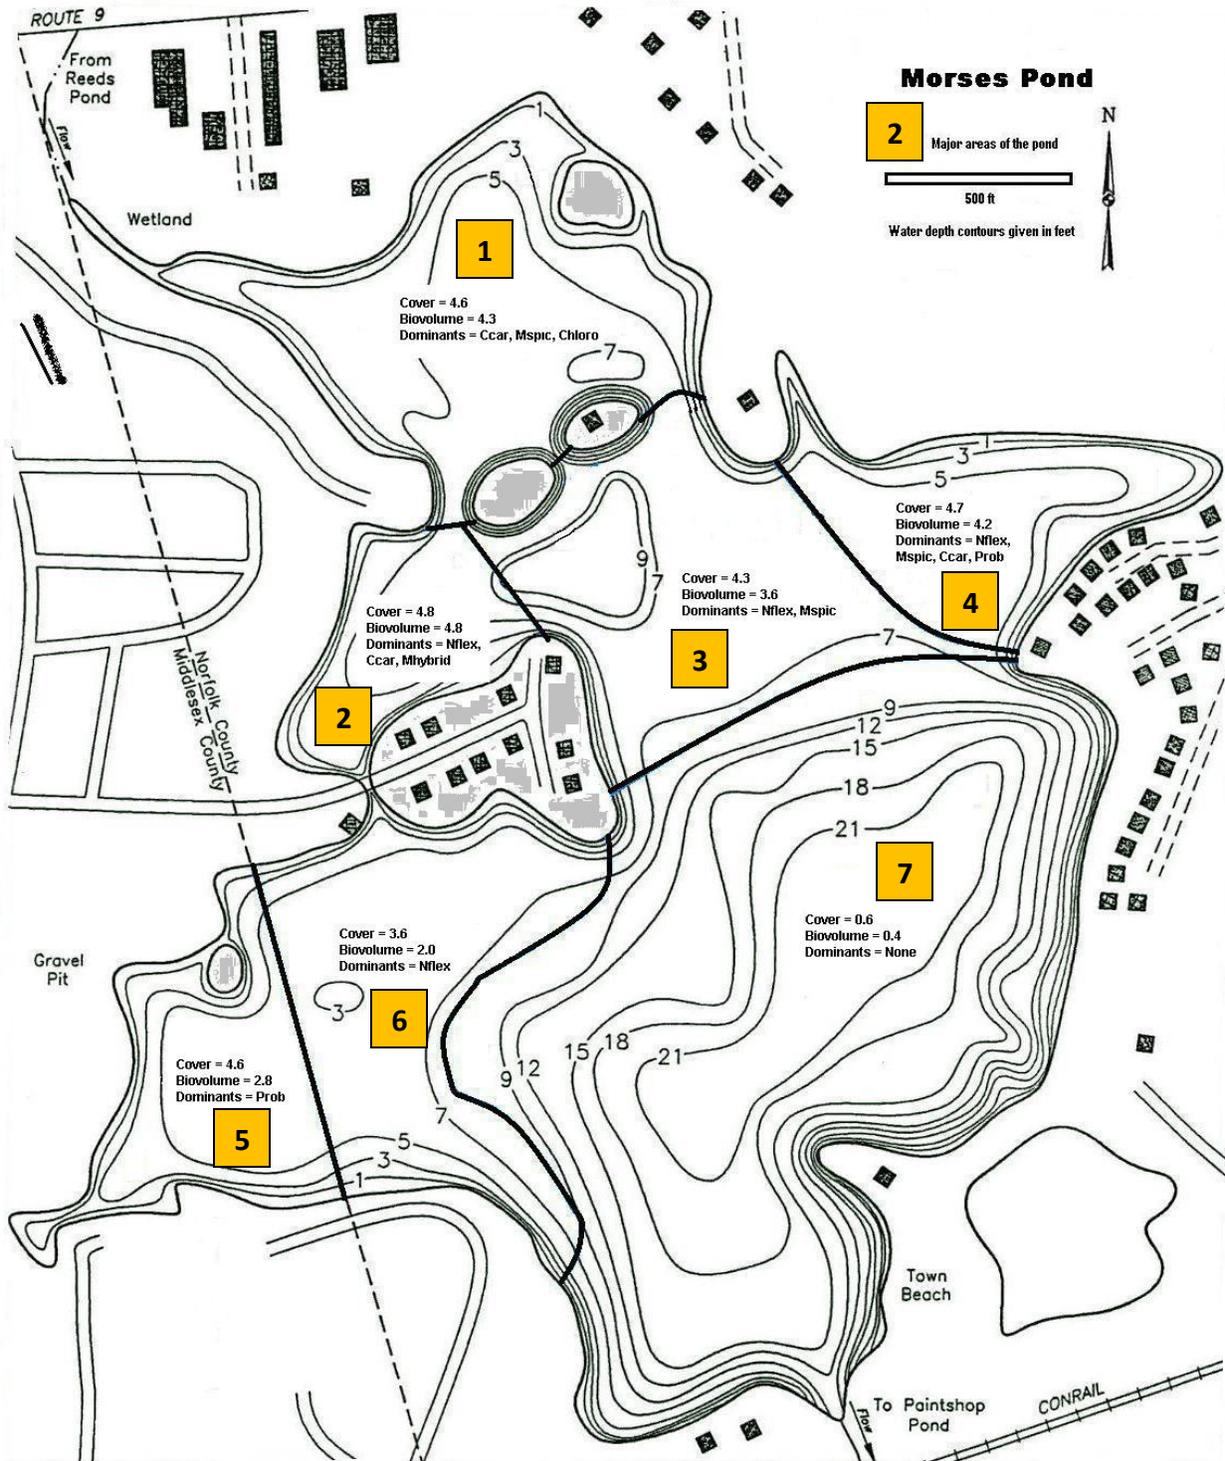
Figure 5. Plant Management Zones for Morses Pond.

- Initiating harvesting by the Memorial Day weekend.
- Cutting the southwest cove (Area 6) first, then proceeding through Areas 2, 3 and 4 in order of
- Cutting with or against the wind, but not perpendicular to the wind, to aid fragment collection.
- Limiting harvesting on very windy days (a safety concern as well as fragment control measure).

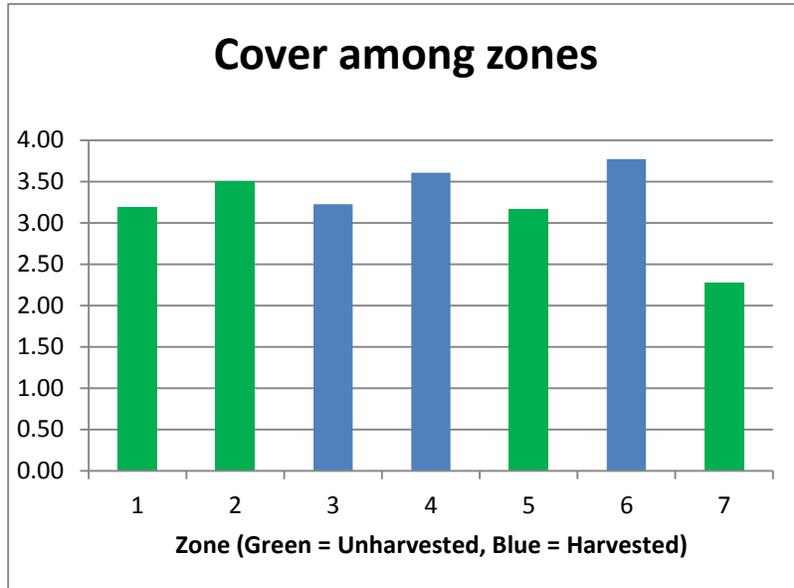
Figure 6. Cover Comparison Between Harvested and Unharvested Zones of Morses Pond in 2013.

Cover (Figure 6) is not greatly altered, as the harvester does not cut to the very bottom of the pond and this measure is two-dimensional. Biovolume (Figure 7) assesses the portion of the water column filled by plants in three dimensions, and is more directly relevant to how people perceive pond condition. The 2013 data shows considerable reduction between harvested and unharvested zones. It is apparent that harvesting, even just the first half of the spring effort, has a clear impact on plant biovolume.

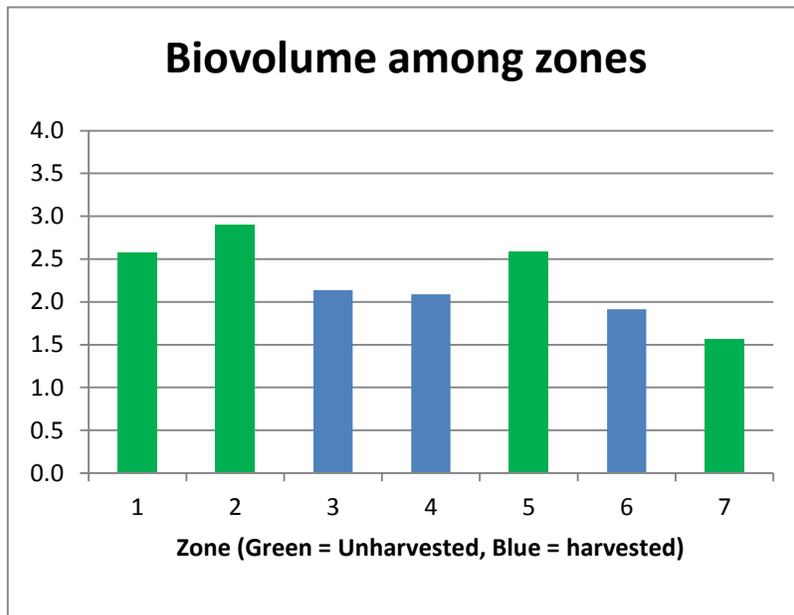
Figure 7. Biovolume Comparison Between Harvested and Unharvested Zones of Morses Pond in 2013.

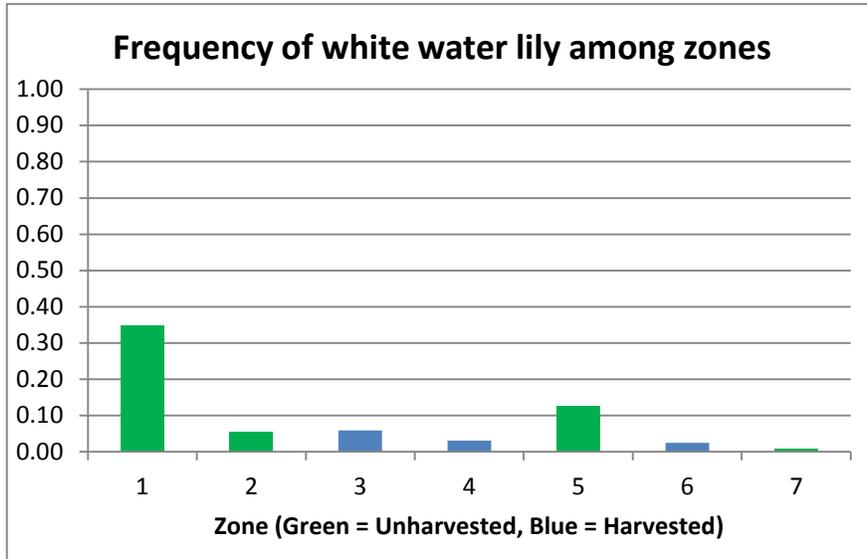
Figure 8. Comparison of White Water Lily Frequency Between Harvested and Unharvested Zones.

Discernible frequency reductions from harvesting are few. White water lily (Figure 8) and yellow water lily (Figure 9) showed decreases, while no apparent change is observed for the major invasive species fanwort (Figure 10), variable milfoil (Figure 11), and Eurasian milfoil (Figure 12). Harvesting does not remove the whole plant in most cases, but biomass is reduced, so the frequency of occurrence of the plants (presence/absence of a plant at a survey location) is largely unchanged while biovolume measures decrease. Those species that are reduced in frequency are more susceptible to harvesting; for example, the bulk of the plant biomass is at the surface for water lilies.

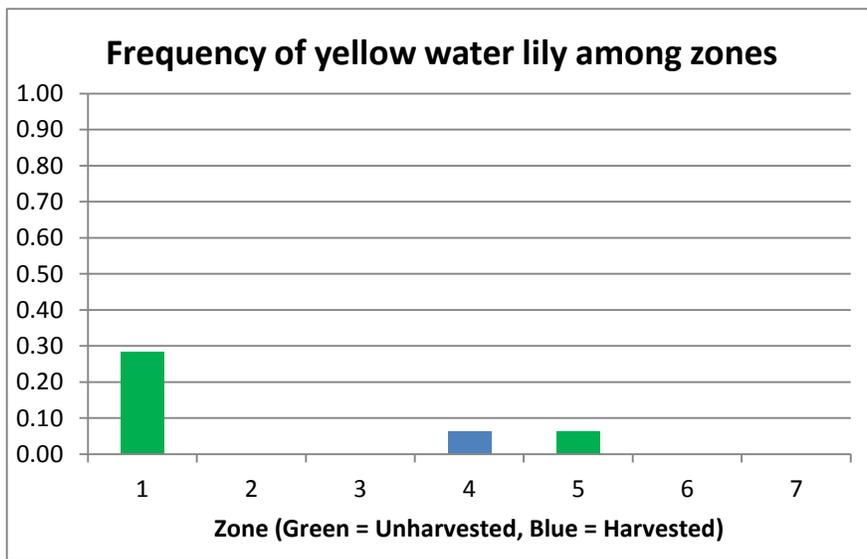
Figure 9. Comparison of Yellow Water Lily Frequency Between Harvested and Unharvested Zones.

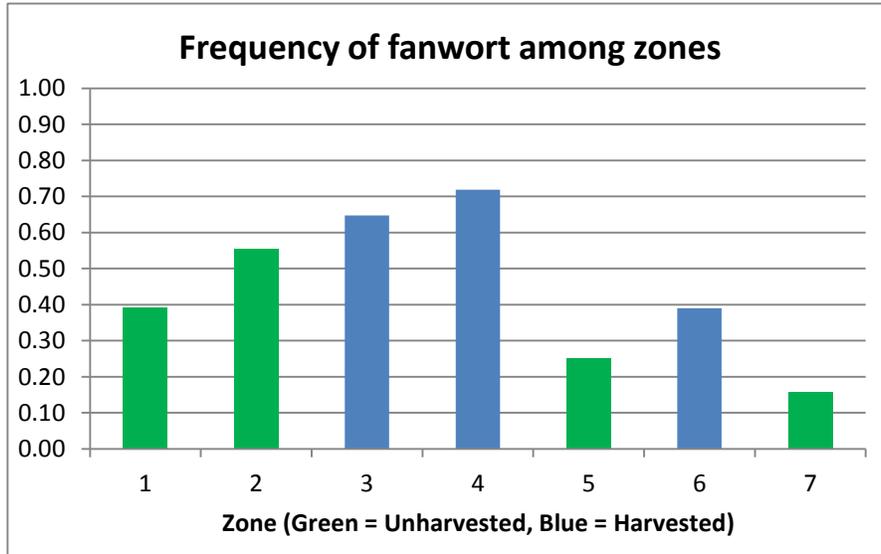
Figure 10. Comparison of Fanwort Frequency Between Harvested and Unharvested Zones.

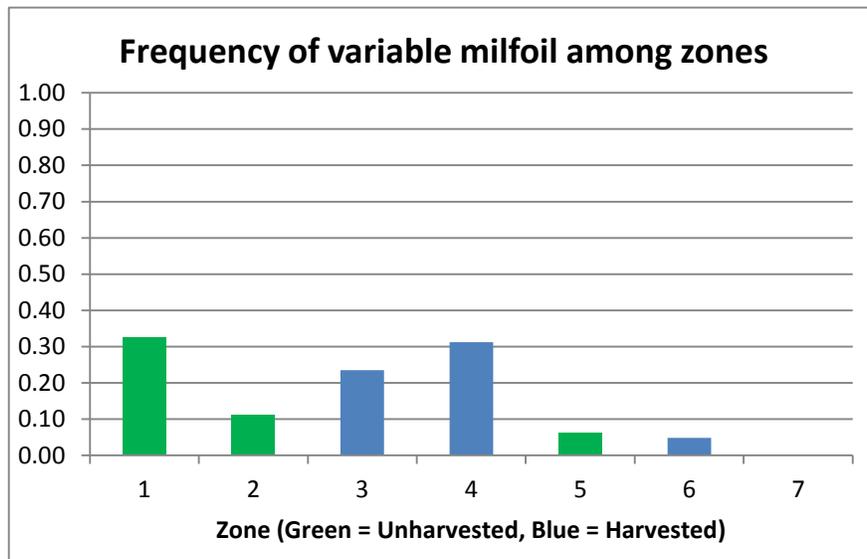
Figure 11. Comparison of Variable Milfoil Frequency Between Harvested and Unharvested Zones.

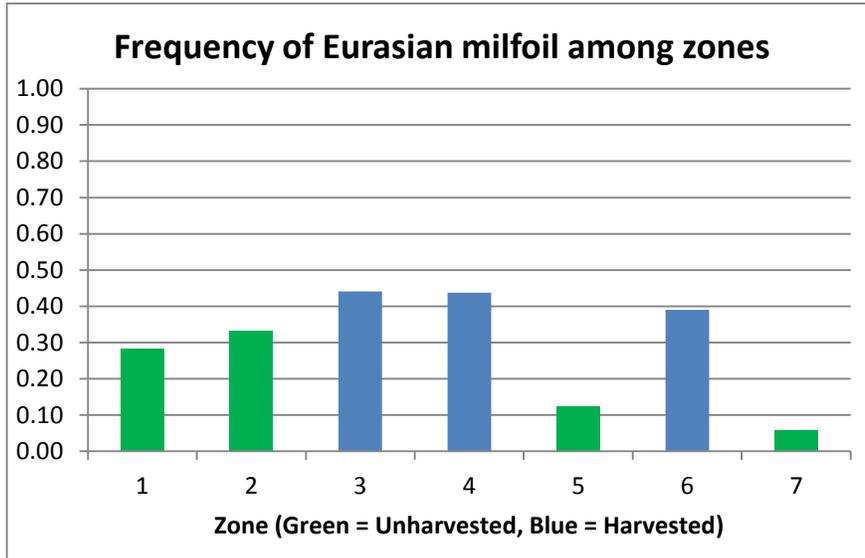
Figure 12. Comparison of Eurasian Milfoil Frequency Between Harvested and Unharvested Zones.

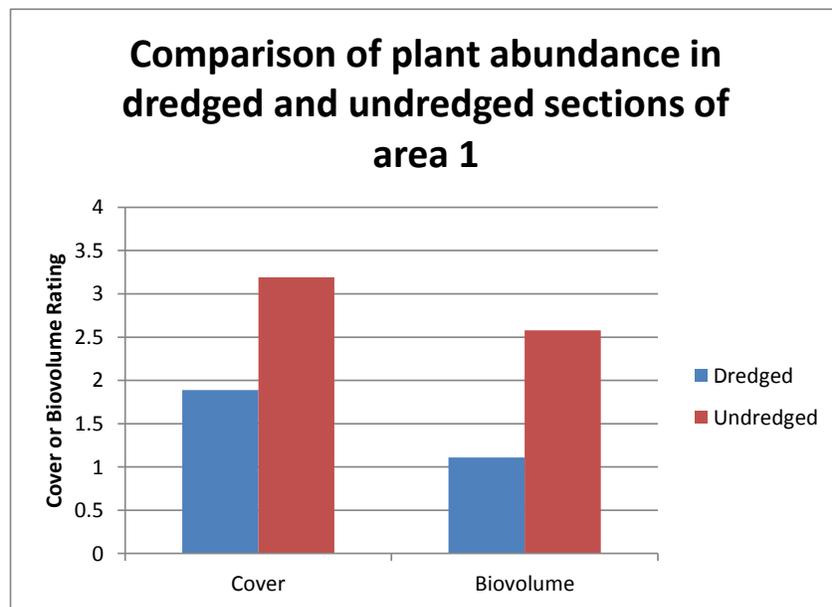
Figure 13. Comparison of plant cover and biovolume in area 1 for dredged and undredged sections.

The plant survey included some points in the dredging area, allowing comparison with non-dredged, unharvested areas (Figure 13). Cover and biovolume were both substantially reduced. However, invasive submergent species were the most common plants found in the dredged areas, albeit at low densities. Visual assessment indicated some accumulation of fine silt after only a month since dredging ended, but this sloughing of nearby organic matter into the new “hole” was expected. The substrate is mostly sandy, but plant growth can be expected in water <8 ft deep. A substantial portion of this area is deeper than 8 ft, however, so regrowth may be low as a function of light limitation.
