81 Arnold Road

Wellesley Planning Board Large House Review Application
Applicant: D. Michael Collins
Land Owner: Greta & Matthew Fruhan
Address: 81 Arnold Road

Statement of Intent

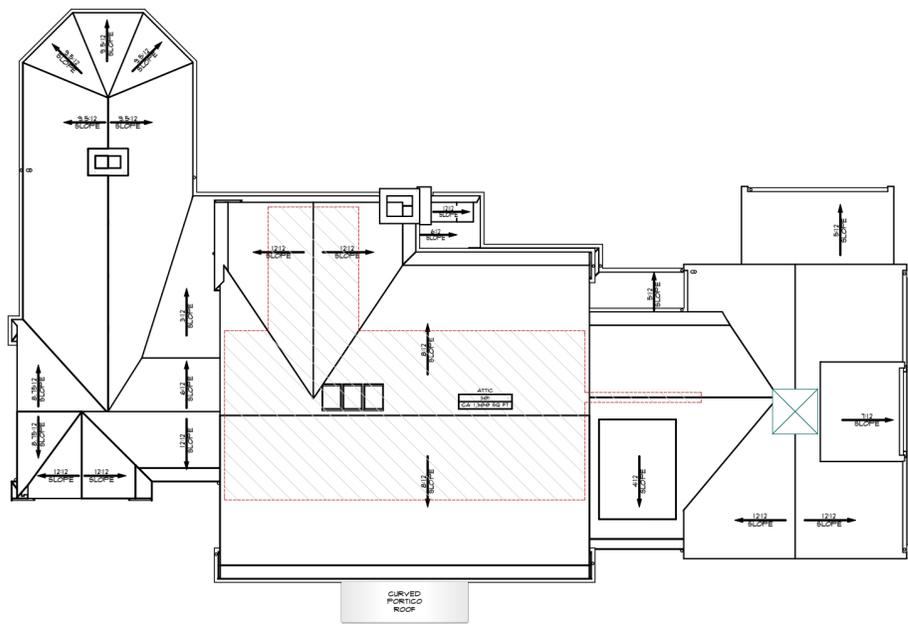
1 ROOF PLAN W/ ATTIC AREA 1,300 SQ.FT.
 SCALE: 1/16" = 1'-0"
 0 8' 16' 32'

TLAG	
PROPOSED FOUNDATION TLAG	0 SQ.FT.
PROPOSED FIRST FLOOR TLAG	4,788 SQ.FT.
PROPOSED SECOND FLOOR TLAG	3,220 SQ.FT.
PROPOSED ATTIC SPACE TLAG	1,300 SQ.FT.
PROPOSED TOTAL	9,308 SQ.FT.

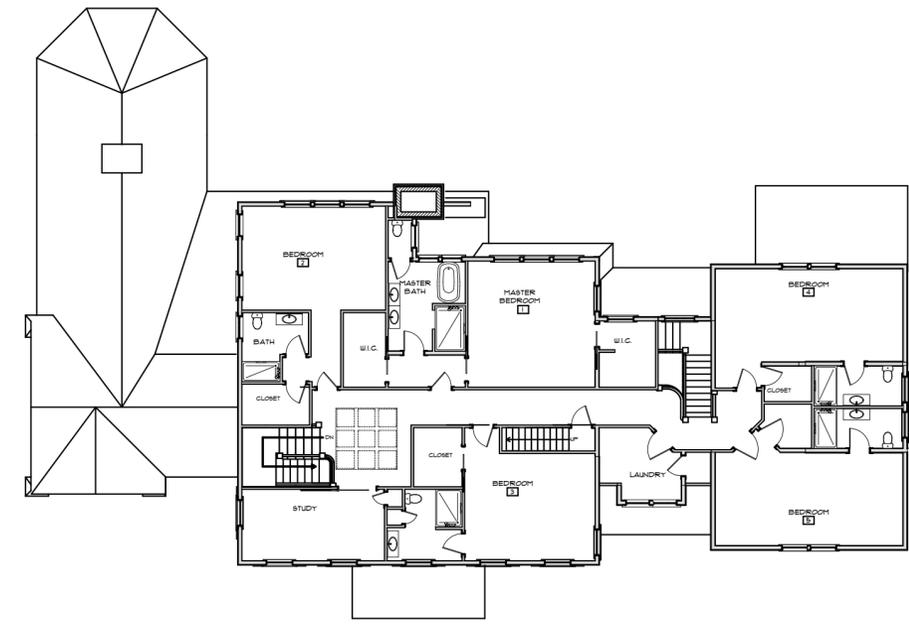
2 2ND FLOOR AREA 3,220 SQ.FT.
 SCALE: 1/16" = 1'-0"
 0 8' 16' 32'

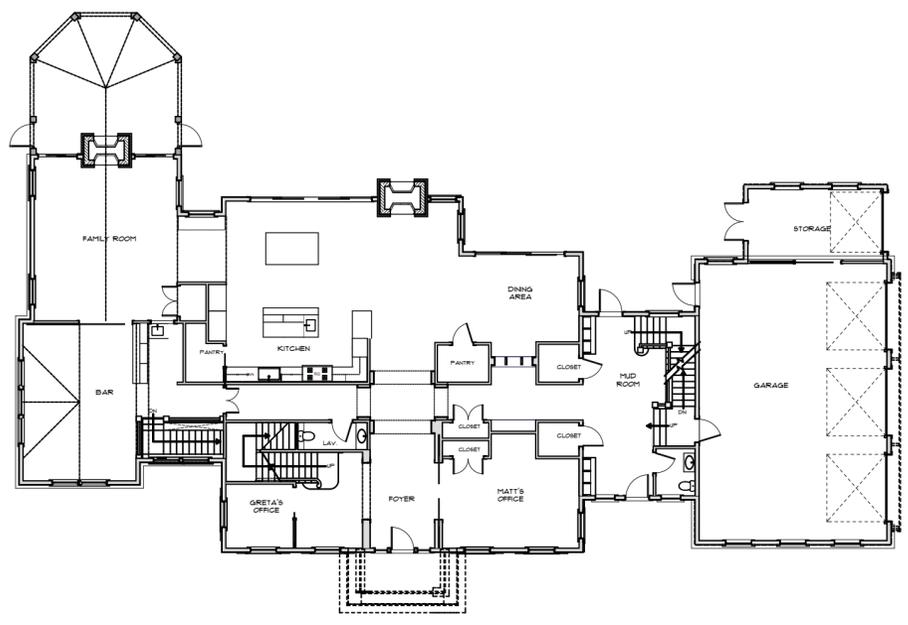
3 1ST FLOOR AREA PLUS GRAGE 4,788 SQ.FT.
 SCALE: 1/16" = 1'-0"
 0 8' 16' 32'

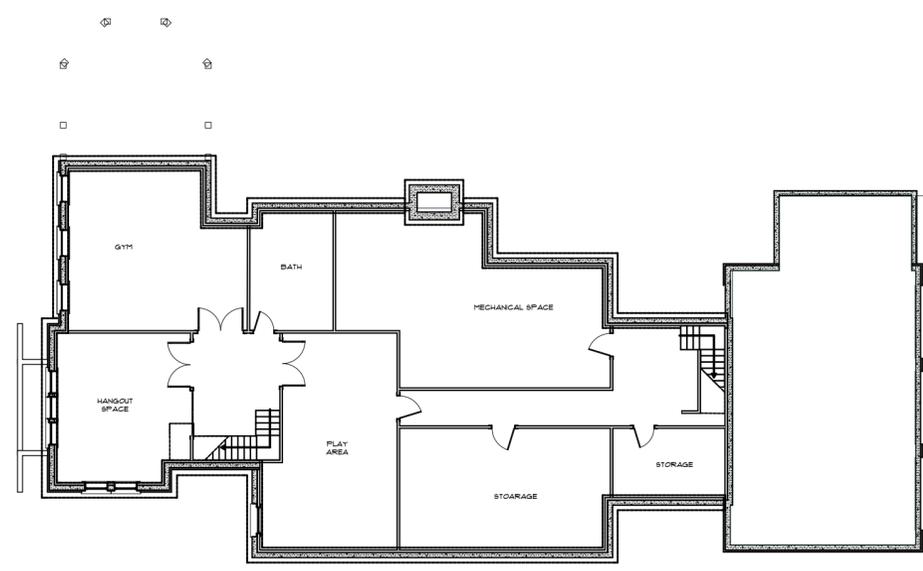
4 BASEMENT TLAG 3,421 SQ.FT.
 SCALE: 1/16" = 1'-0"
 0 8' 16' 32'

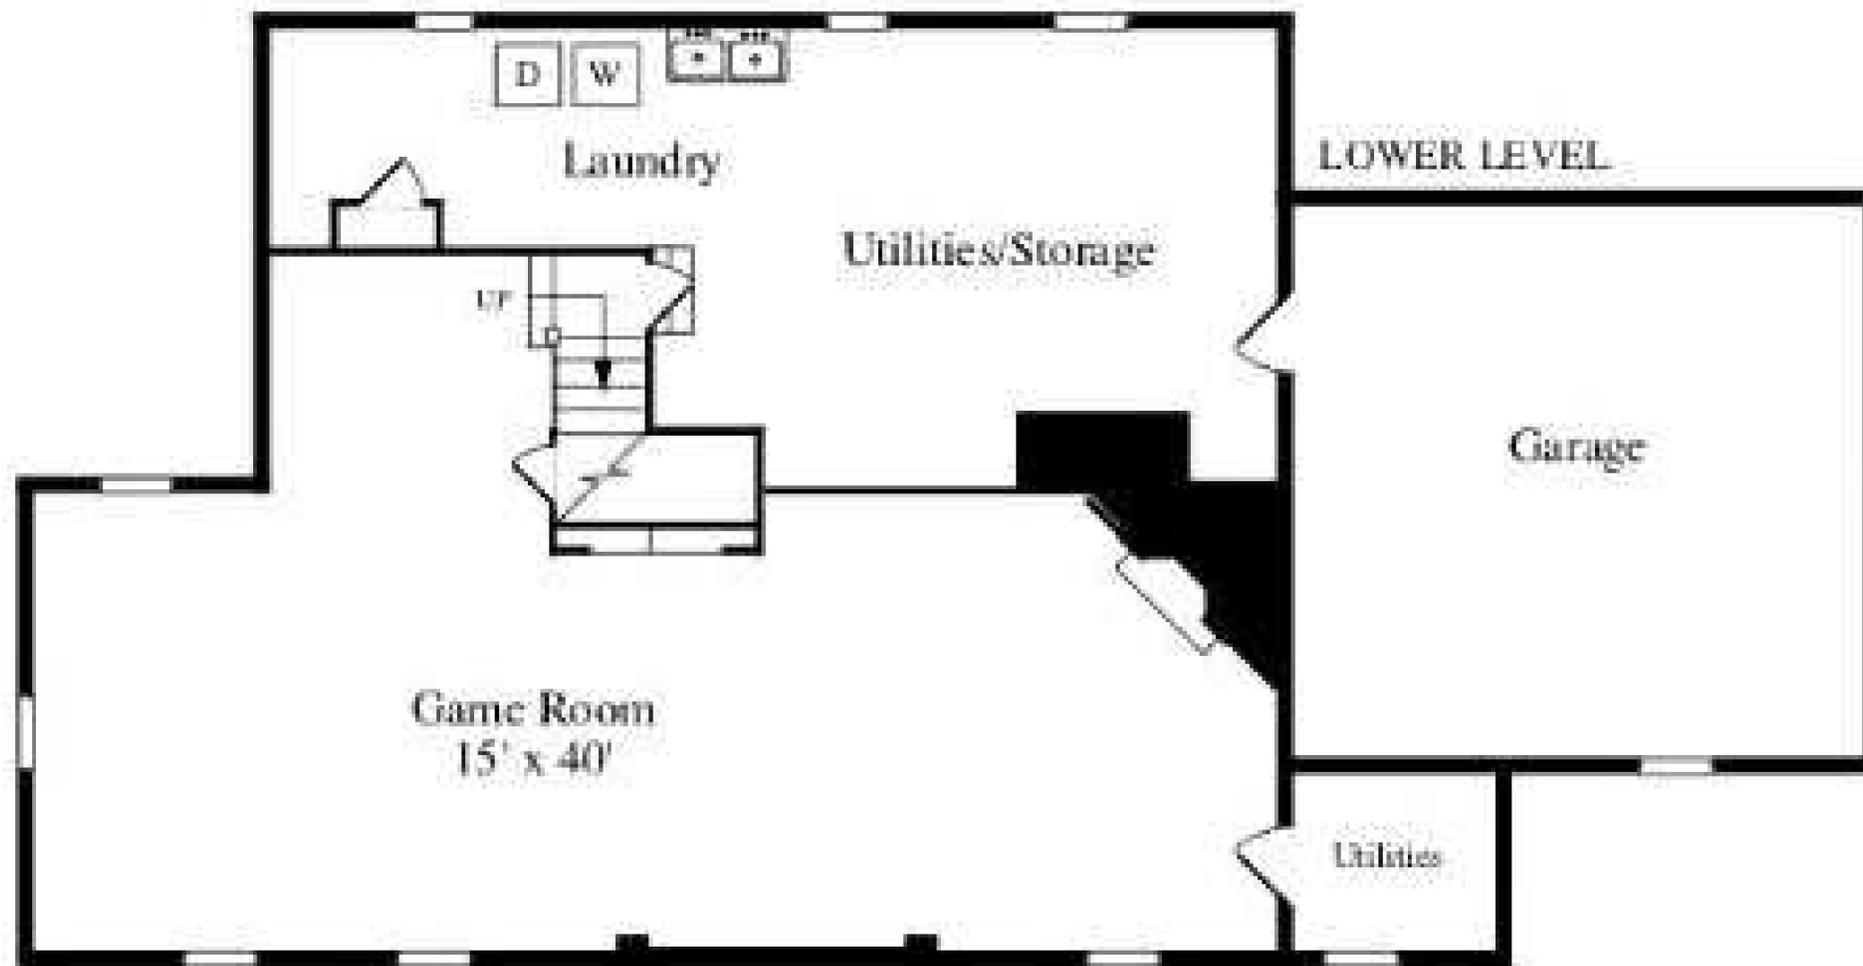
DWG. #
EX-1.0

EXISTING BASEMENT PLAN
SCALE: 1/8" = 1'-0"

TLA- 802 SF

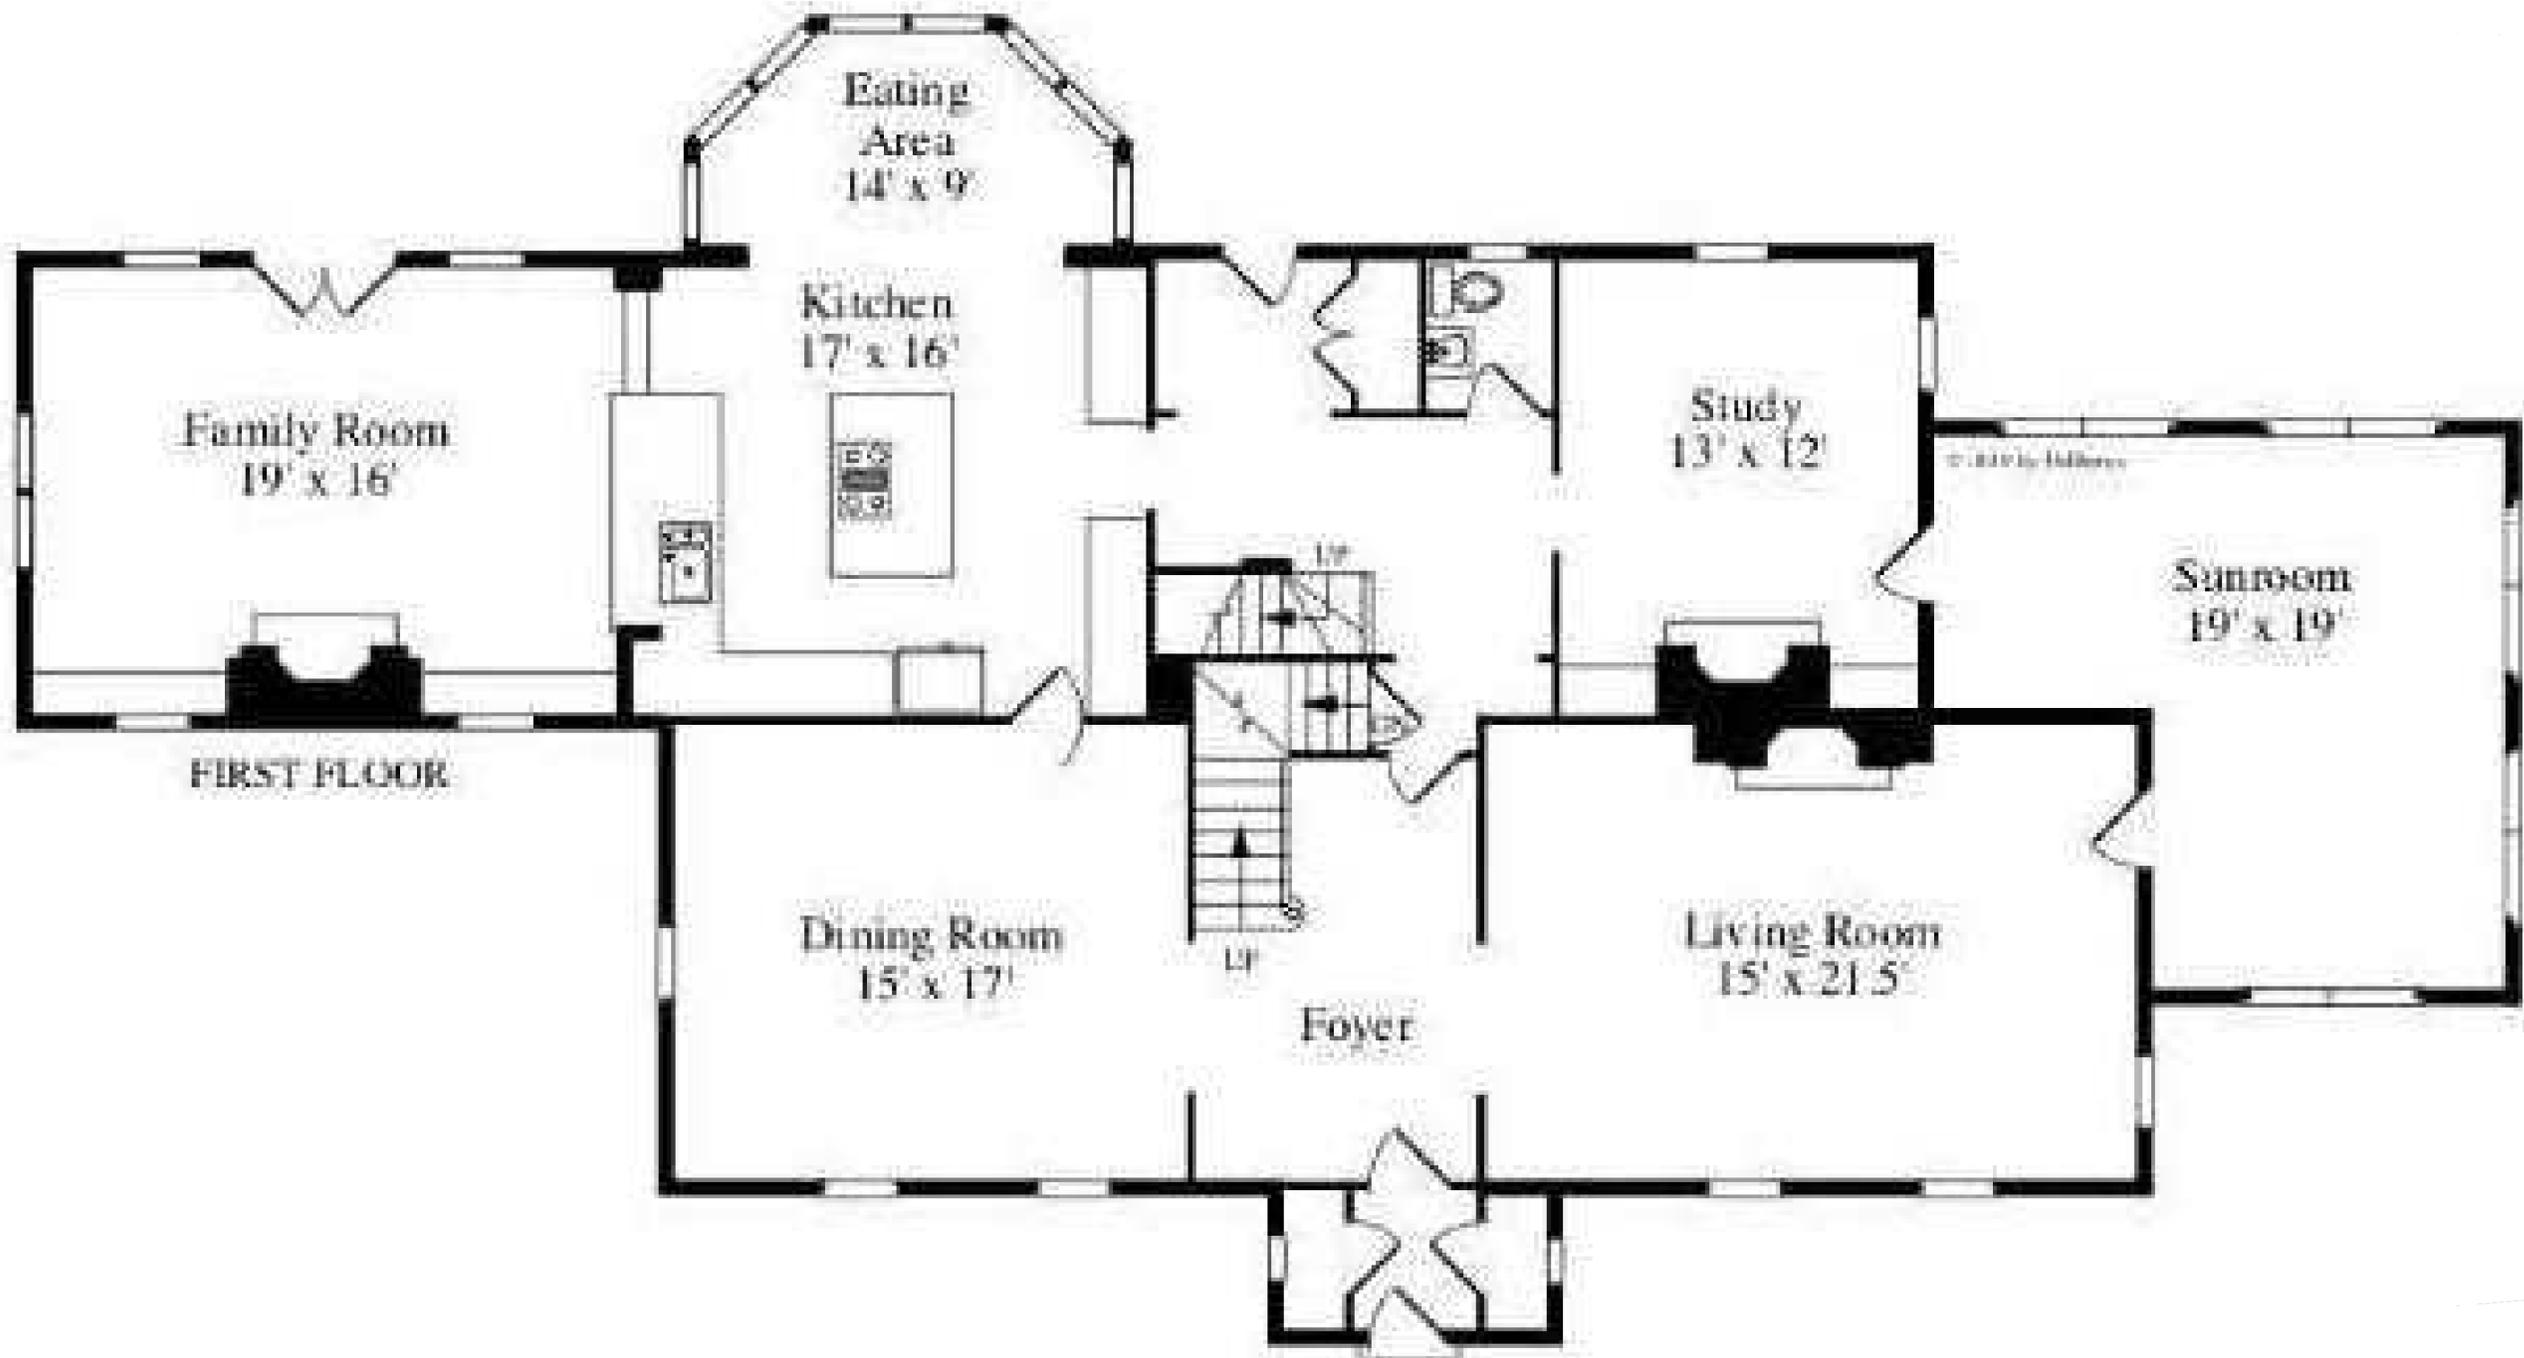
DWG. #
EX-1.1

EXISTING FIRST FLOOR PLAN
 SCALE: 1/8" = 1'-0"

TLA 2,276 SF

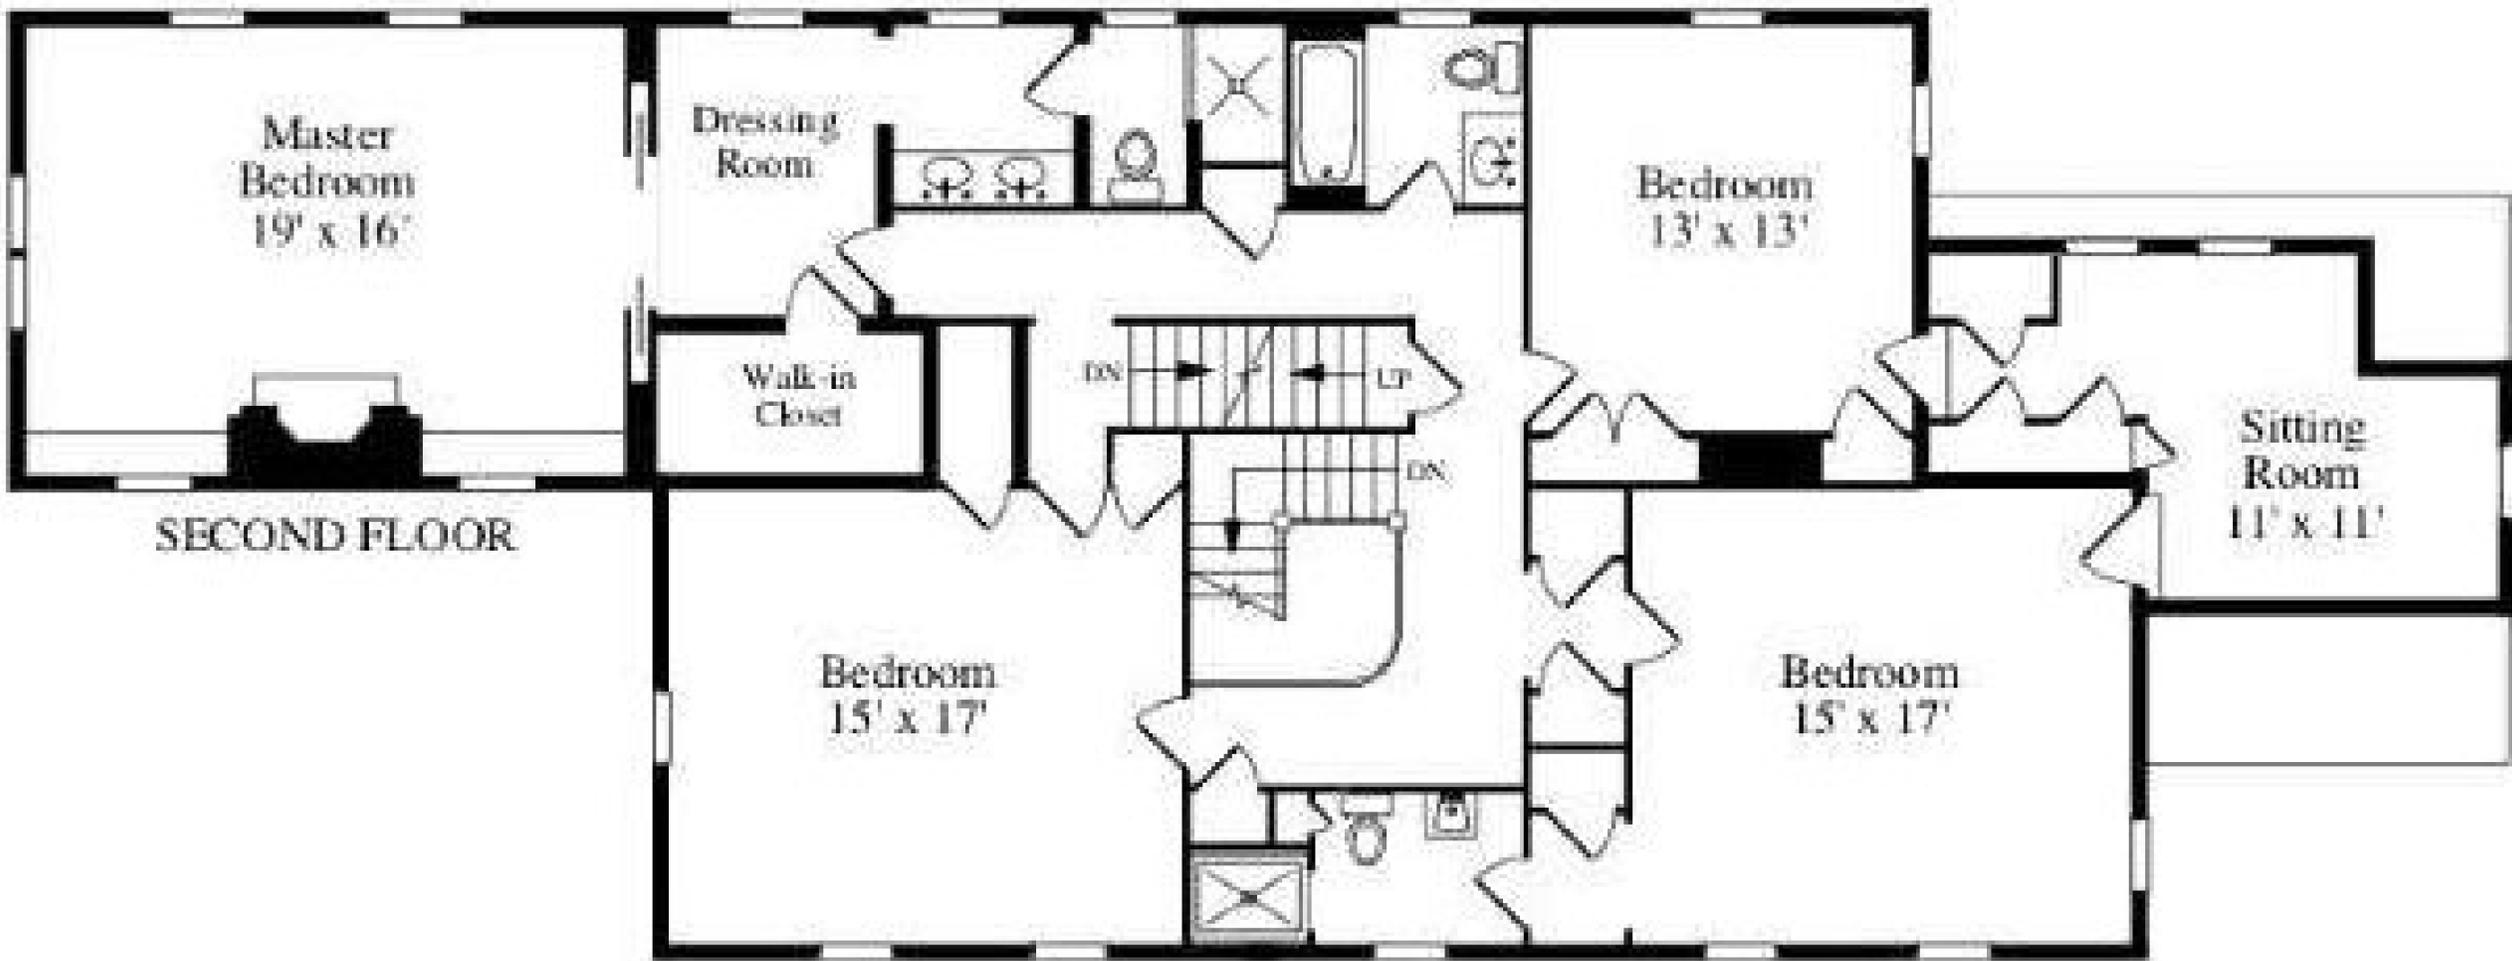
DWG. #
EX-1.2

EXISTING SECOND FLOOR PLAN
SCALE: 1/8" = 1'-0"

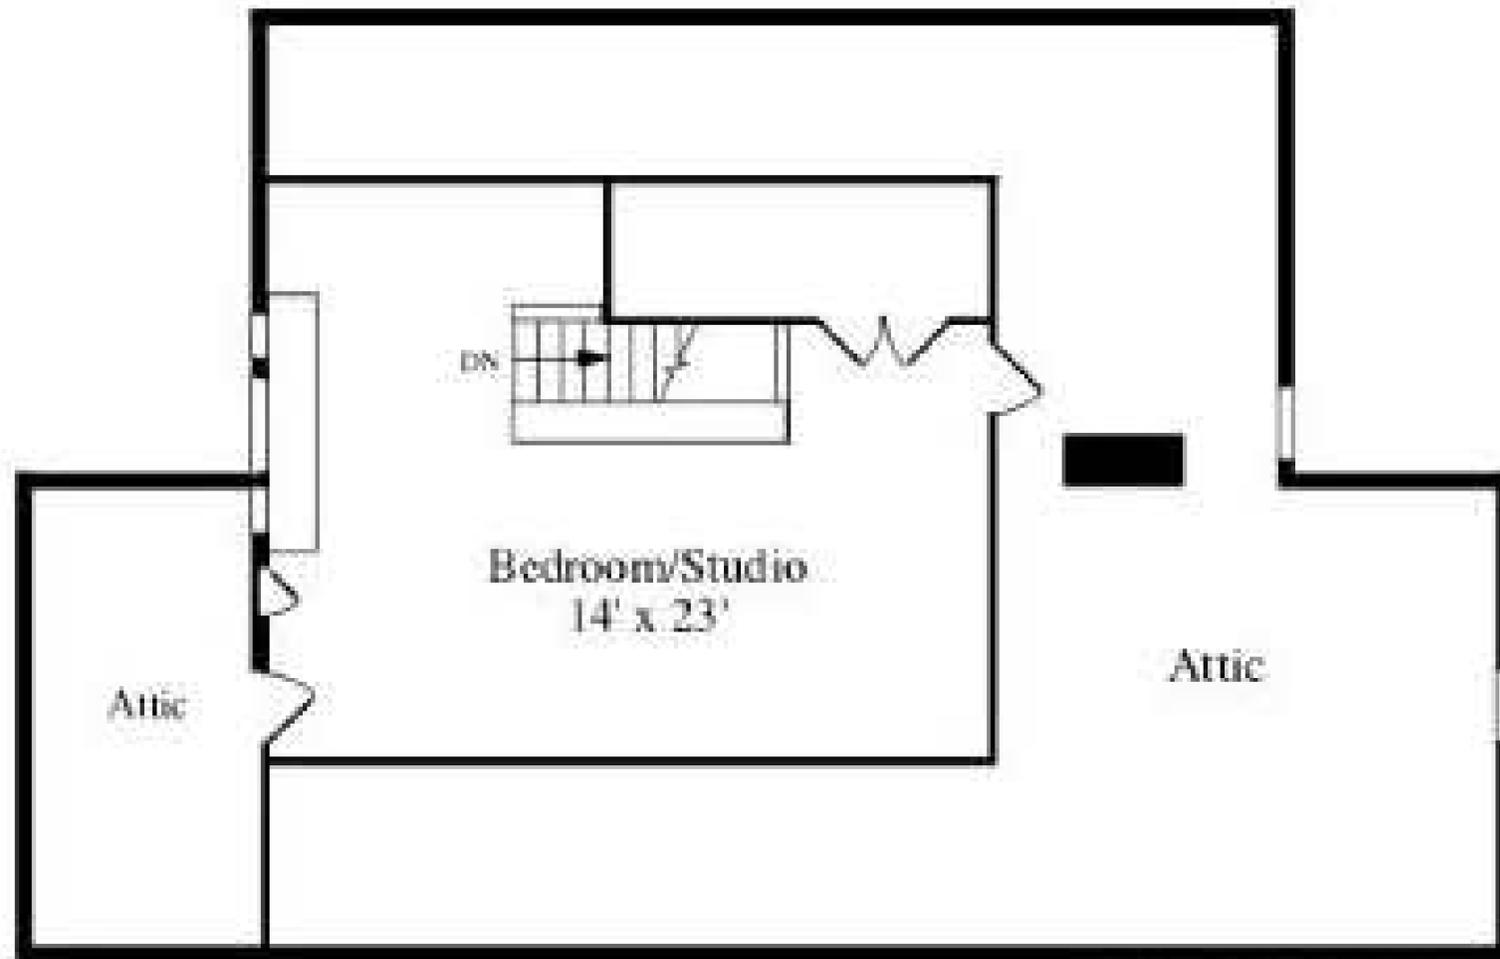
EXISTING ATTIC PLAN
 SCALE: 1/8" = 1'-0"

TLA - 429 SF

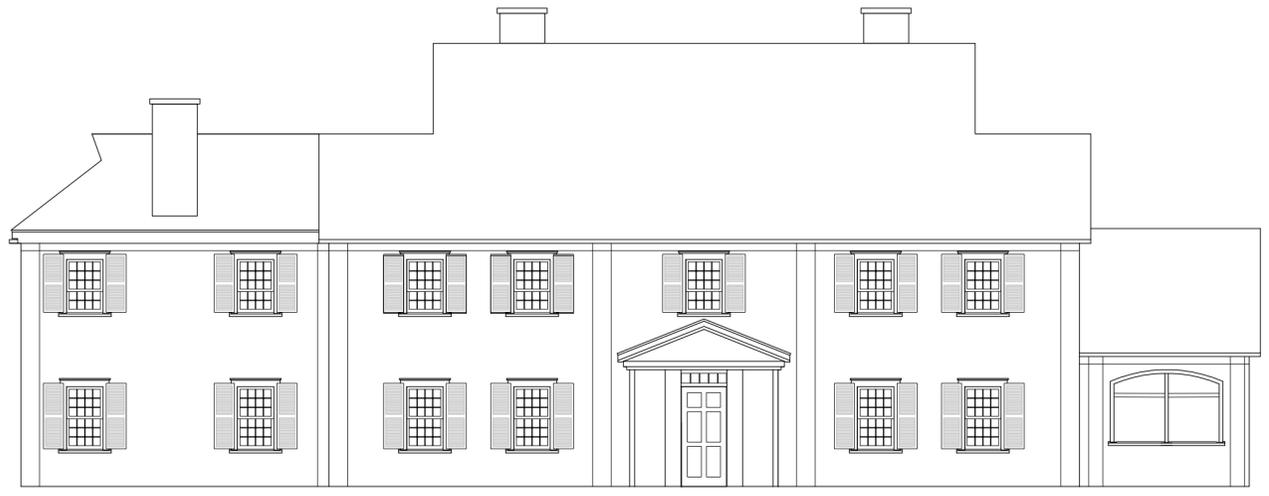
EXISTING FRONT ELEVATION
 SCALE 1/8" = 1'-0"

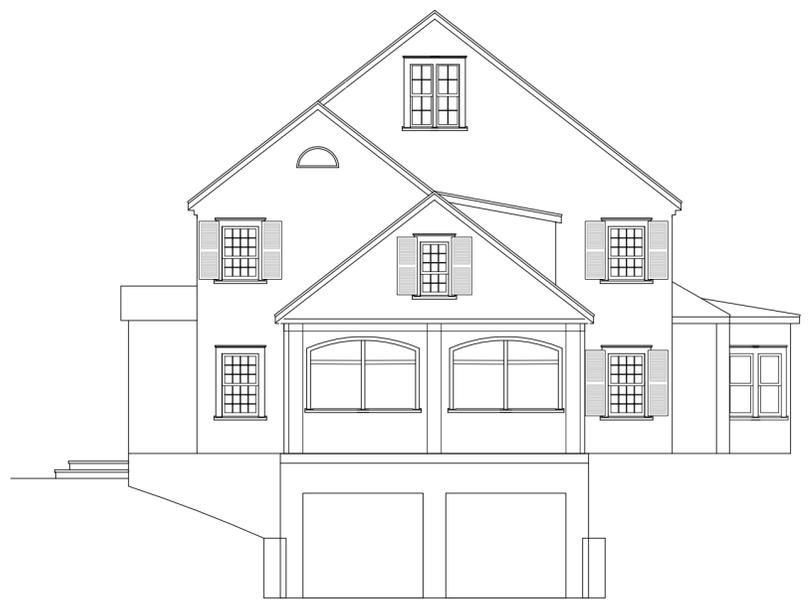
EXISTING RIGHT SIDE ELEVATION
 SCALE 1/8" = 1'-0"

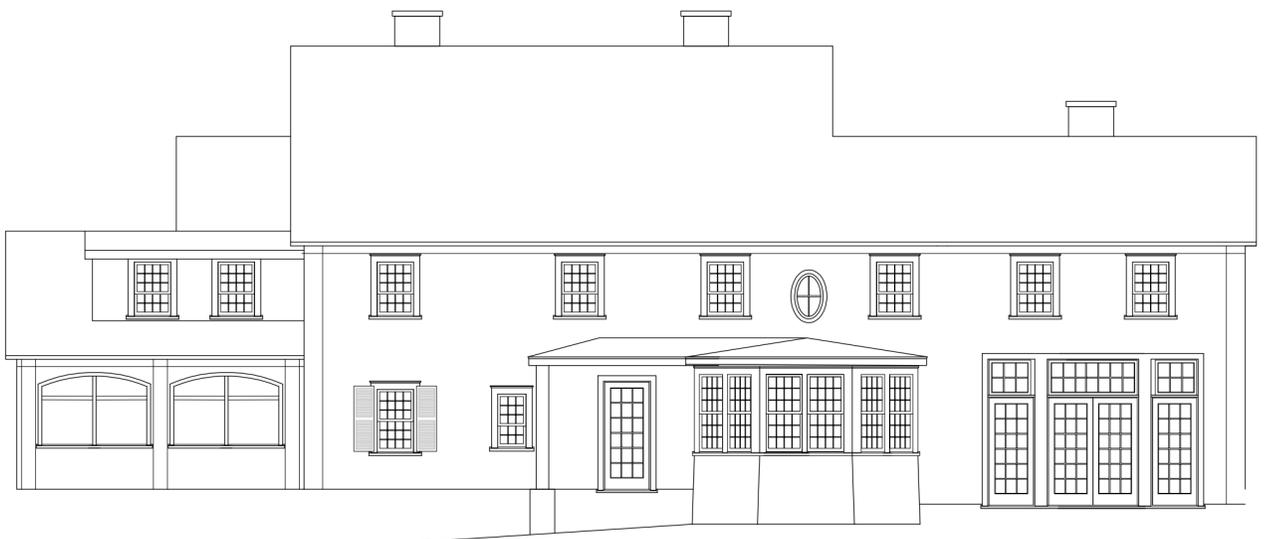
EXISTING REAR ELEVATION
 SCALE 1/8" = 1'-0"

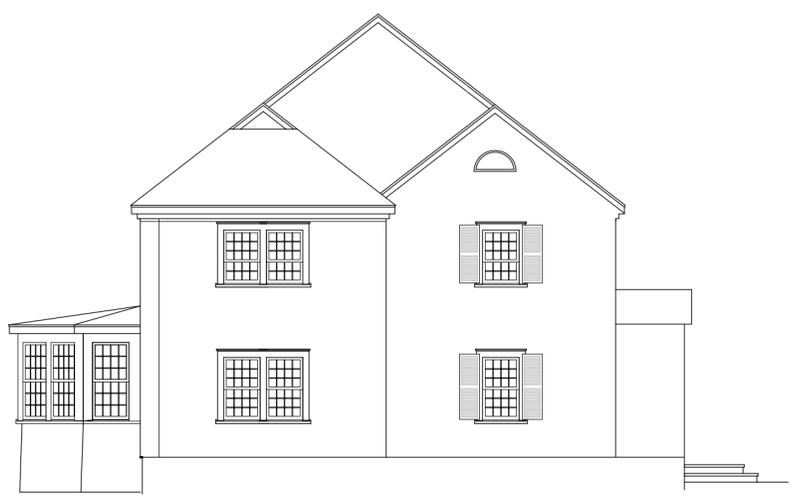
EXISTING LEFT SIDE ELEVATION
 SCALE 1/8" = 1'-0"

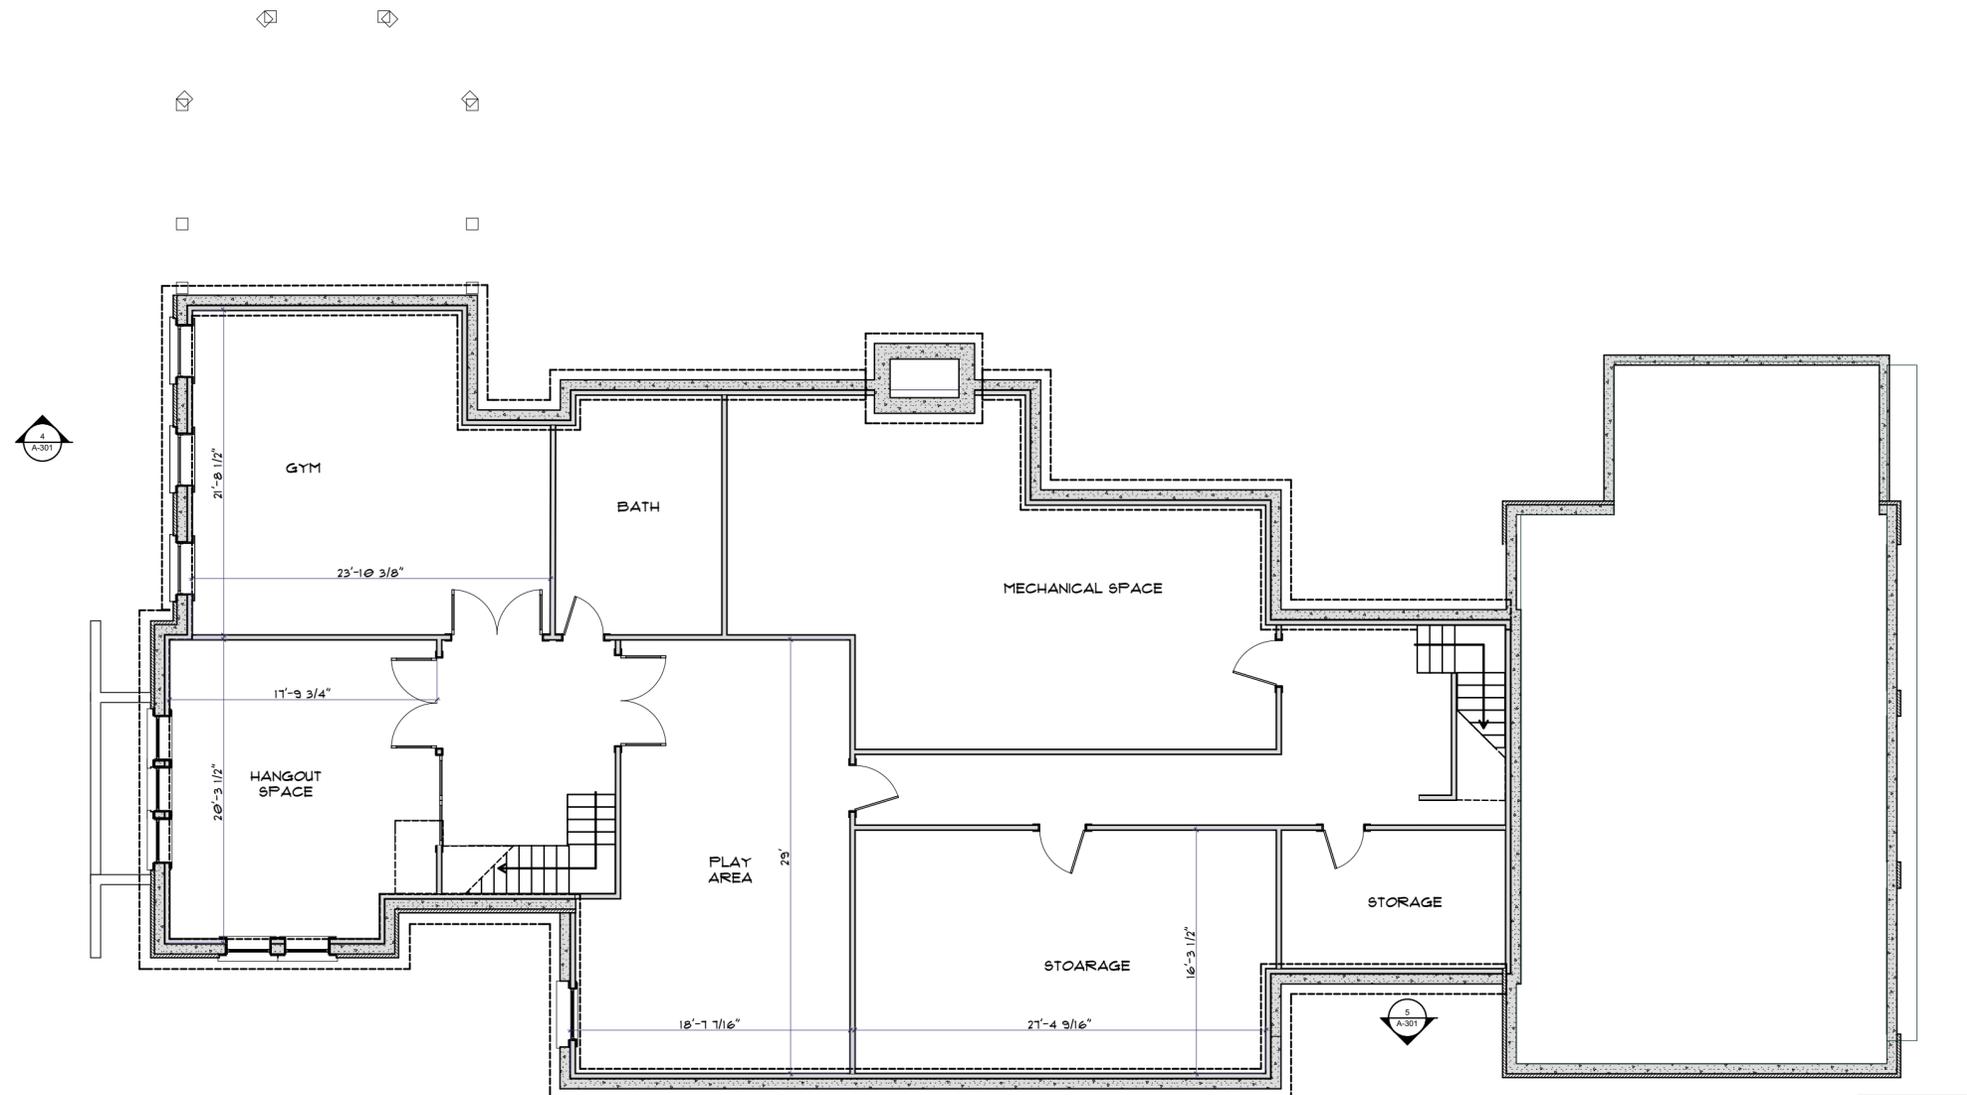
DWG. #
A1.0

FOUNDATION PLAN
SCALE: 1/8" = 1'-0"

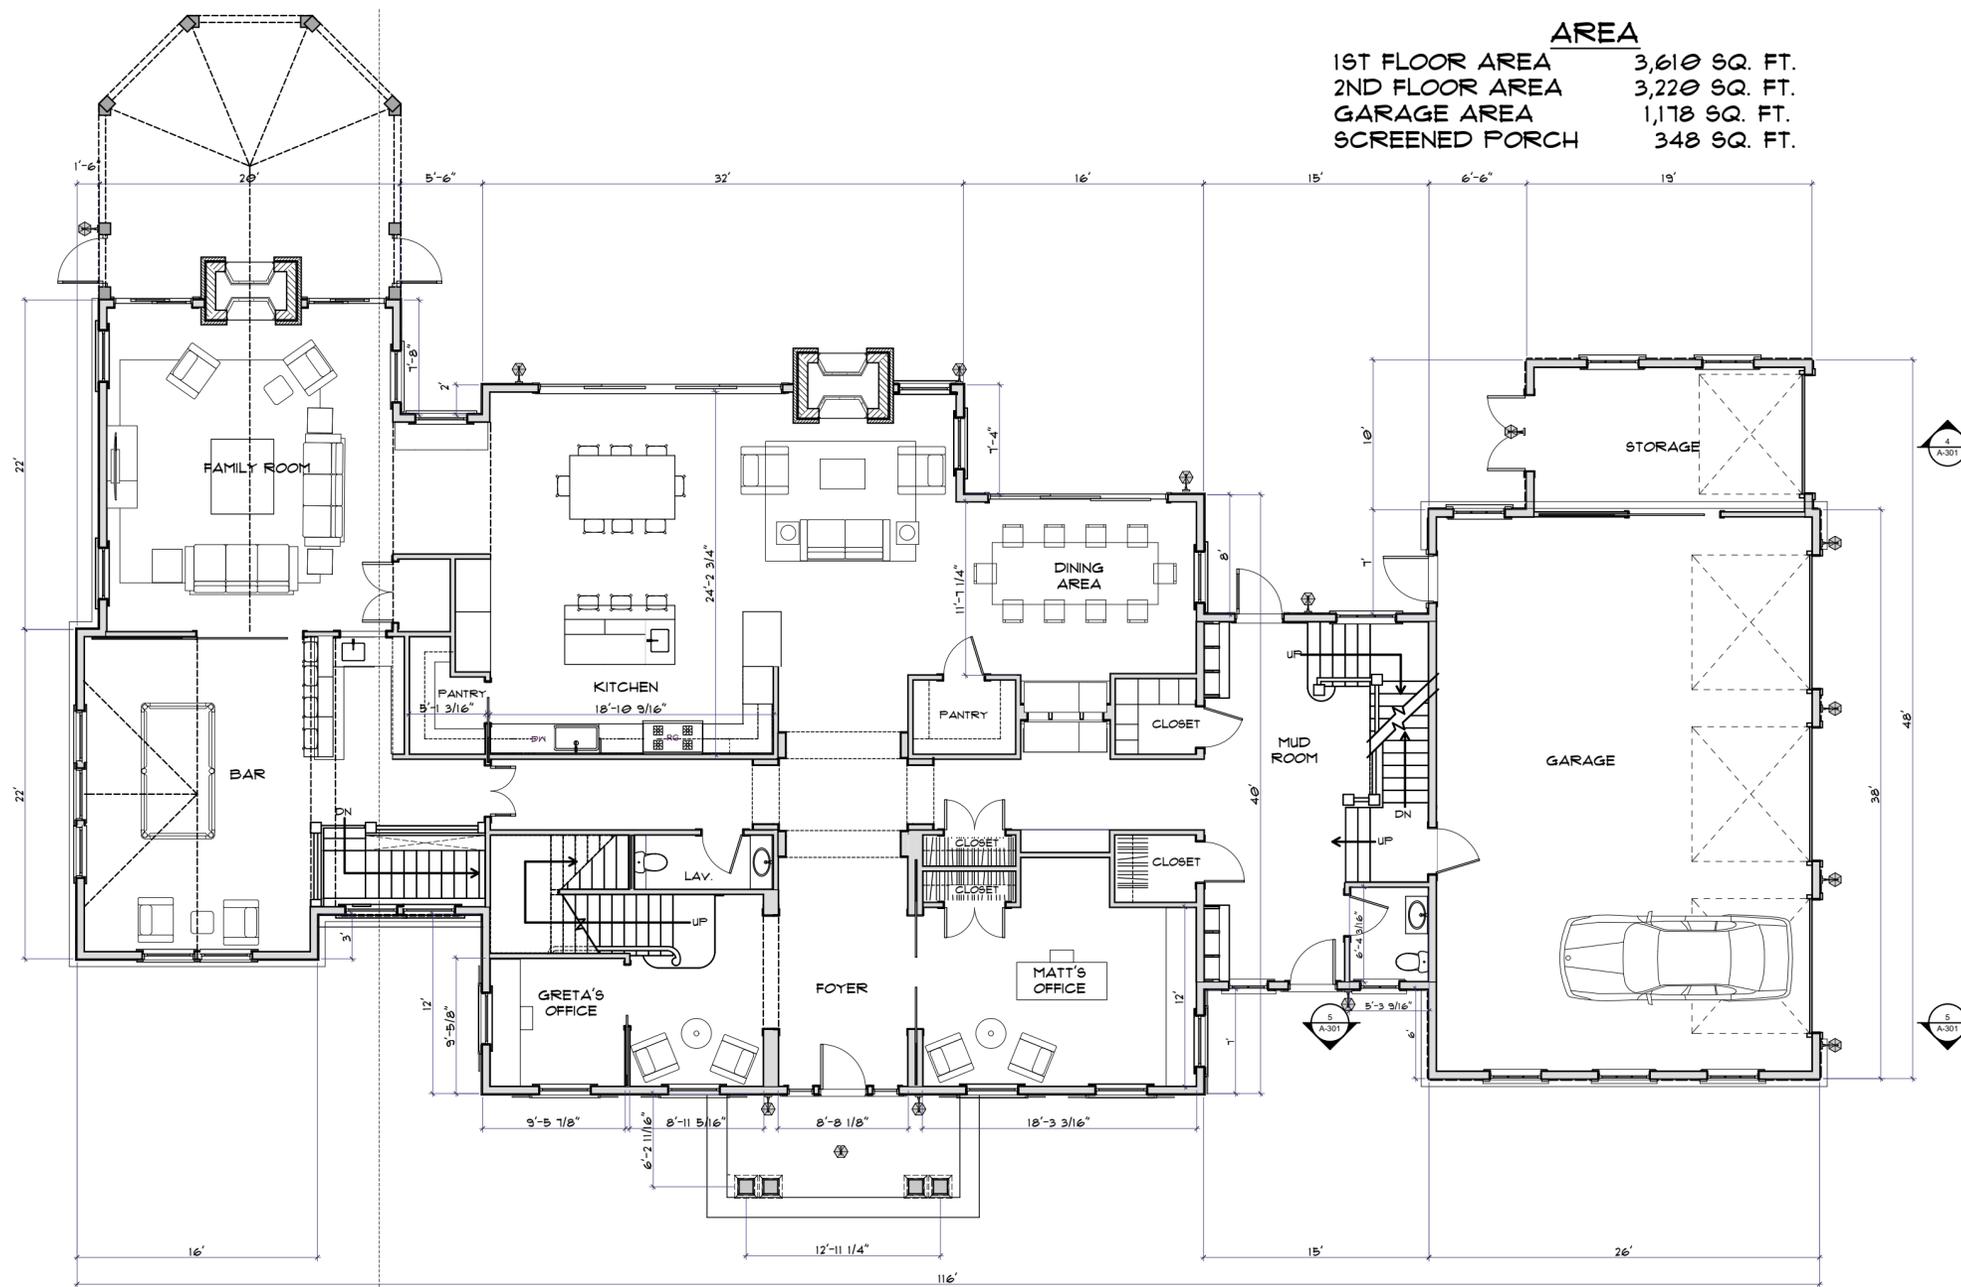
DWG. #
A1.1

AREA	
1ST FLOOR AREA	3,610 SQ. FT.
2ND FLOOR AREA	3,220 SQ. FT.
GARAGE AREA	1,178 SQ. FT.
SCREENED PORCH	348 SQ. FT.

FIRST FLOOR PLAN
SCALE: 1/8" = 1'-0"

First floor living area proposed 3610sf

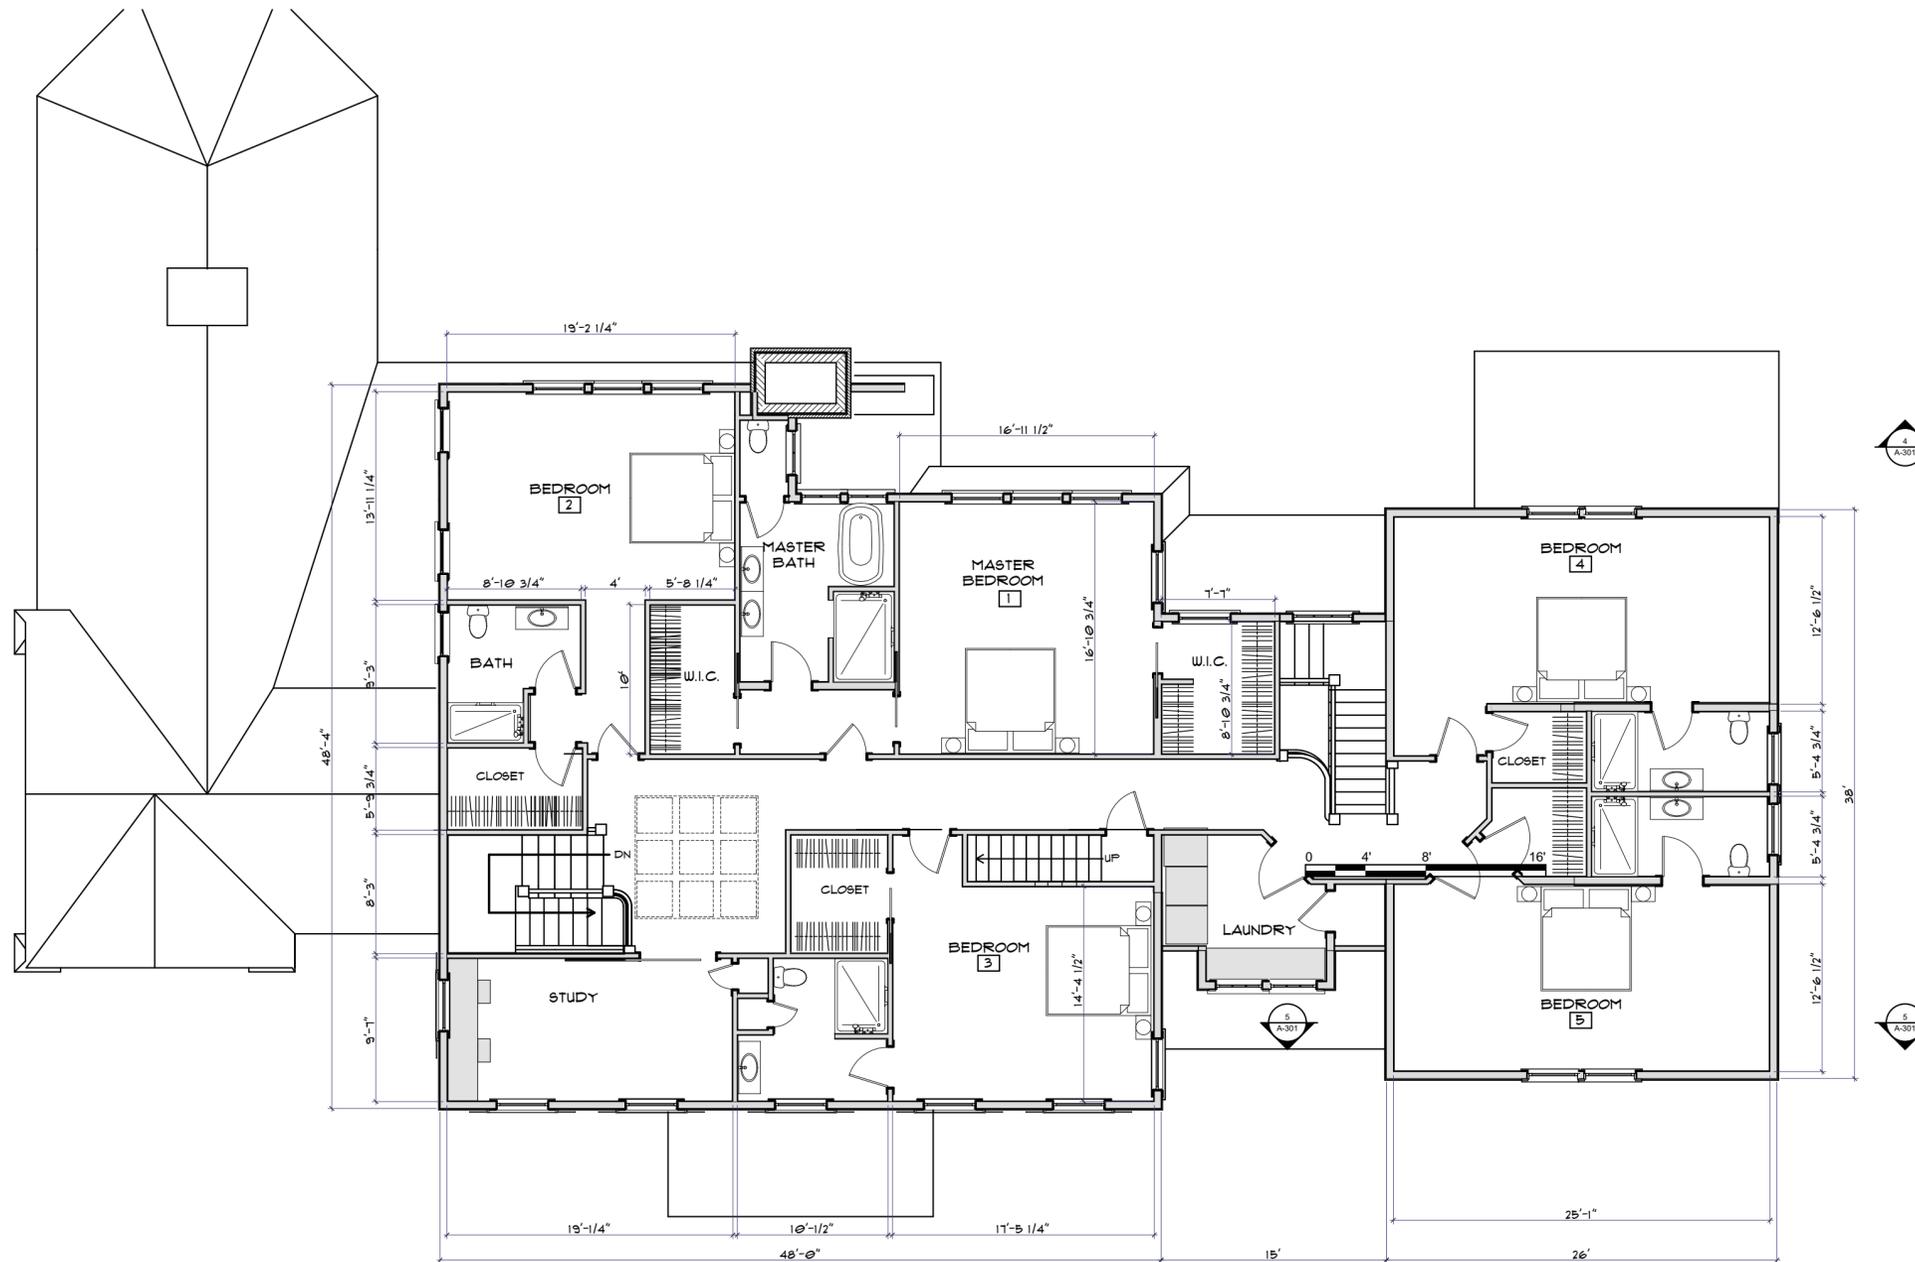
DWG. #
A1.2

SECOND FLOOR PLAN
SCALE: 1/8" = 1'-0"

3,220 S.F.

Second floor living area proposed 3220sf

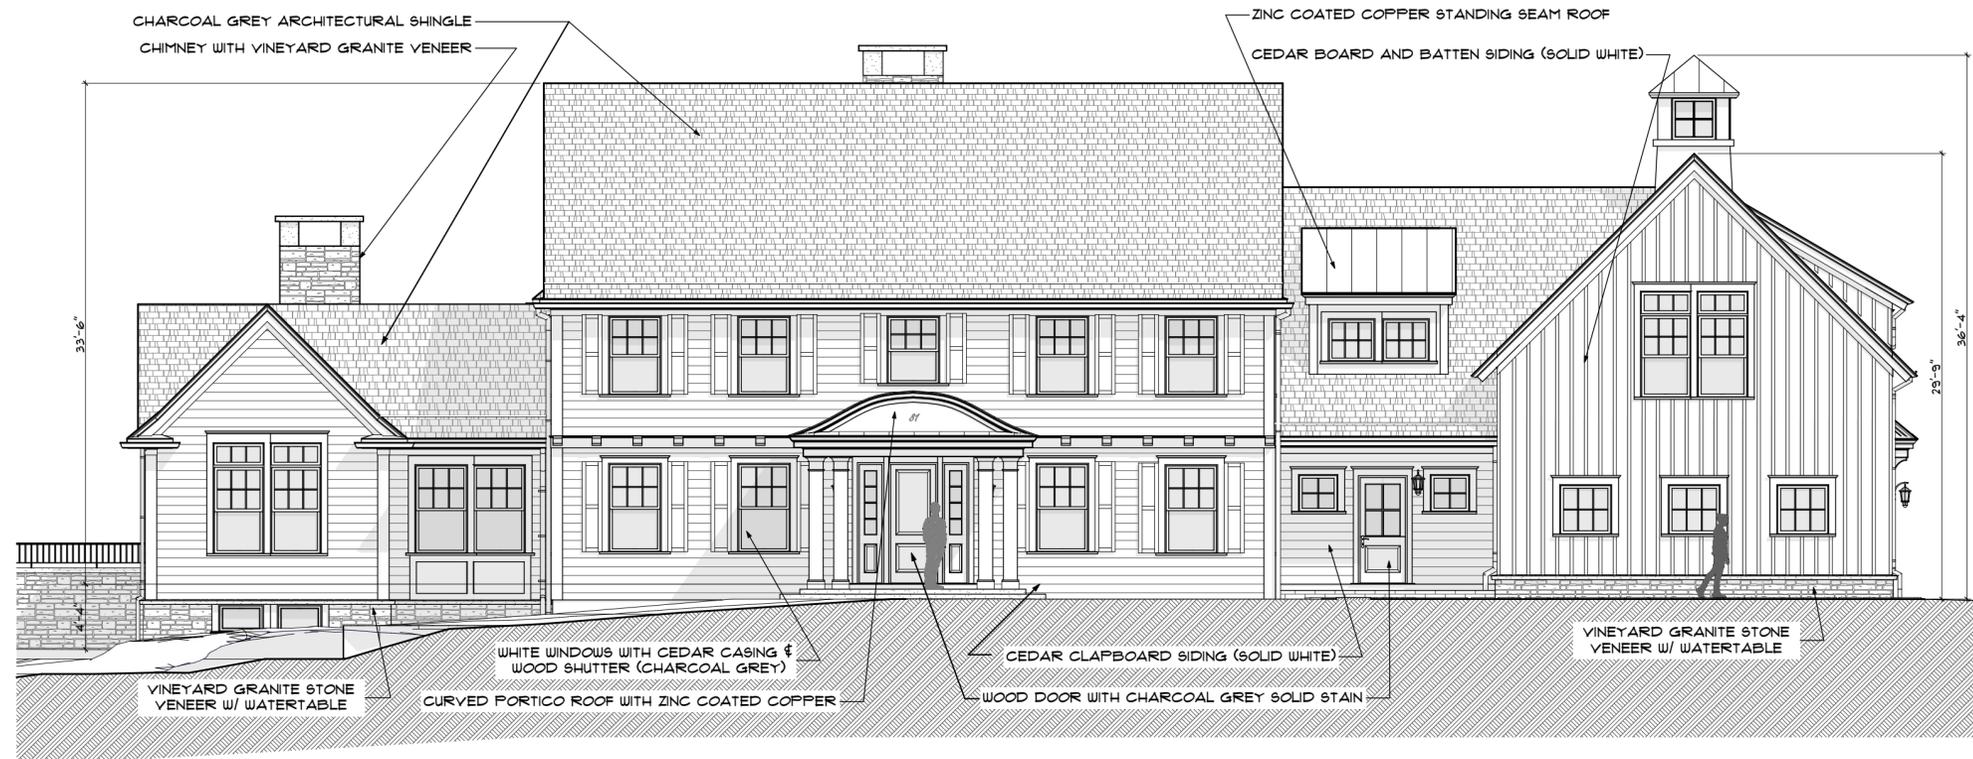
FRONT ELEVATION
SCALE: 1/8" = 1'-0"

The building ridge height is an average of 32 ft and generally consistent with the neighboring structures. All of the surrounding homes within this Arnold Road neighborhood (as shown on the delineation plan), are generally in the colonial revival style with similar materials and details.
