81 Arnold Road

Wellesley Planning Board Large House Review Application
Applicant: D. Michael Collins
Land Owner: Greta & Matthew Fruhan
Address: 81 Arnold Road

Statement of Intent

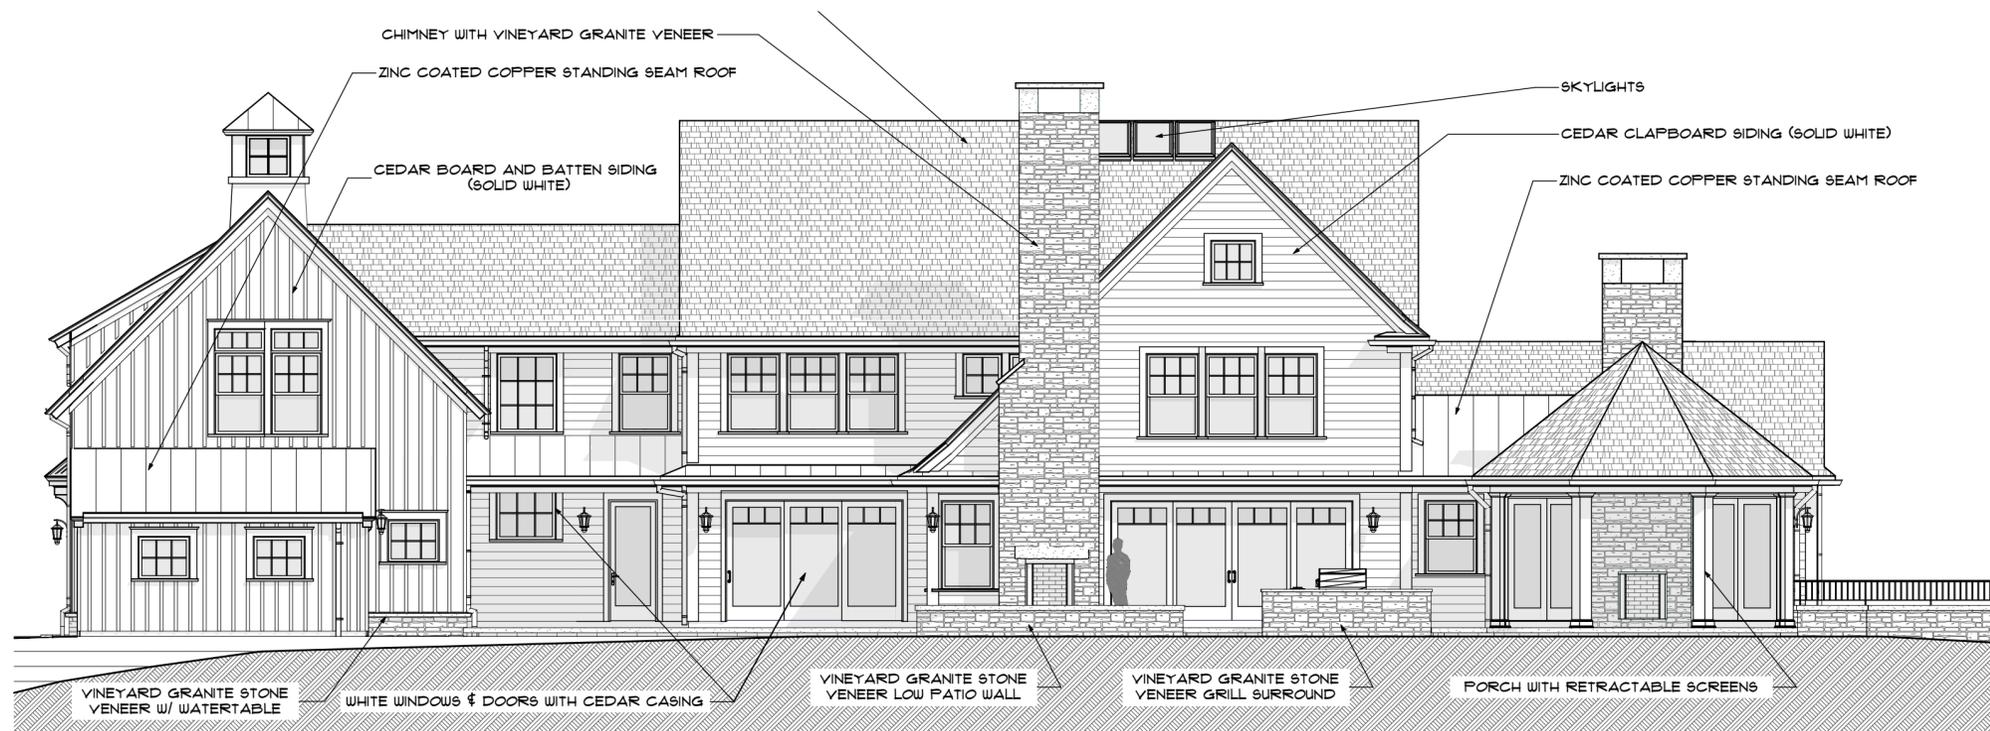
REAR ELEVATION
SCALE: 1/8" = 1'-0"

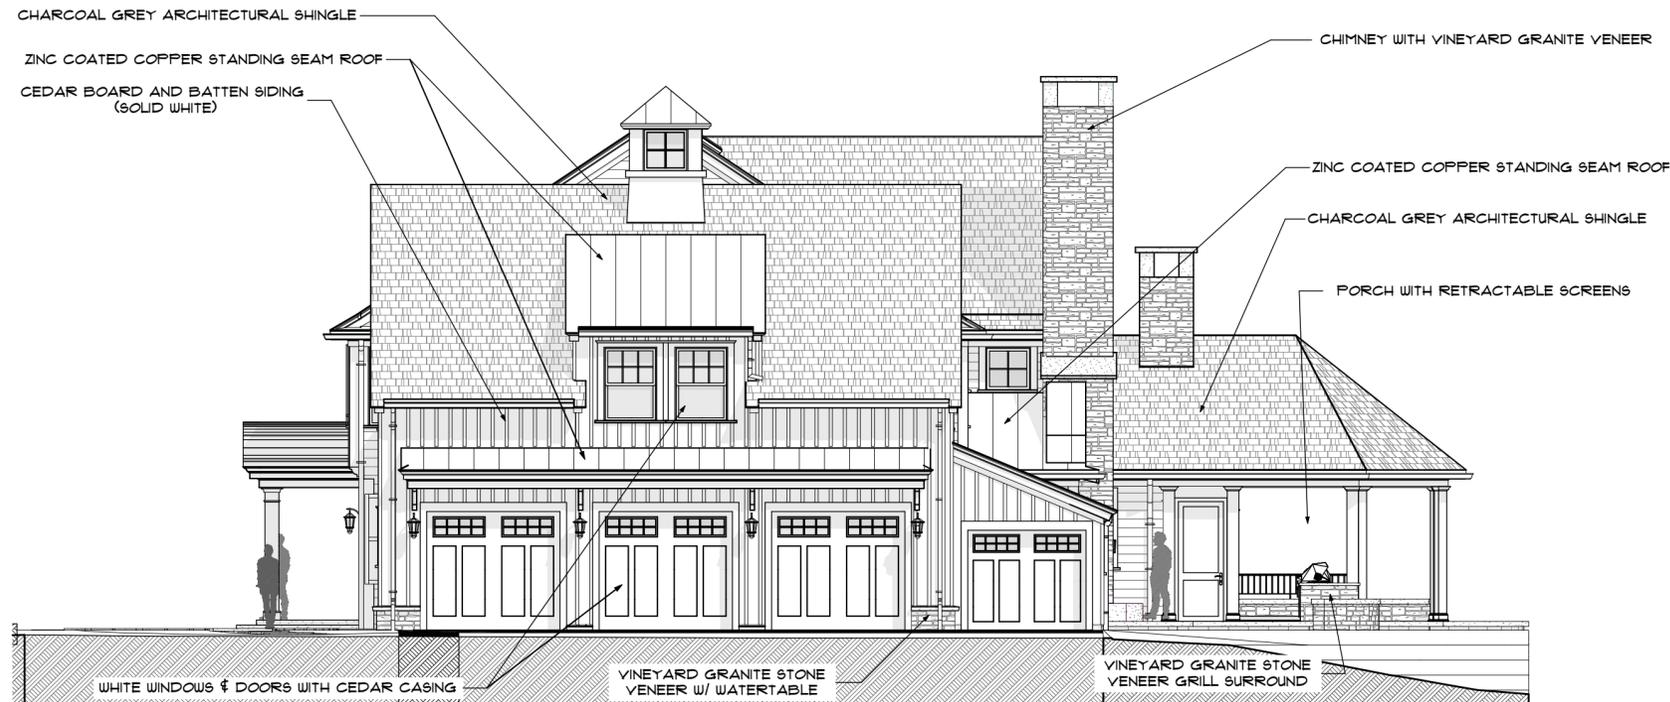
SIDE ELEVATION
SCALE: 1/8" = 1'-0"

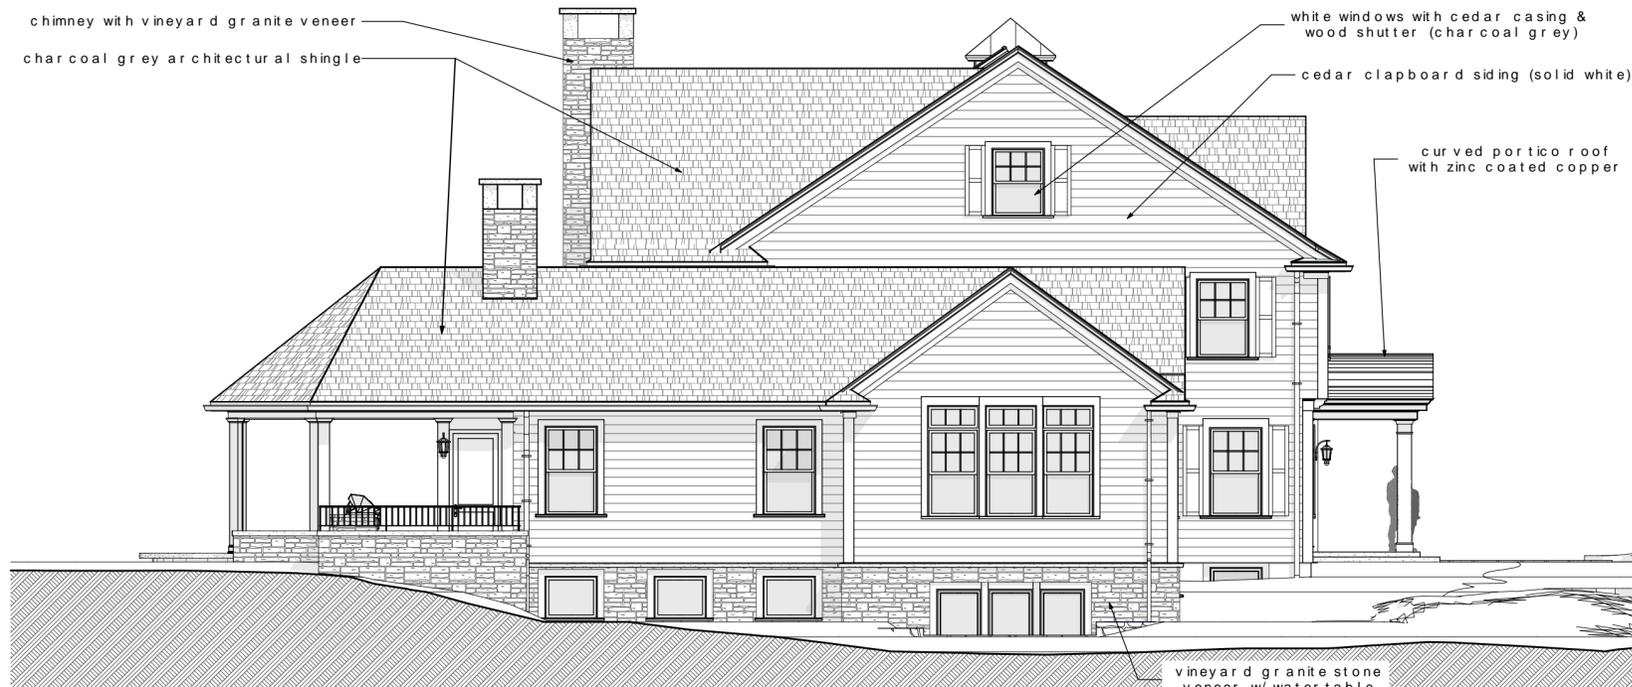
SIDE ELEVATION
SCALE: 1/8" = 1'-0"

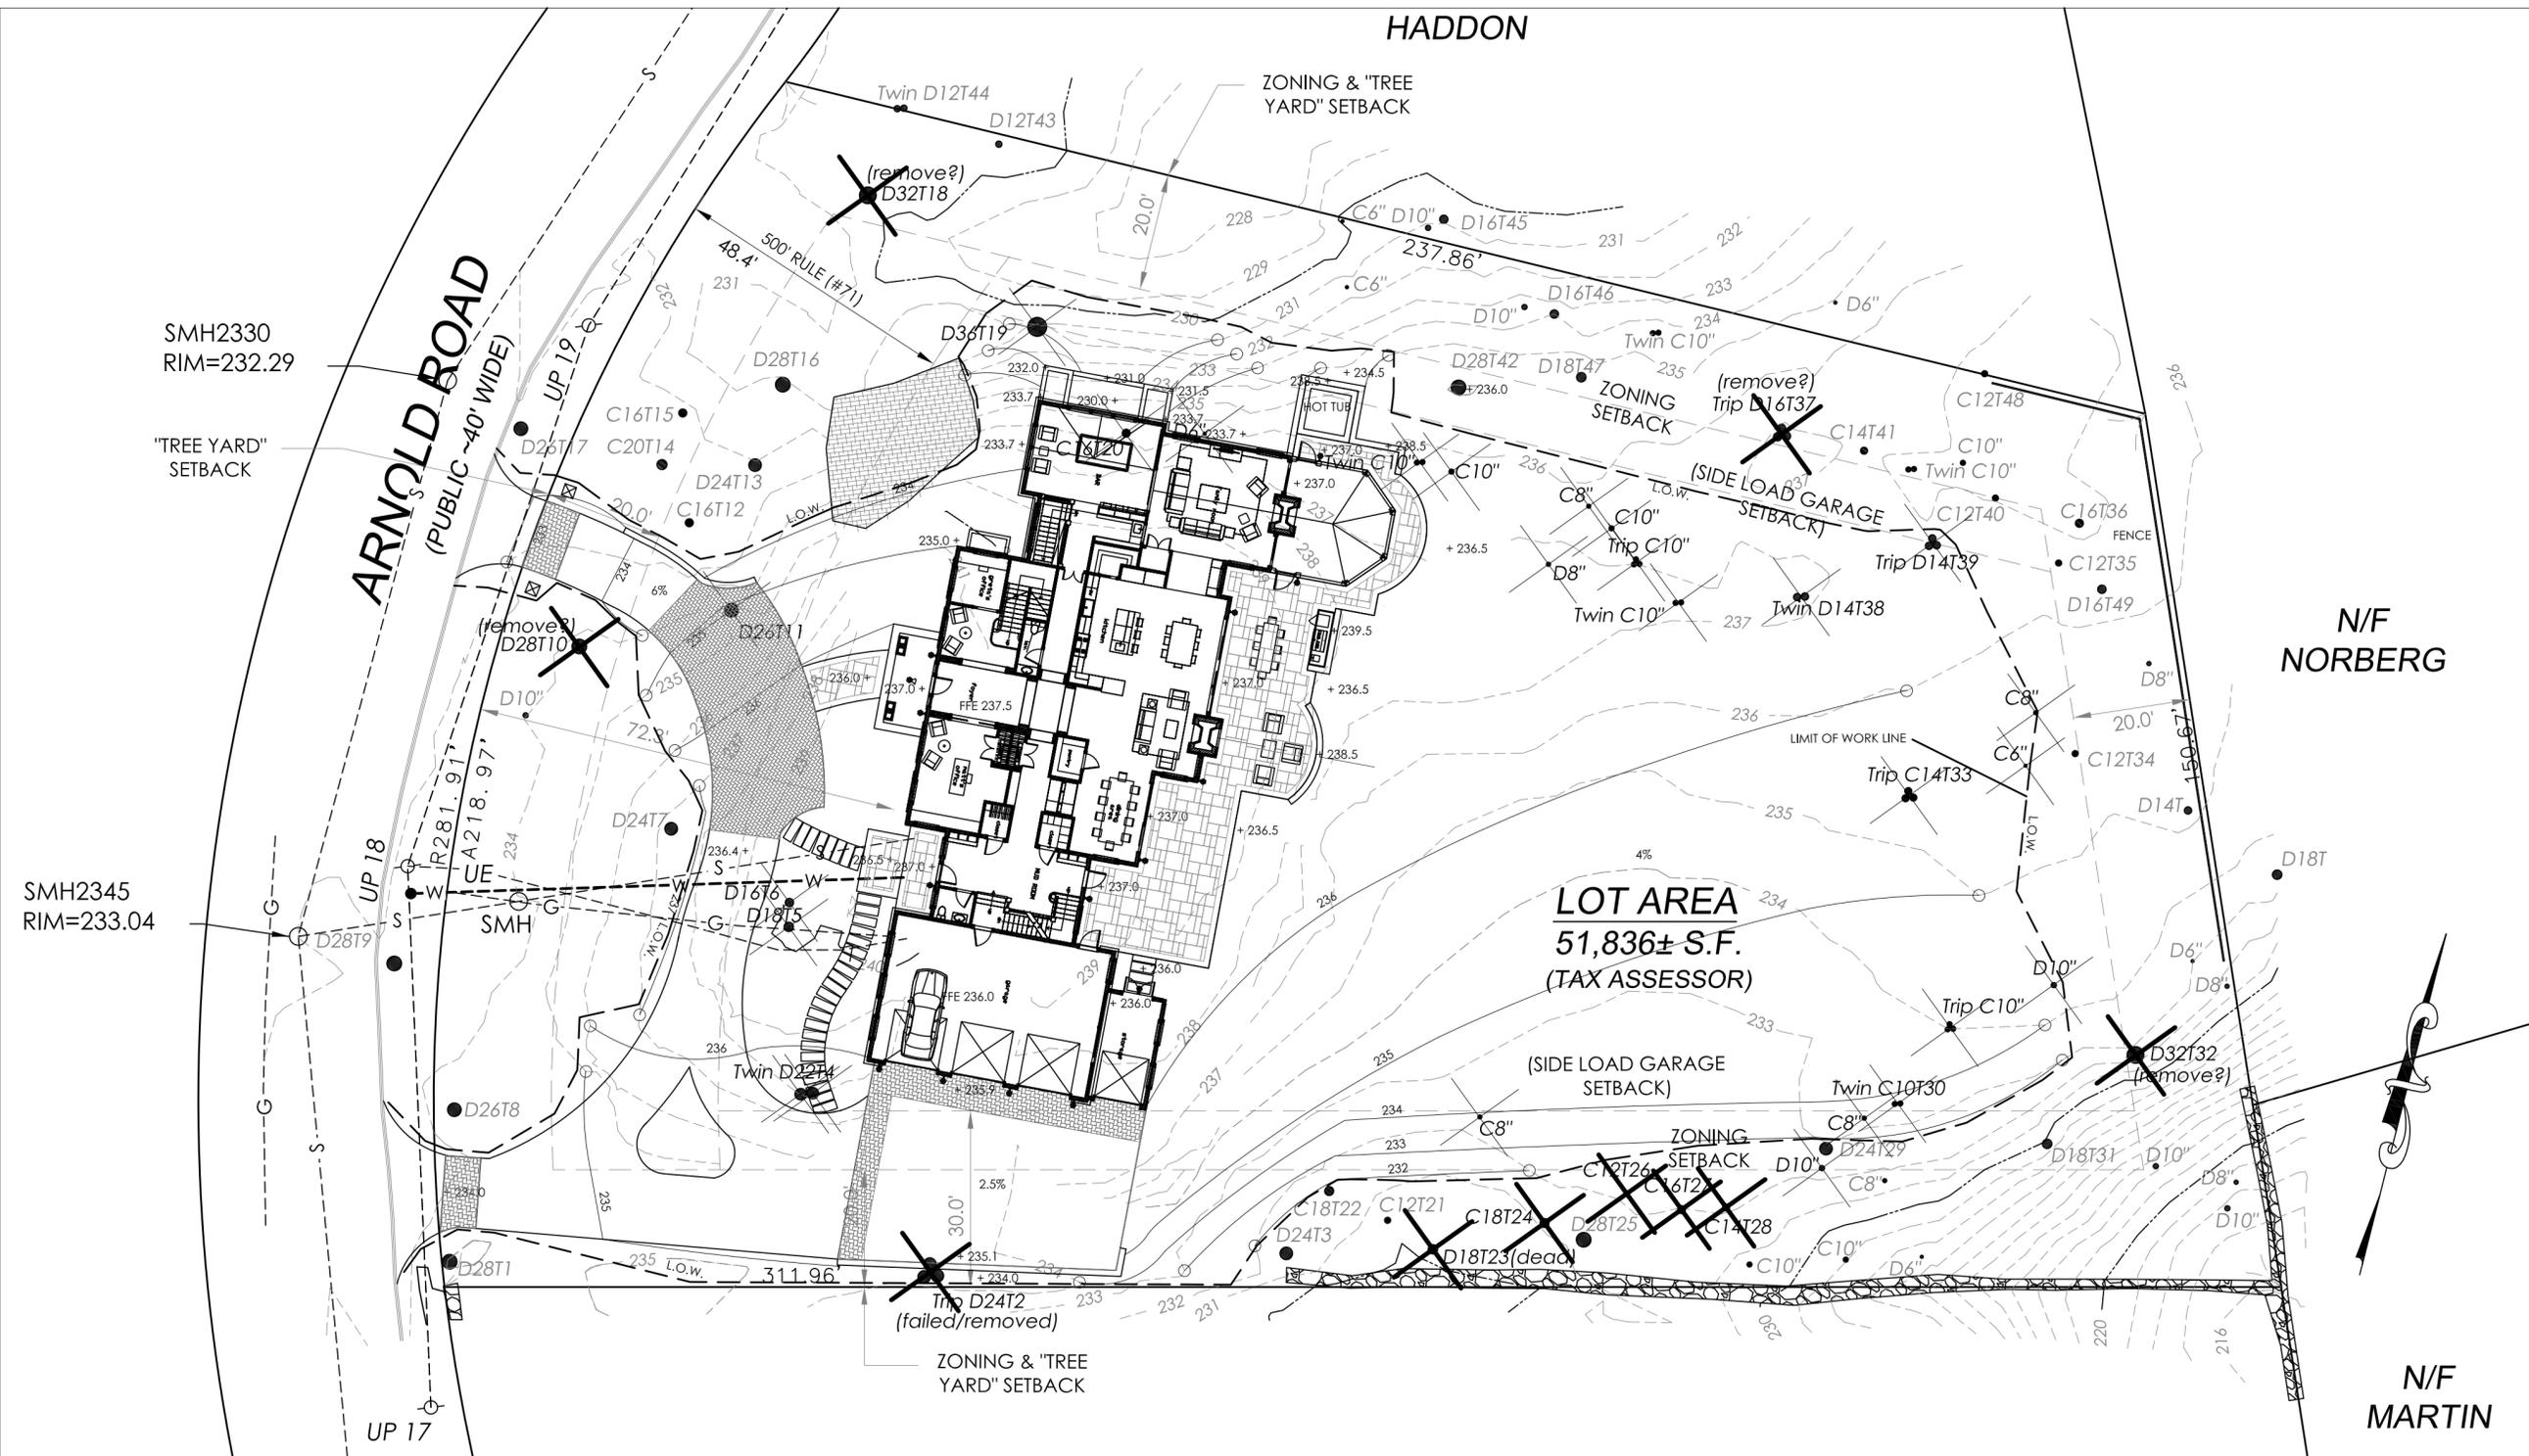
Tree Removal Plan
 Scale: 1"=20'-0"

Fruhan Residence Tree Removal and Replacement Table

Site Key	Tree Species	Note	DBH
T2	Red Oak, triple leader (Decid)	Failed during 3/17 storm, removed	24"
T10	Red Oak (Decid)	Advised to be removed, poor structure	28"
T18	Elm (Decid)	Advised to be removed, poor health	32"
T23	Red Maple (Decid)	Dead	18"
T24	Pine (Conif)	Remove to improve health of neighboring Oak	18"
T26	Pine (Conif)	Remove to improve health of neighboring Oak	12"
T27	Pine (Conif)	Remove to improve health of neighboring Oak	16"
T28	Pine (Conif)	Remove to improve health of neighboring Oak	14"
T32	Red Oak (Decid)	Advised to be removed, poor structure	32"
T37	Red Oak, triple leader (Decid)	Advised to be remove, poor structure	16"

A visual level 2 assessment was performed on these trees and the recommendation for removal of these trees is based on the current health and/or structural stability of the trees.

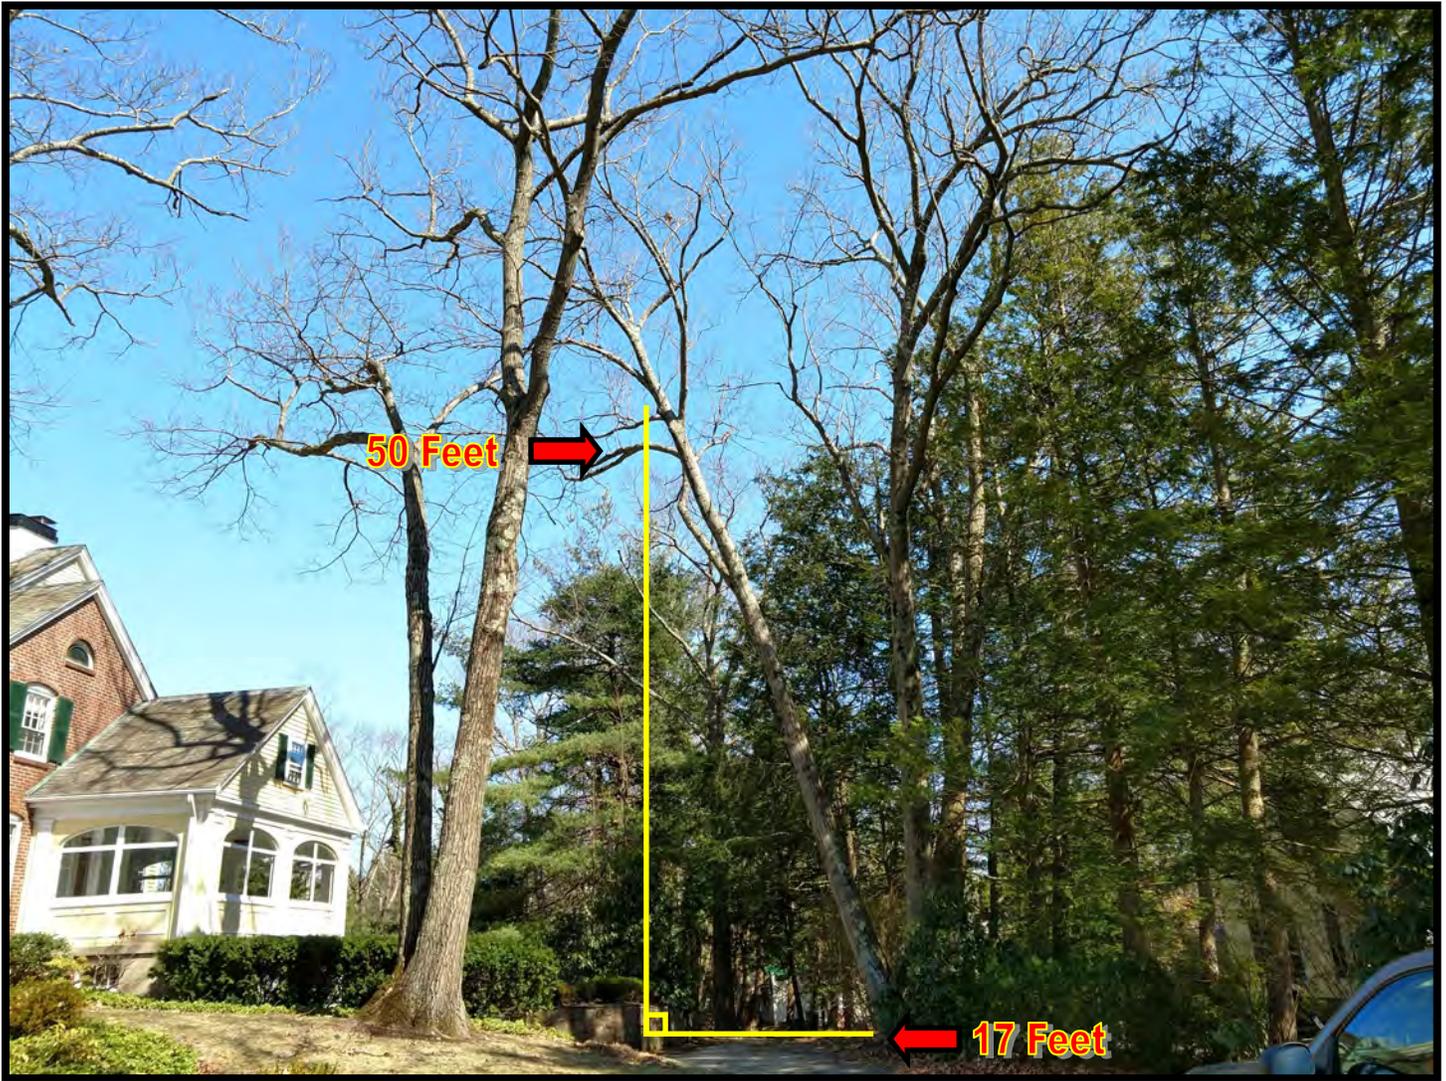
Picture above: taken Thursday, March 26, 2020, 1:51:23 PM

The picture shows one of the leaders of the triple leader oak leaning over the driveway toward the house. The tree is located in the planting bed between the driveways of the two houses and has been impacted by the installation of the driveways, construction, and maintenance. One leader is leaning at approximately 18 to 20 degrees. According to Dr. Kim Coder, University of Georgia. Trees with a lean of 15-20 degrees should be considered for removal and as lean angle passes 20 degrees, structural failure risks are compounded geometrically. These recommendations **do not** take into consideration complications such as cut, damaged, or decayed roots, different soil types, the impacts of construction damage, or fill. All of these things can greatly affect the likelihood of failure.

This assessment was started and the TRAQ form was generated prior to the failure of the tree. As a result of the failure it is clear that the extent of the decay is significant. It is likely that the remaining two trunks of the oak tree are in similar structural condition and represent a high likelihood of failure.

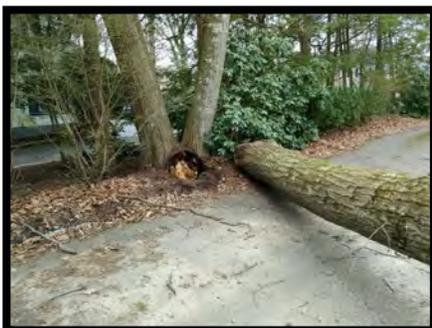
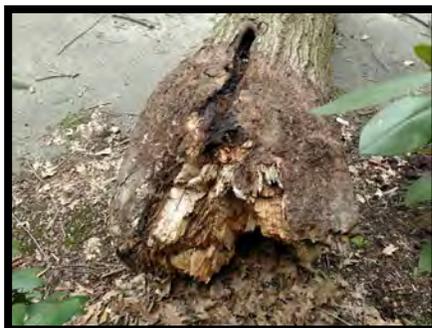
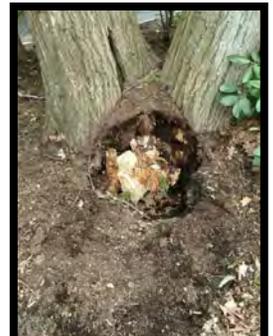
Pictures below: Taken Monday, April 20, 2020, 12:42:24 PM

Show the leader that was leaning over the driveway toward the house after failure during the wind storm. It is clear from the pictures that the tree has been negatively impacted by the driveway, prior construction, and maintenance. The failure revealed the extent of the decay present in the base of the tree. It is likely that the other two leaders are in similar structural condition.

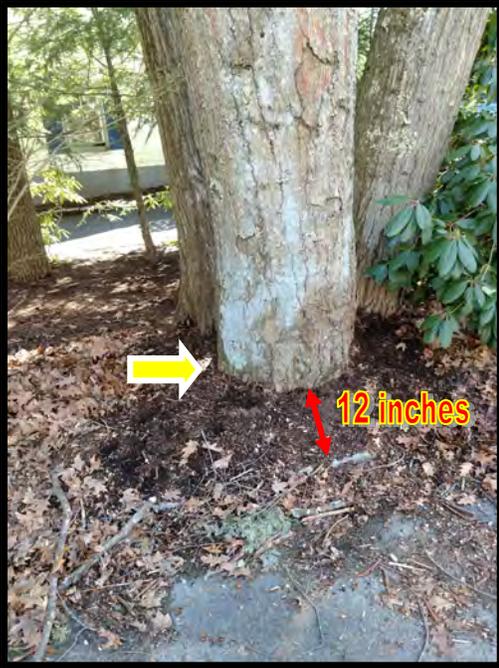
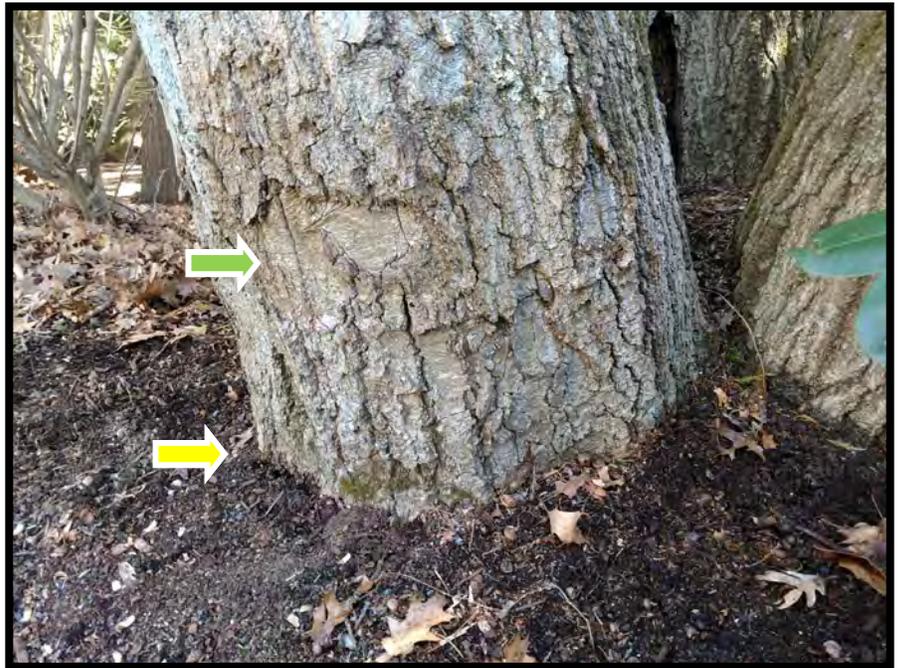
Picture top left: taken Thursday, March 26, 2020, 1:49:14 PM. Yellow arrow is pointing to the lack of trunk flare indicating that the grade was raised around this tree at some point in the past. The red arrow is indicating the proximity of the cobble stones and the edge of the driveway to the base of the tree. It is very likely that the root system of the tree has been damaged and is compromised in some way.

Picture top right: taken Thursday, March 26, 2020, 1:50:36 PM. Yellow arrow is pointing to the lack of trunk flare. The Green arrow is pointing to the trunk of the tree indicating past mechanical damage.

Picture bottom left: taken Thursday, March 26, 2020, 1:49:52 PM. The red arrow is indicating the seem with included bark between the leaders.

Picture bottom left: taken Thursday, March 26, 2020, 1:49:32 PM. Red arrow pointing to the included bark between the two leaders. Blue arrow indicating the mulch and composted material built up in the area between the leaders. This material holds moisture against the trunk of the tree. The green arrow is indicating mechanical damage to the trunk of the tree where there is an open cavity. The mulch and decomposing material between the trunks of the tree holds moisture against the trunk and any damage on the trunk providing a good environment for the decay fungi.

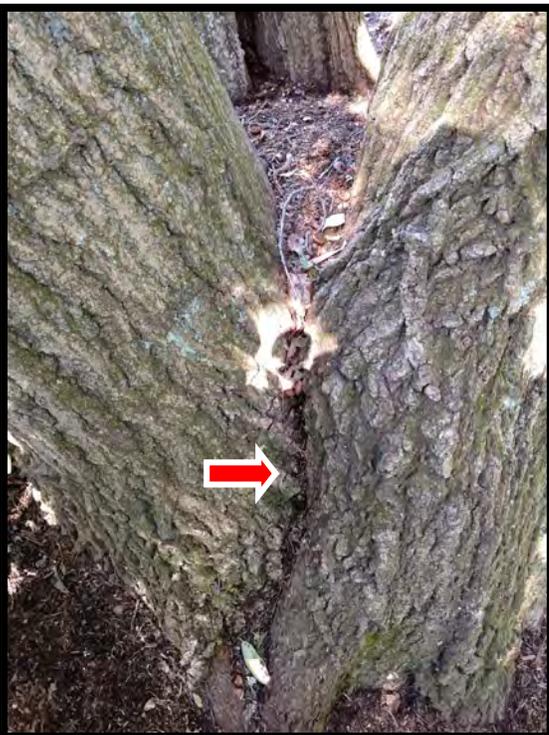
Picture: taken Thursday, March 26, 2020, 1:52:38 PM. The red arrow is pointing to the bifurcation in the trunk with an acute angle and included bark. The swelling is the production of reaction wood produced by the tree to compensate for the increased force generated at the point of attachment between the two leaders.

Picture bottom left: taken Thursday, March 26, 2020, 1:52:38 PM. The red arrow is pointing to a close-up of the seam between the two leaders.

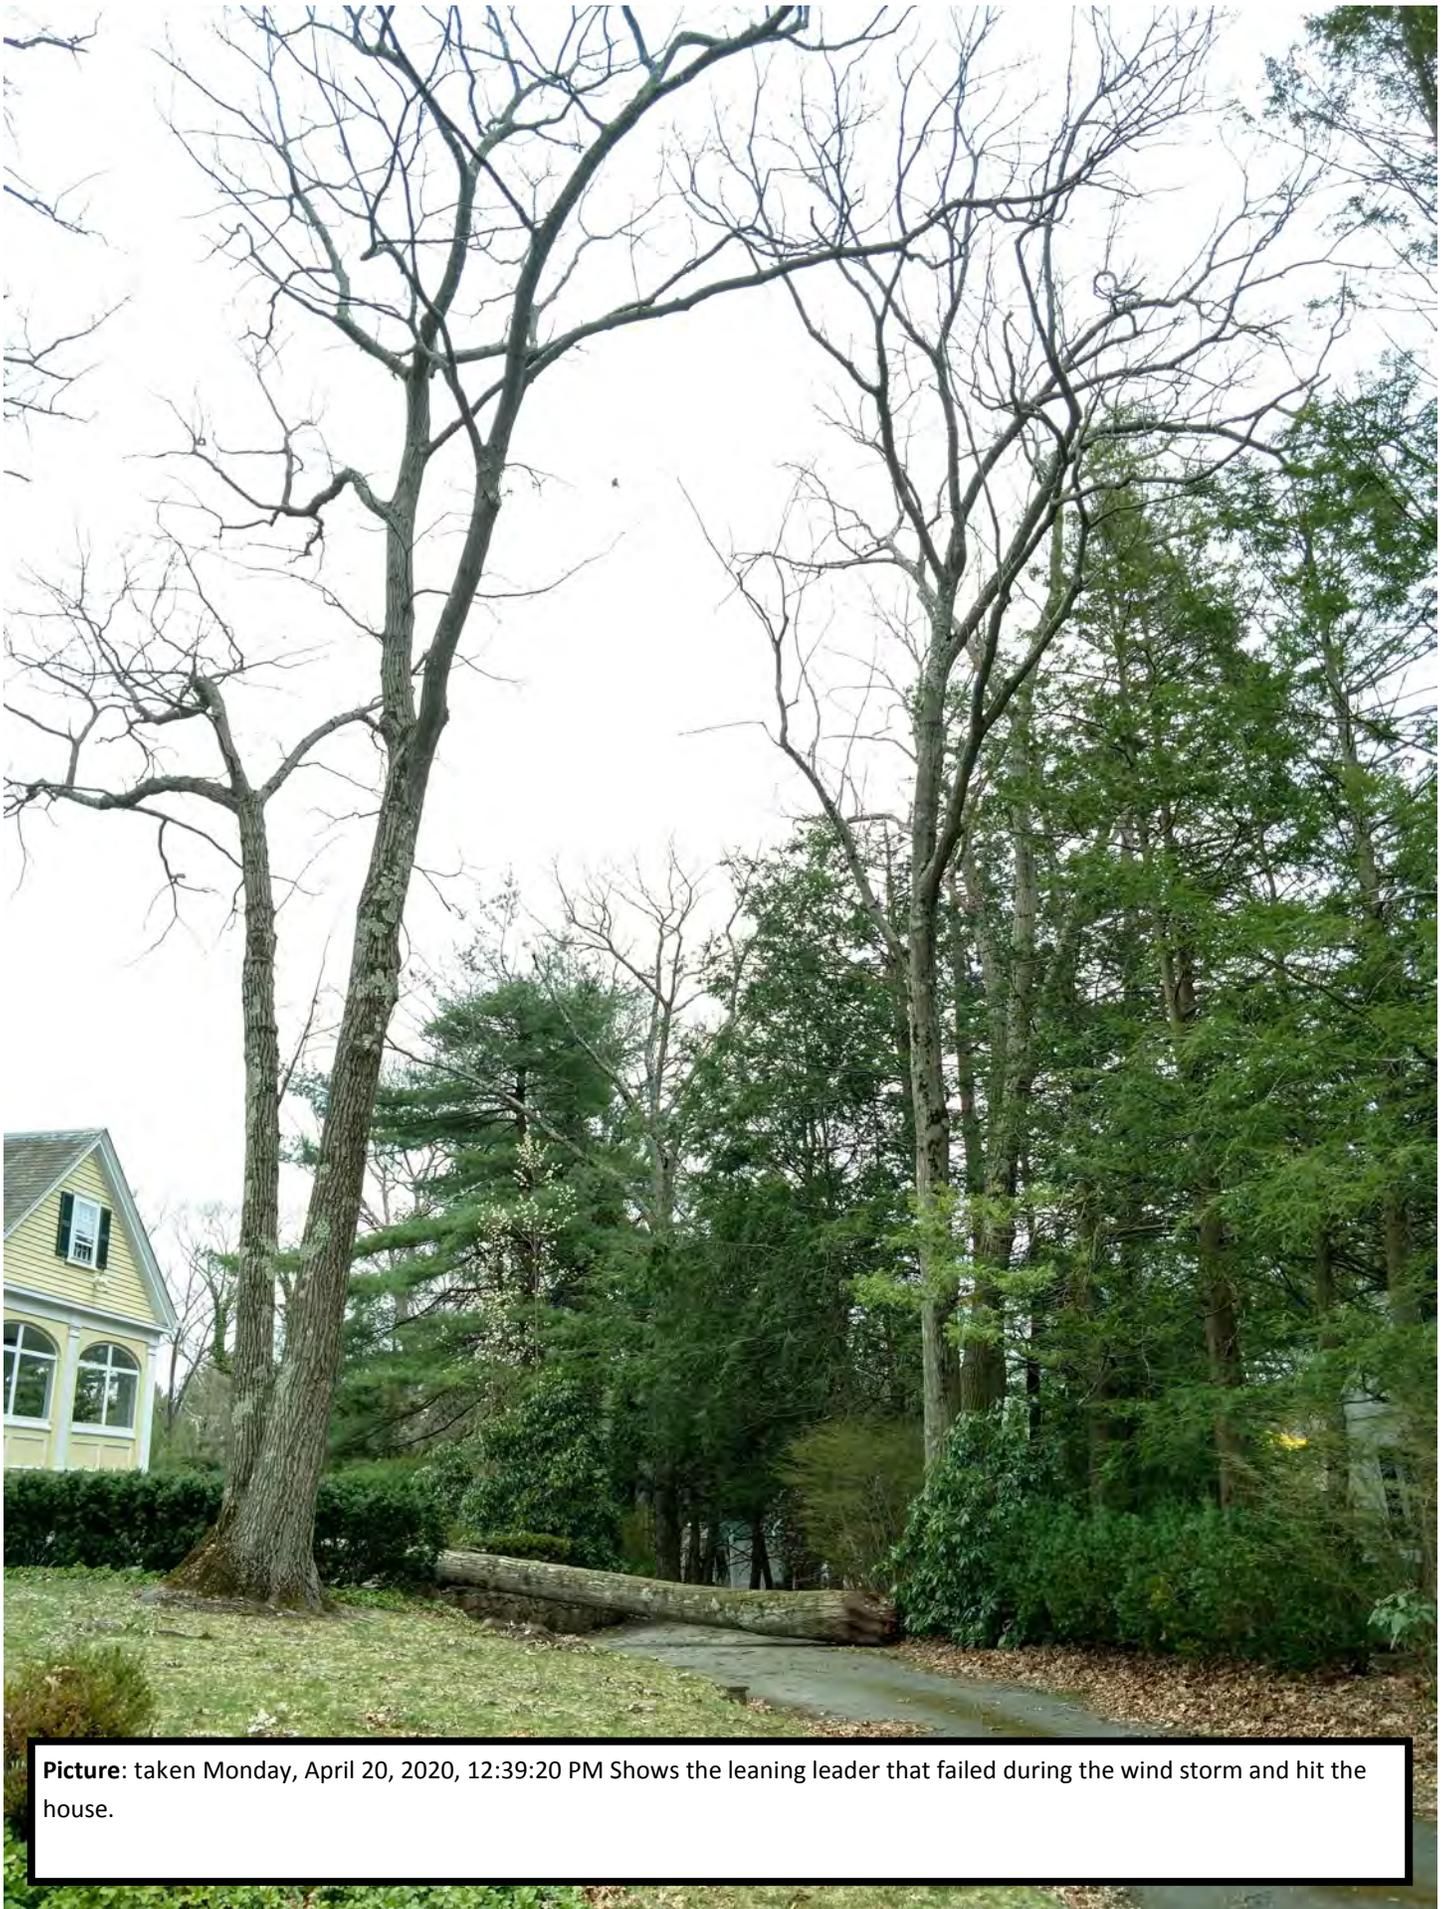
Picture: taken Monday, April 20, 2020, 12:39:20 PM Shows the leaning leader that failed during the wind storm and hit the house.

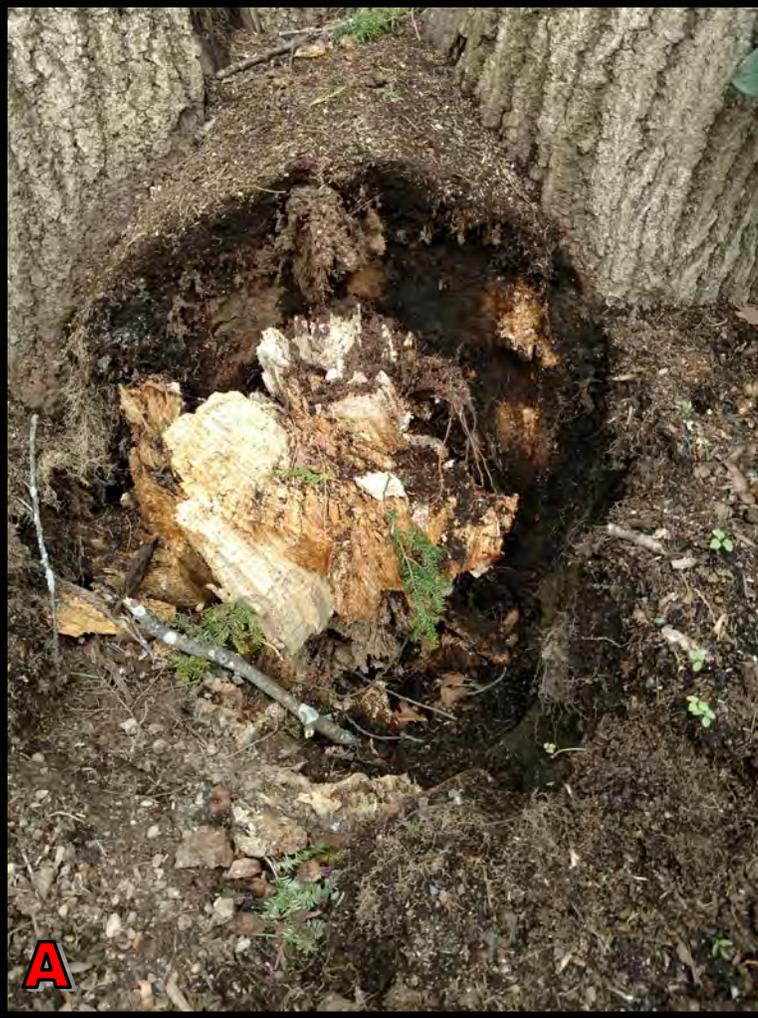
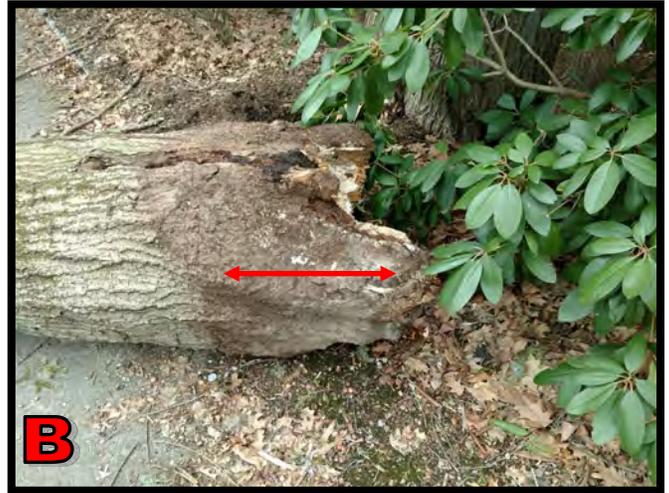
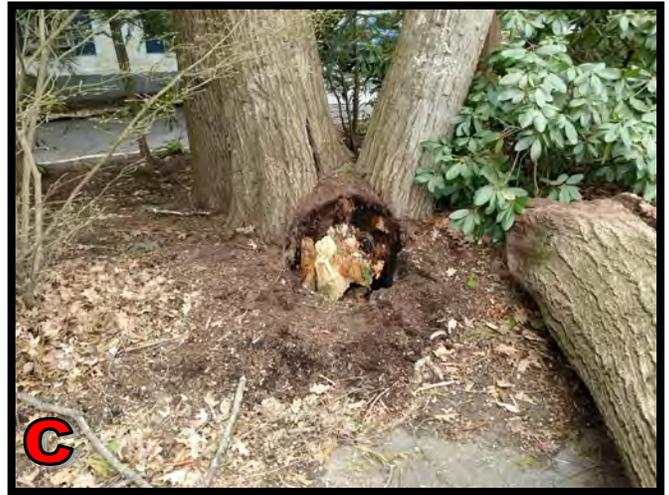
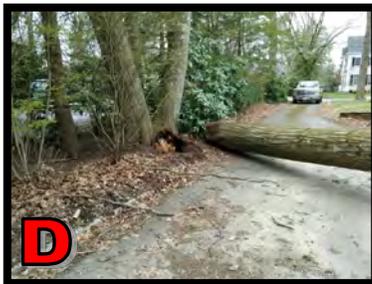
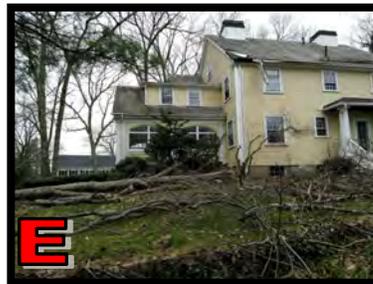
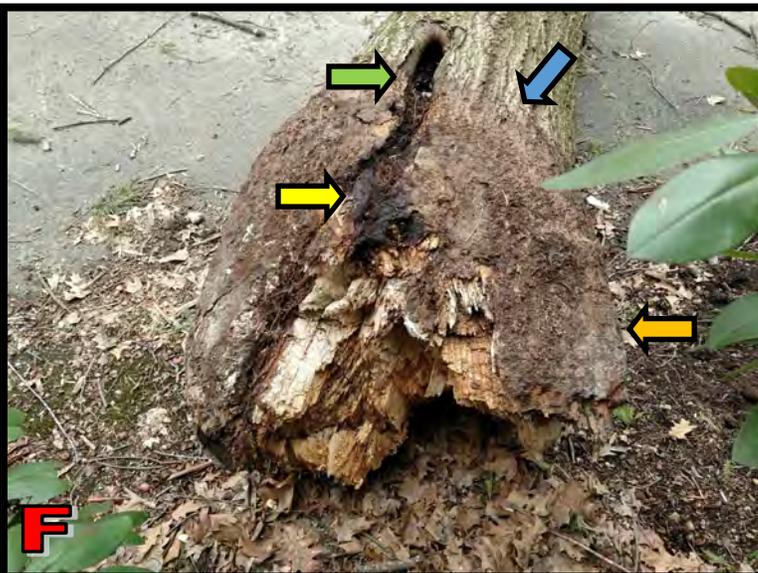
A. Picture taken: Monday, April 20, 2020: Picture of the base of the tree showing the decay where the trunk failed. Notice there is no fiber tear or roots pulled out of the ground. The decay is quite extensive.

B. Picture taken: Monday, April 20, 2020: The red arrow is indicating the soil line on the trunk of the tree. The soil line is an indication of the amount of grade change around the tree. Notice there are no roots attached to the trunk.

E. Picture taken: Monday, April 20, 2020: Picture of the back of the house and the damage caused by the tree.

F. Picture taken: Monday, April 20, 2020: Close up of the base of the tree. Green arrow pointing to the mechanical damage. The blue arrow pointing to the soil line on the trunk. The yellow arrow pointing to the discoloration. The orange arrow pointing to the included bark where the trunks of the tree grow together.

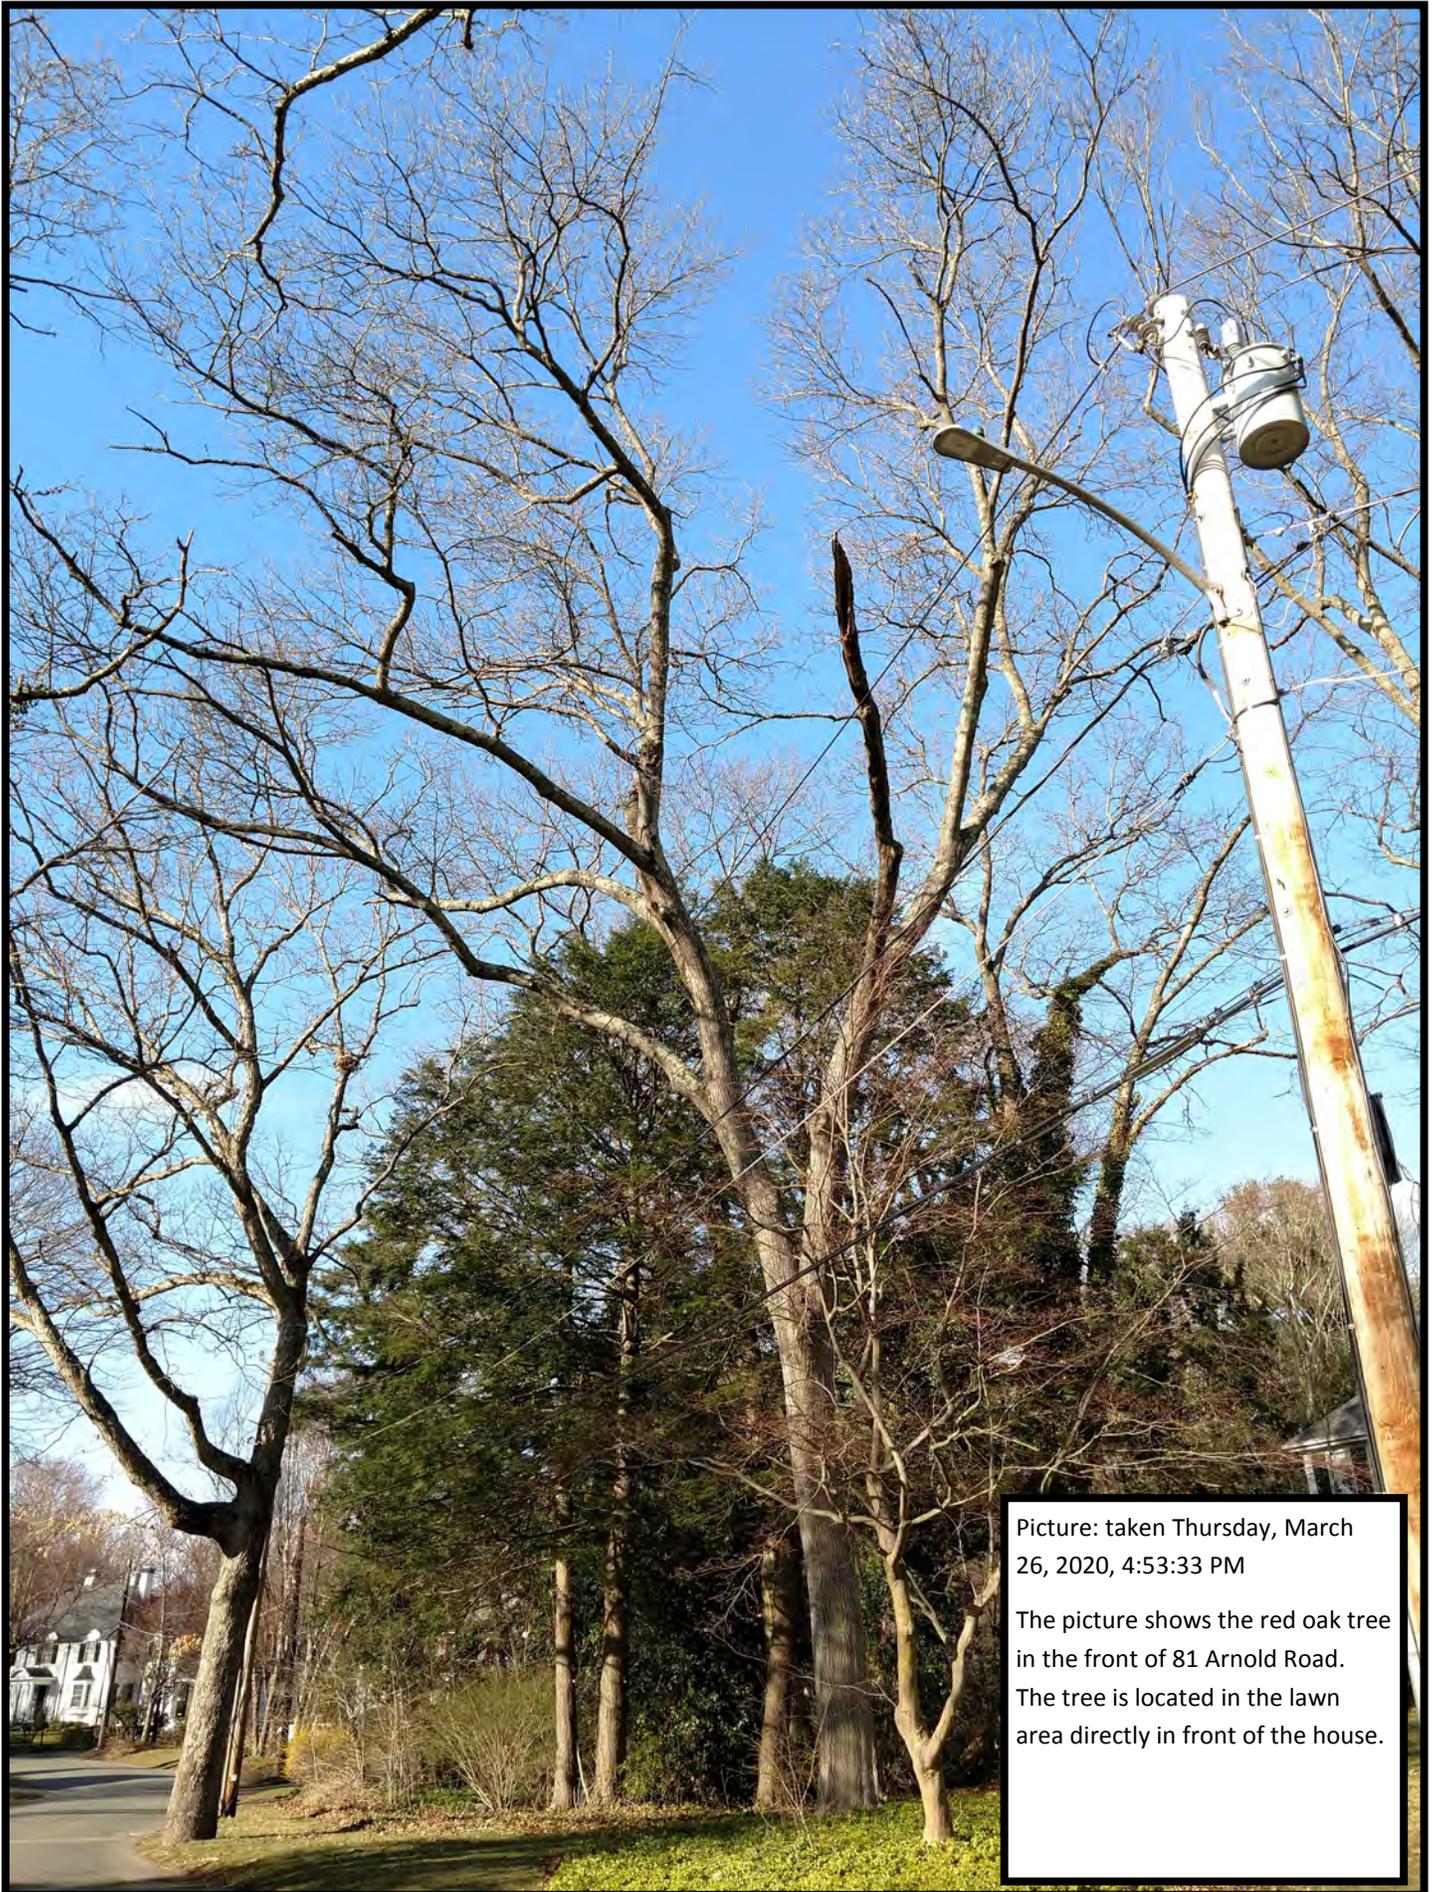
Picture: taken Thursday, March 26, 2020, 4:53:33 PM

The picture shows the red oak tree in the front of 81 Arnold Road. The tree is located in the lawn area directly in front of the house.

Notes, explanations, descriptions Large red oak with abnormal growth and bark patterns at the base. Missing and dead bark and reaction wood production. Included bark at main bifurcation of trunk the large leader leans heavily out over the road and the power lines. Tree has a history of failure.

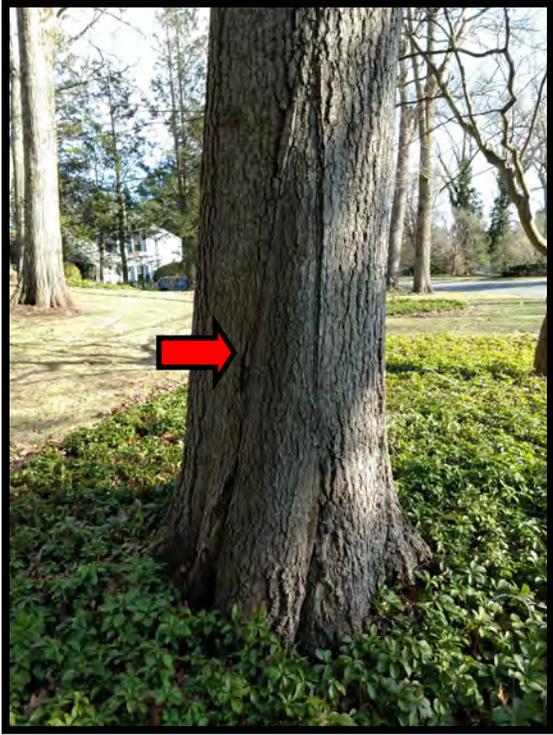
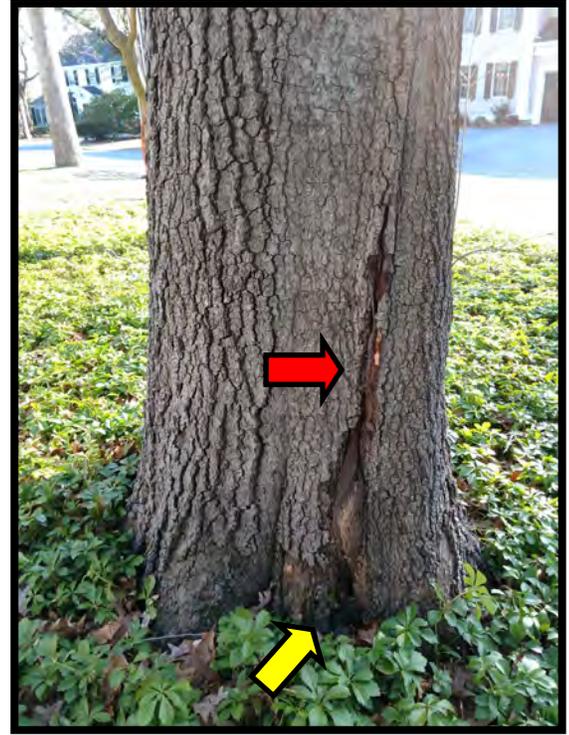
Picture top left: taken Thursday, March 26, 2020, 4:51:11 PM. Picture of the reaction wood production on the trunk. The red arrow is pointing to the location of the wound wood.

Picture top right: taken Thursday, March 26, 2020, 4:51:19 PM. The red arrow is pointing to the reaction wood and the yellow arrow is pointing to the dead spot at the base of the tree.

Picture bottom middle: taken Thursday, March 26, 2020, 4:51:38 PM. Blue arrow is pointing to the flattening of the trunk and the green arrow is indicating the abnormal bark pattern.

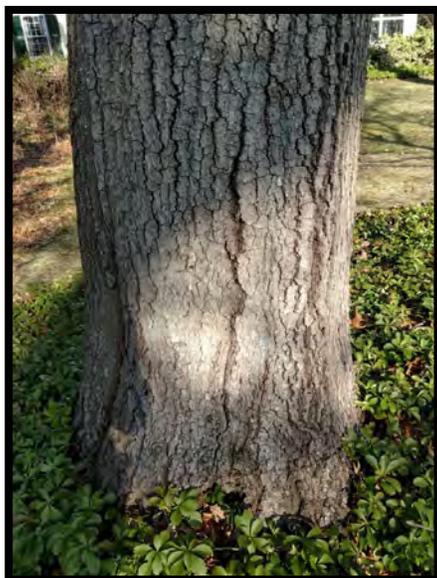
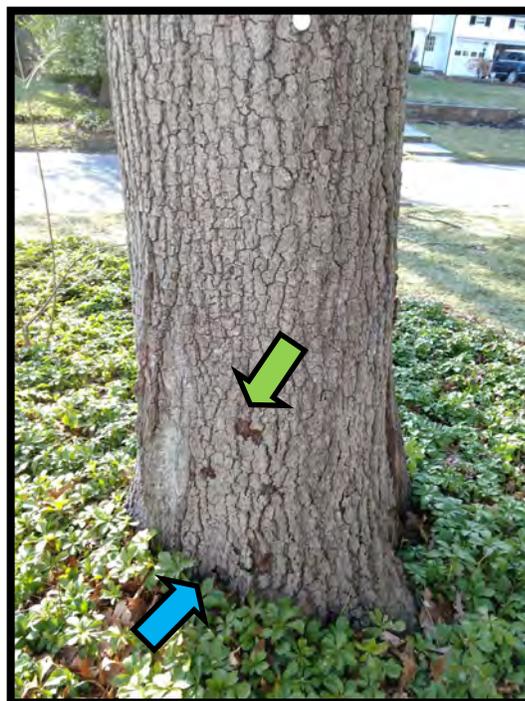
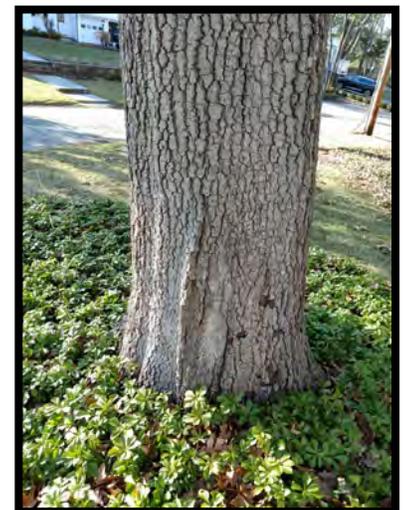
Picture: taken Thursday, March 26, 2020, 4:52:04 PM. The picture show the Codominant leaders. The red arrow is pointing to the bifurcation in the trunk with an acute angle and included bark. As the trunks increase in diameter and grow together the bark becomes trapped between the two leaders and is referred to as “included bark”. The larger the trunks grow the larger the seam between the two leaders gets. Eventually the size of the leader becomes disproportional to the attachment point and the likelihood of failure increases.

The yellow arrow is pointing to the swelling that is caused by the production of reaction wood created by the tree to compensate for the increased force generated at the point of attachment between the two leaders.

Picture bottom left: Thursday, March 26, 2020, 4:52:04 PM. Close up of the seam between the codominant leaders.
