81 Arnold Road

Wellesley Planning Board Large House Review Application
Applicant: D. Michael Collins
Land Owner: Greta & Matthew Fruhan
Address: 81 Arnold Road

Statement of Intent

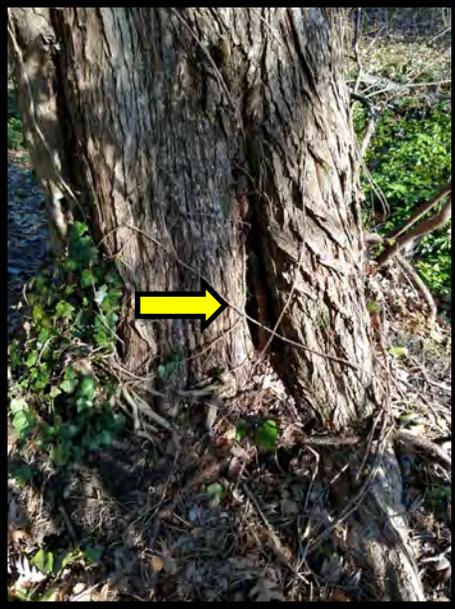
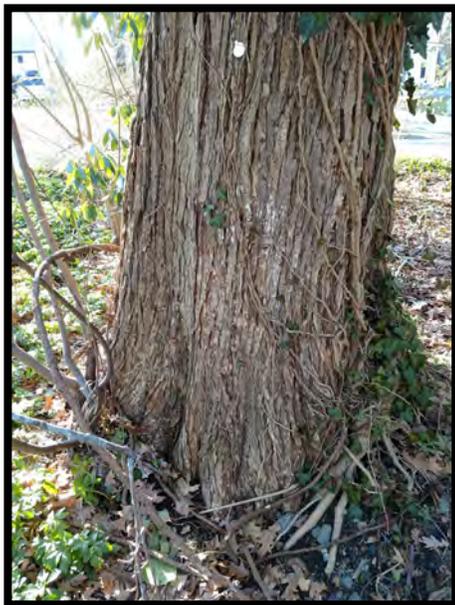
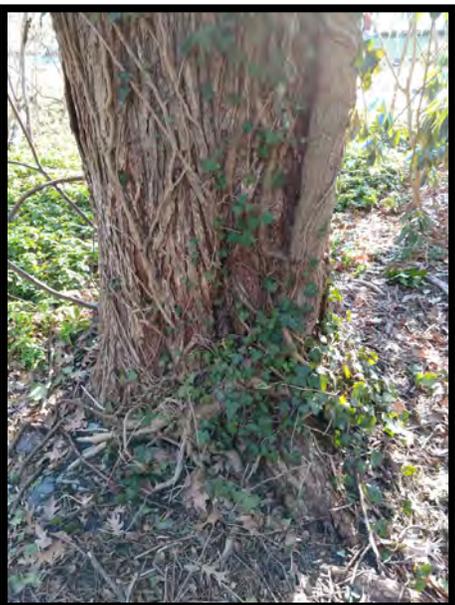
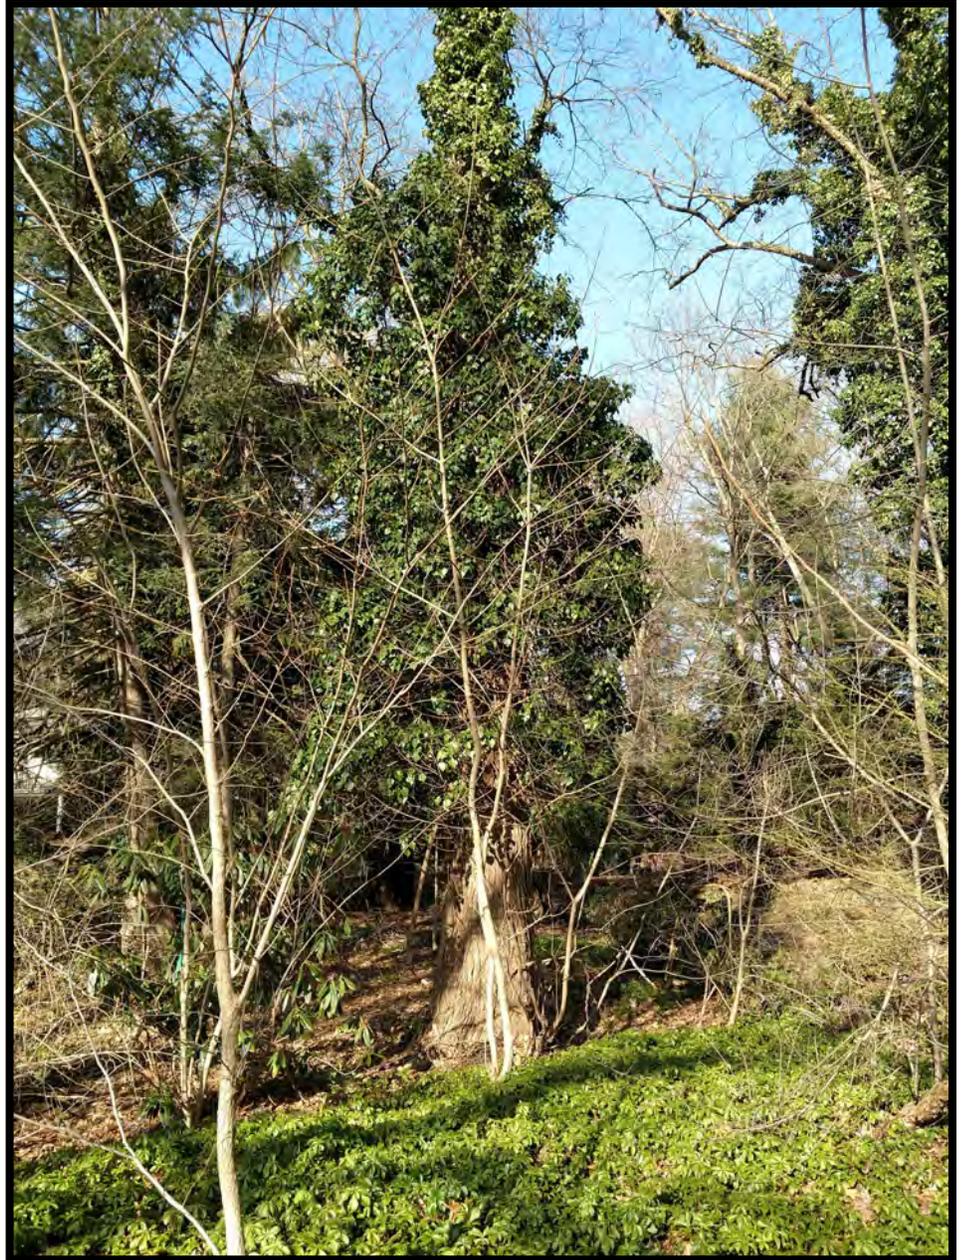
Picture top left: taken Thursday, March 26, 2020, 4:29:44 PM. The yellow arrow indicating the location of the cavity at the base of the trunk. The extent of the decay is unknown.

Picture middle left: taken Thursday, March 26, 2020, 4:30:02 PM. Image is a close up of the base of the tree.

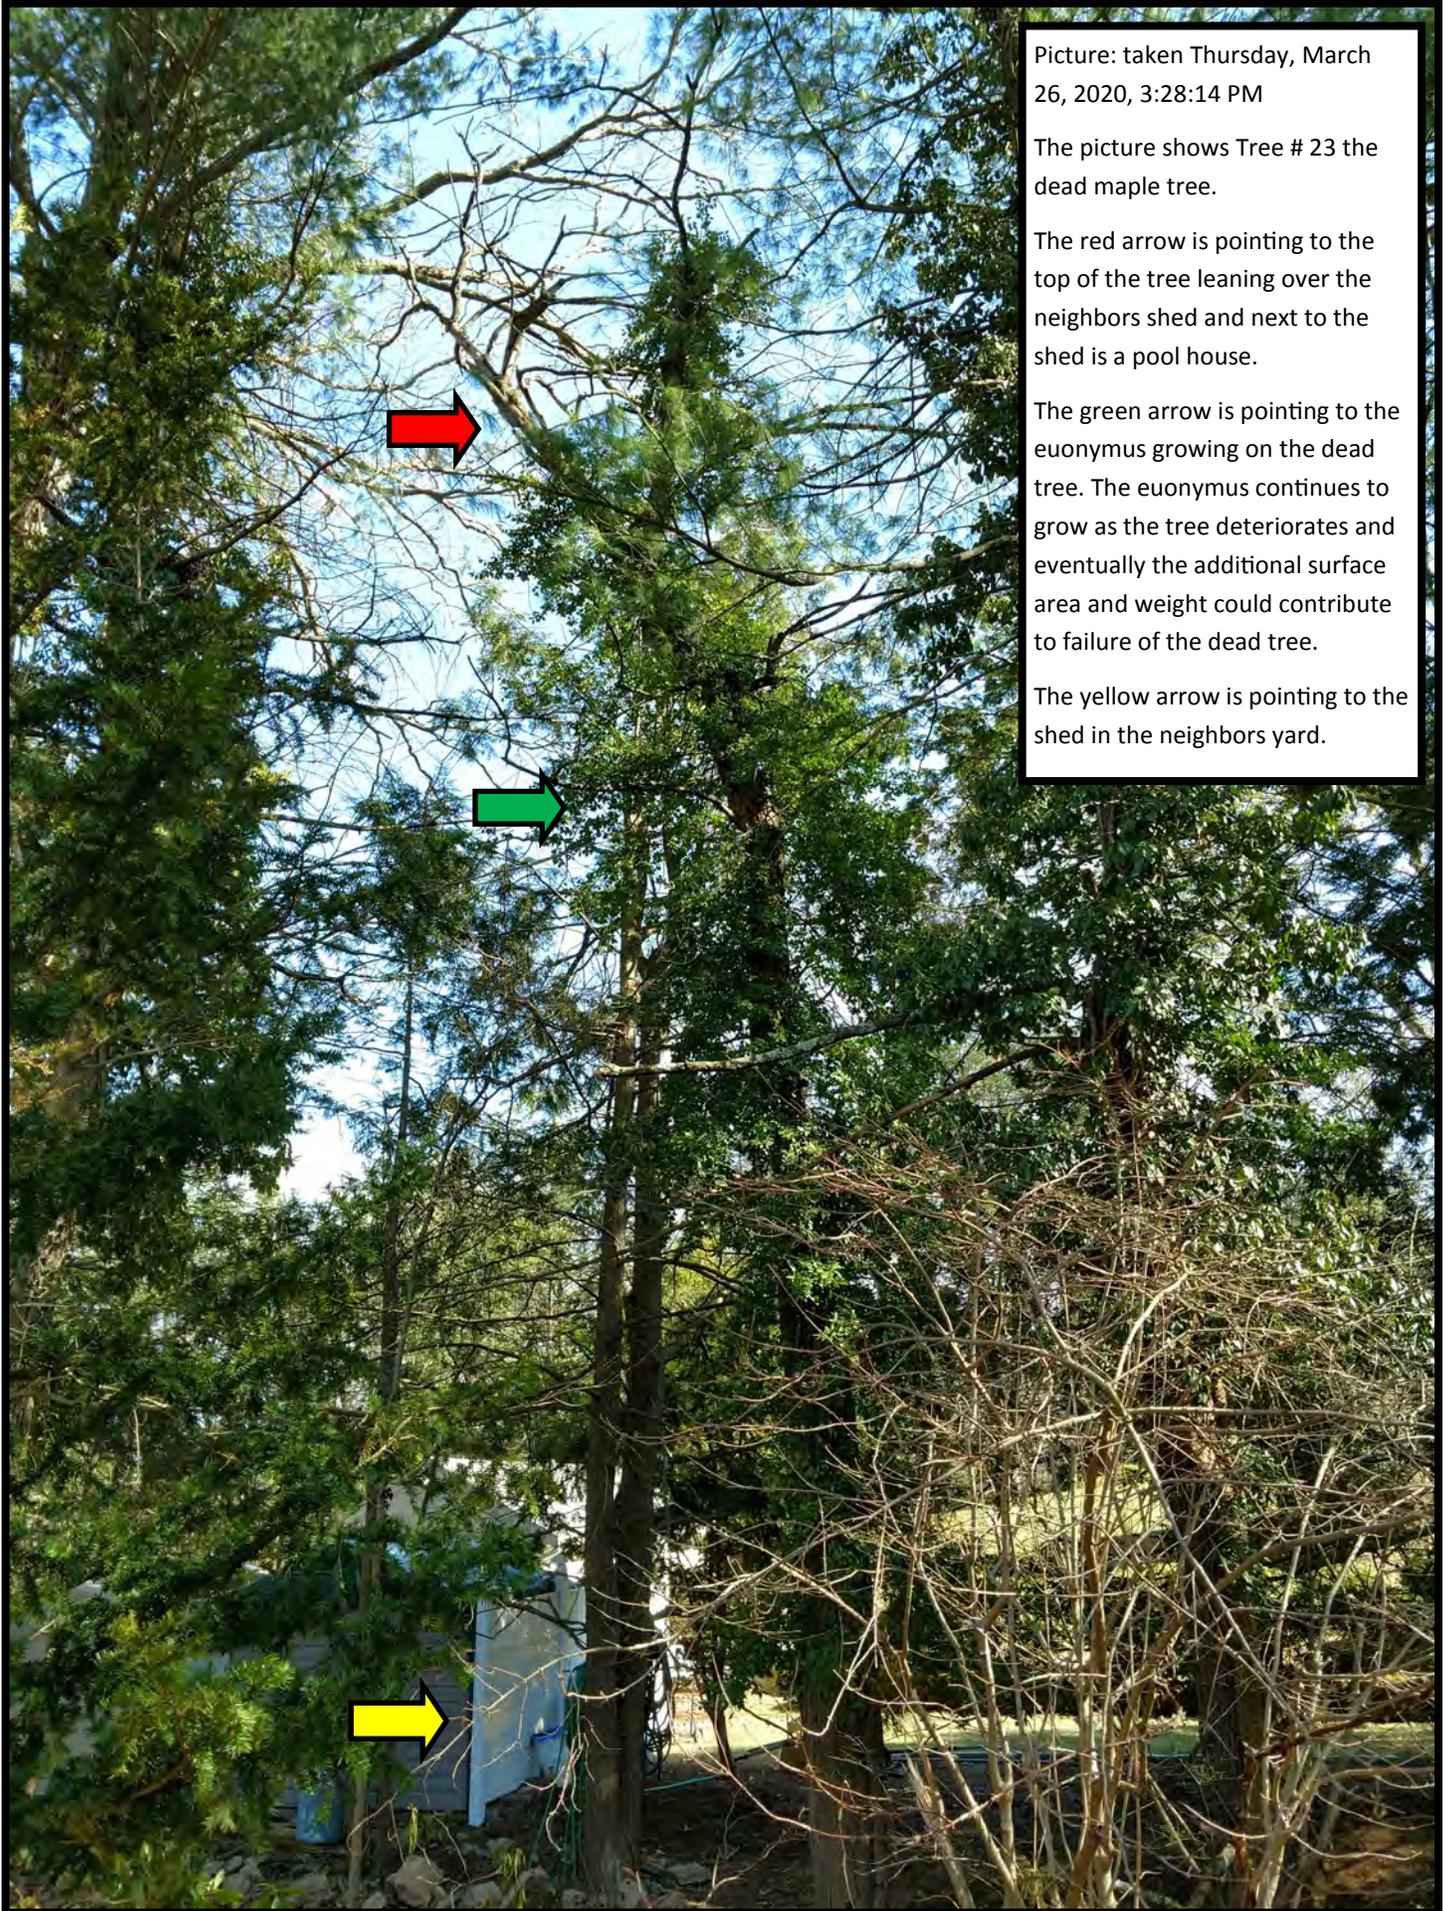
Picture: taken Thursday, March 26, 2020, 3:28:14 PM

The picture shows Tree # 23 the dead maple tree.

The green arrow is pointing to the euonymus growing on the dead tree. The euonymus continues to grow as the tree deteriorates and eventually the additional surface area and weight could contribute to failure of the dead tree.

- **Tree #23 *Acer rubrum* (Red Maple)** This tree is dead. Recommend removal.
- **Tree #32 *Quercus rubra* (Red Oak)** This tree is in fair to poor health and fair to poor structural condition. This tree is very large and leans heavily to one side there is a large cavity on the trunk. Recommend Removal.

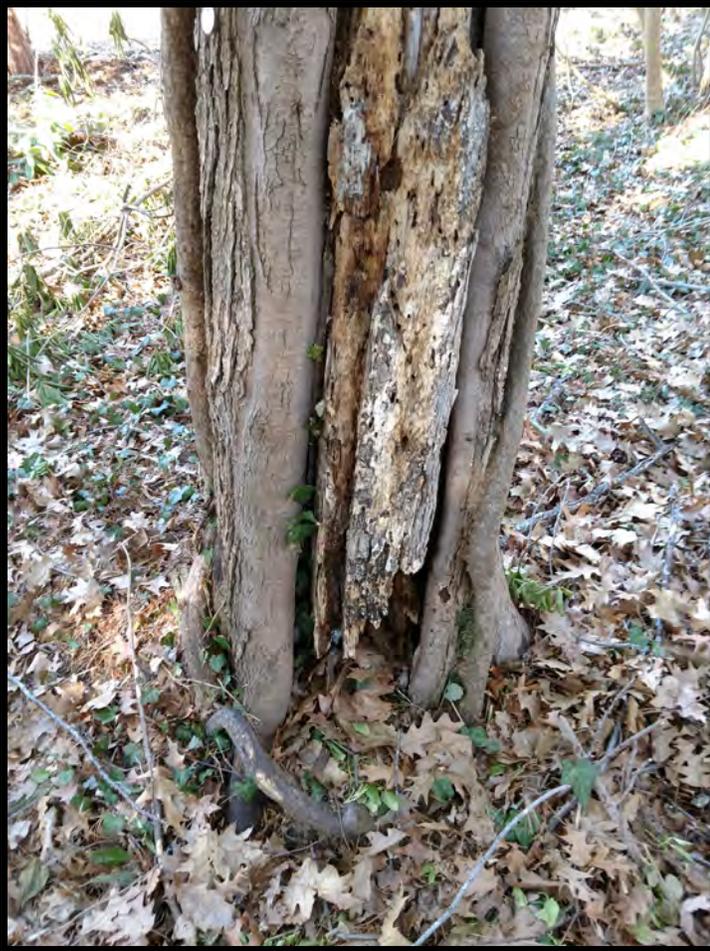
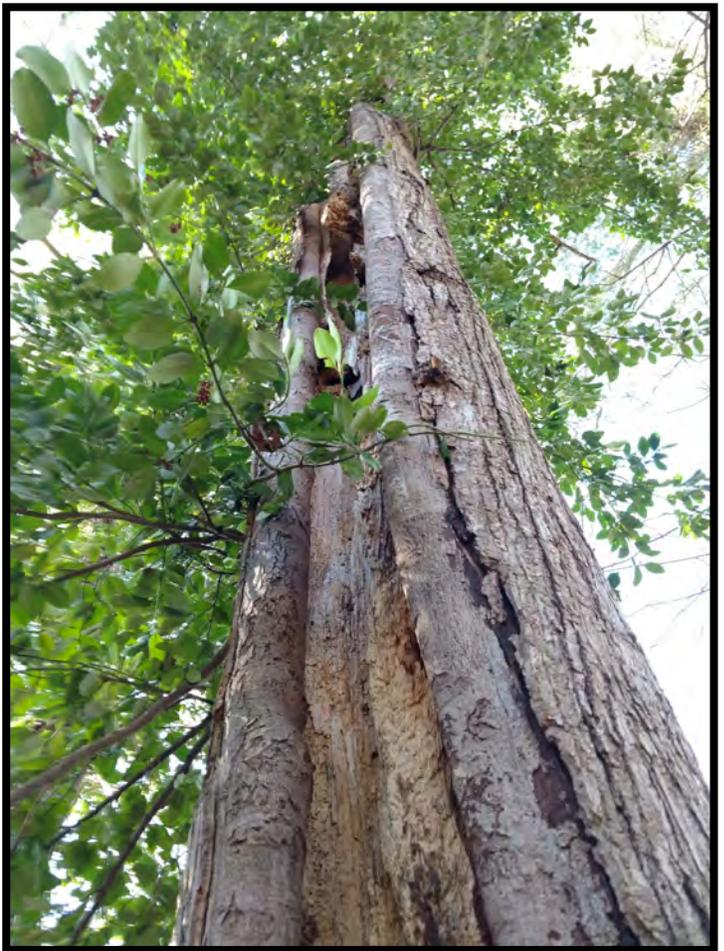
Picture top left: taken Thursday, March 26, 2020, 3:27:27 PM. Shows the decay at the base of the tree.

Picture top right: taken Thursday, March 26, 2020, 3:33:12 PM. Shows the tear down the side of the trunk and the decay

Picture bottom middle: Thursday, March 26, 2020, 3:32:39 PM. Shows trunk and euonymus.

Picture bottom right: Thursday, March 26, 2020, 3:37:27 PM. Shows the damage at the base of the tree.

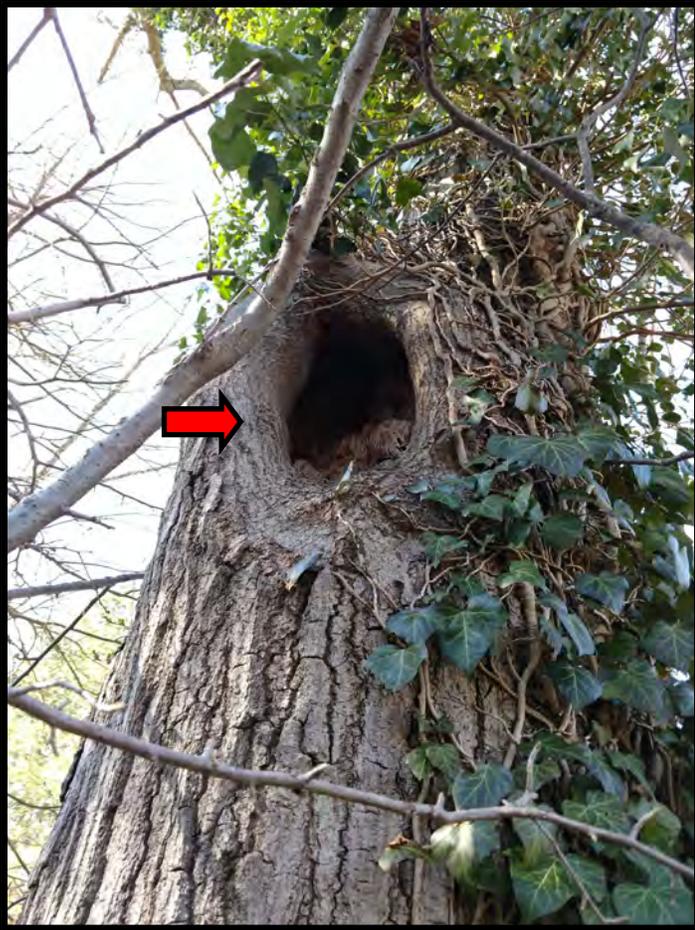
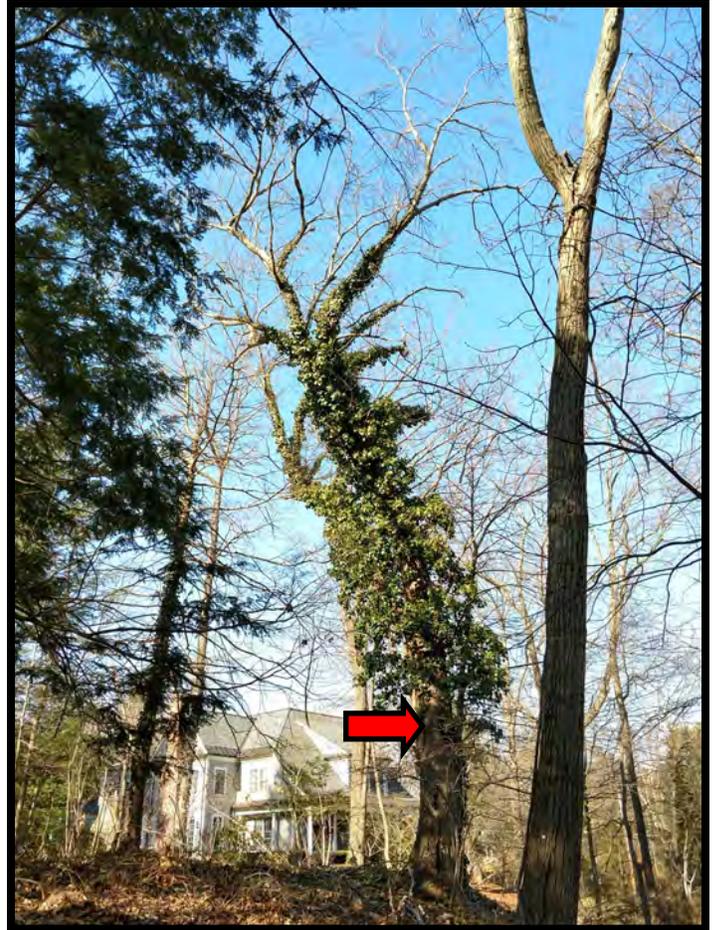
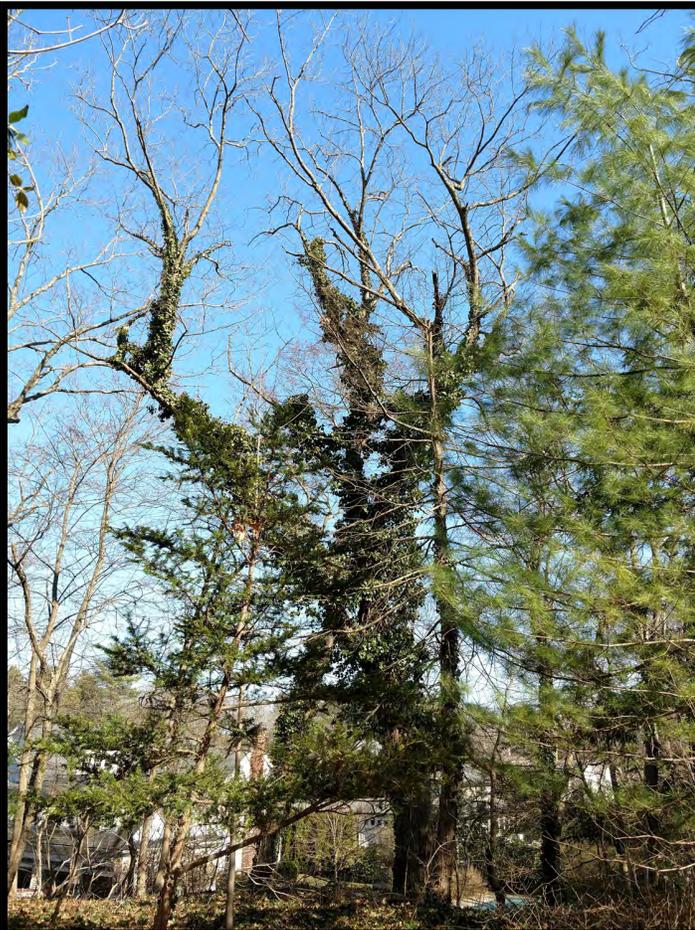
Picture Top left: taken Thursday, March 26, 2020, 3:45:58 PM. The picture shows the cavity in the side of the trunk. The extent of the decay is not known. An off center open cavity can affect the structural stability of the trunk.

Picture Top right: taken Thursday, March 26, 2020, 3:46:31 PM. Shows the tree leaning toward the neighbors yard. The red arrow is pointing to the location of the cavity.

Picture Bottom left: taken Thursday, March 26, 2020, 3:43:21 PM. Shows how much of the tree is covered by ivy. Eventually the ivy will grow to the top of the canopy. The picture also shows the lean of the tree.

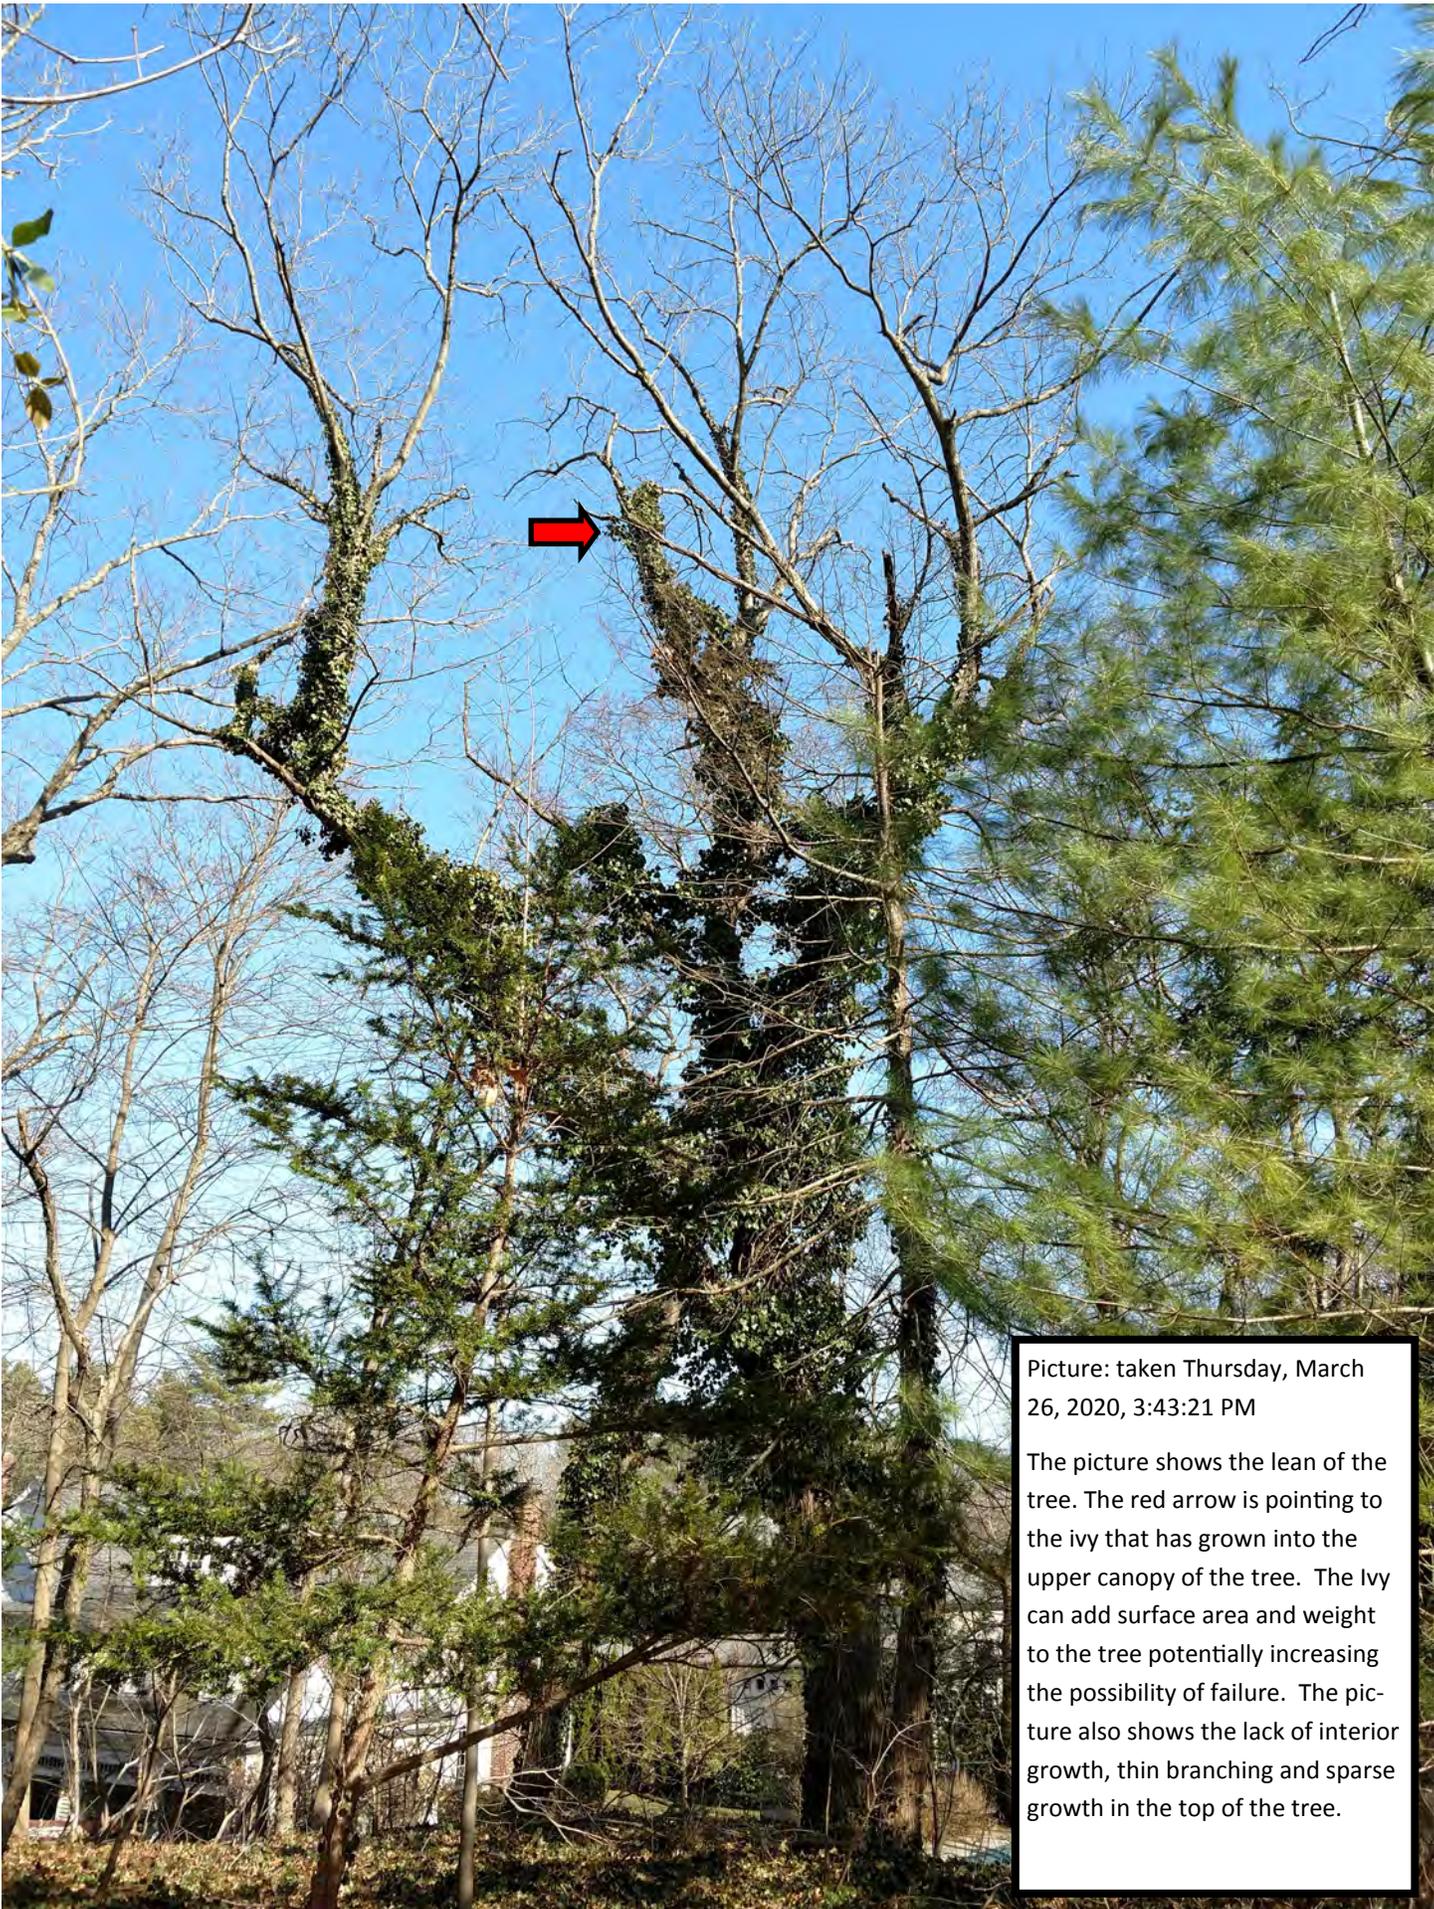
Picture: taken Thursday, March 26, 2020, 3:43:21 PM

The picture shows the lean of the tree. The red arrow is pointing to the ivy that has grown into the upper canopy of the tree. The ivy can add surface area and weight to the tree potentially increasing the possibility of failure. The picture also shows the lack of interior growth, thin branching and sparse growth in the top of the tree.

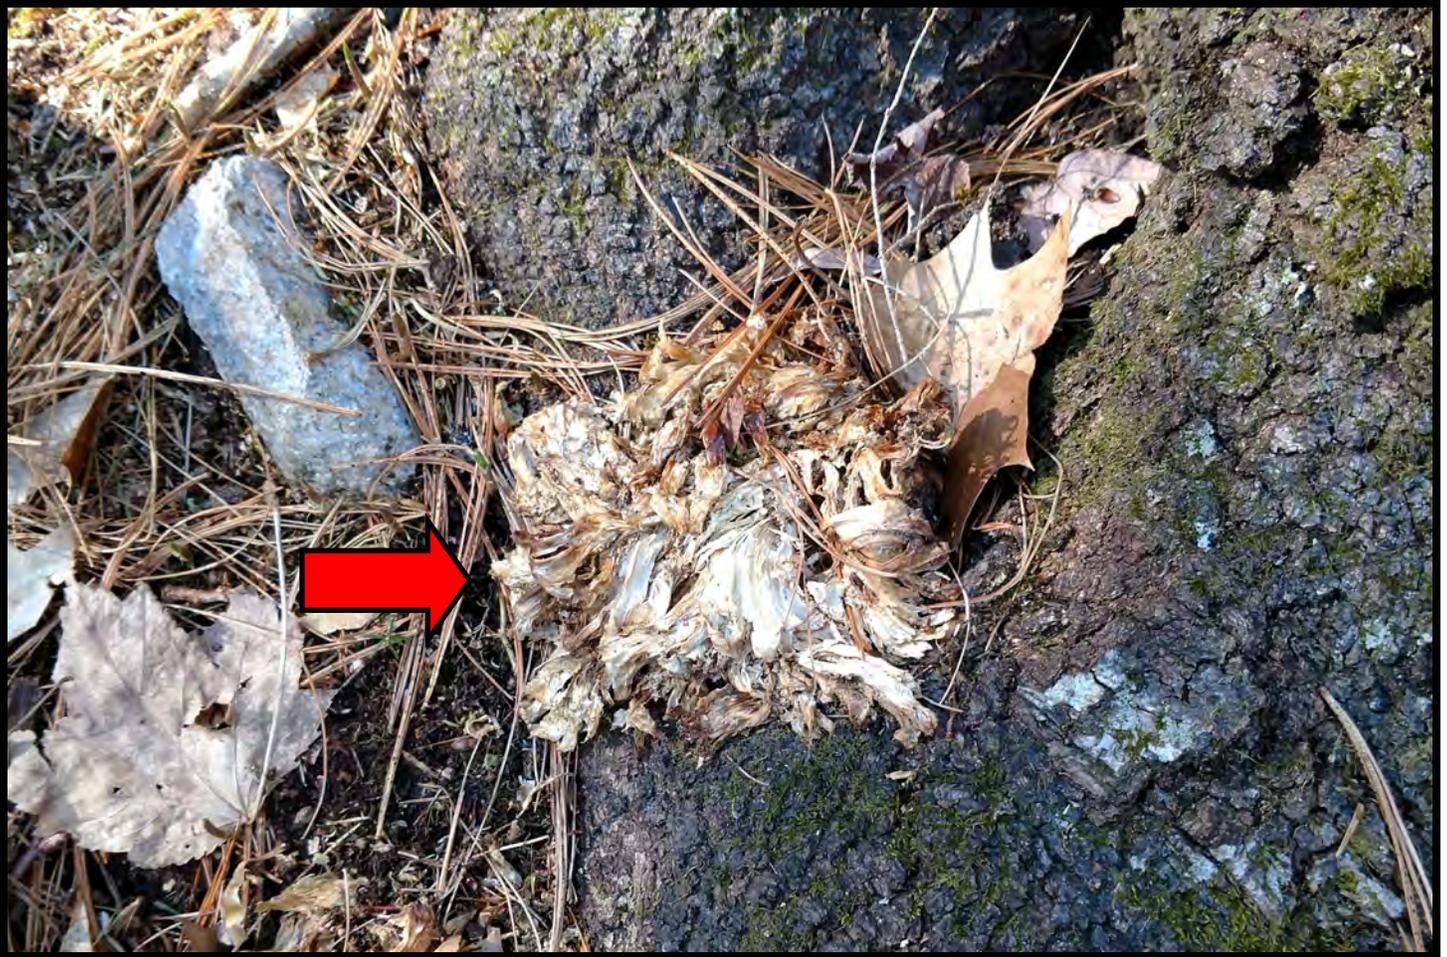
Picture above: taken Thursday, March 26, 2020, 4:05:11 PM: The red arrow is pointing to the remanence of mushrooms growing at the base of the tree. Mushroom production can be a sign of decay in the tree.

Picture lower left: taken Thursday, March 26, 2020, 4:05:56 PM: The yellow arrow is pointing to the seem between the two trunks of the tree. The red circle is around the remanence of mushrooms at the base of the tree. There are two locations mushrooms growing on the tree.

- **Tree #37 *Quercus rubra* (Red Oak)** This tree is in fair to good health and fair to poor structural condition. This triple leader oak tree has included bark between the leaders and signs of unidentified mushrooms growing on the trunk flare. Recommend removal.

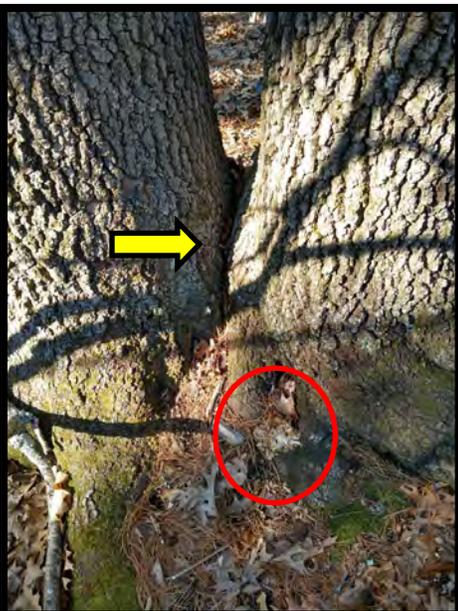
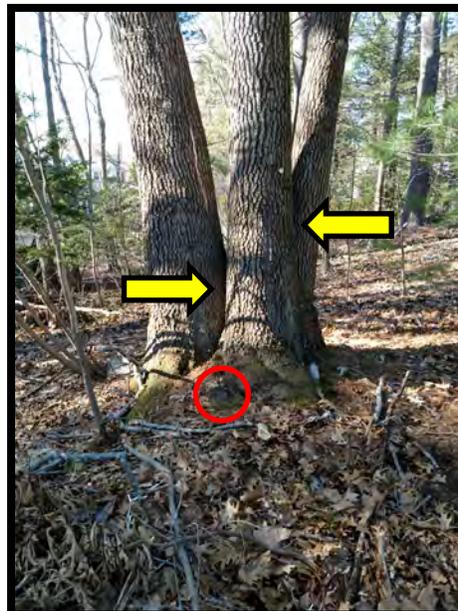
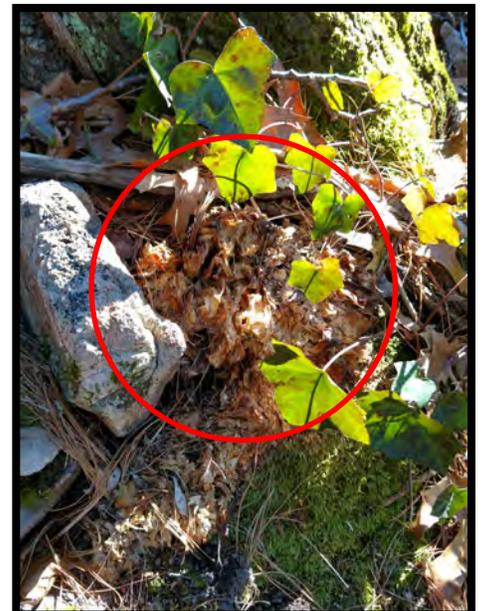
Picture lower middle: Thursday, March 26, 2020, 4:05:44 PM: Yellow arrows pointing to locations where the trunks of the tree are growing together with "included bark". The red circle is around one of the two locations mushrooms are growing at the base of the tree.

Picture lower right: March 26, 2020, 4:05:44 PM: Red circle around the mushroom growth at second location on the base of the tree.

The tree is located on the north side of the lot in a wooded area. This triple leader oak tree has structural characteristics known to increase the likelihood of failure. There is "included bark" present at the junctions of all 3 leaders. This characteristic is known to affect the structural stability of the tree. In addition to the codominant leaders there are mushrooms growing at two locations on the base of the tree. The mushrooms are unidentified, however they are usually an indication of decay. Some types of fungi only produce mushrooms at an advanced state of decay while others produce mushrooms much earlier in the process. The extent of the decay is unknown. Due to the existing conditions it is my opinion that this tree is a poor candidate for retention.

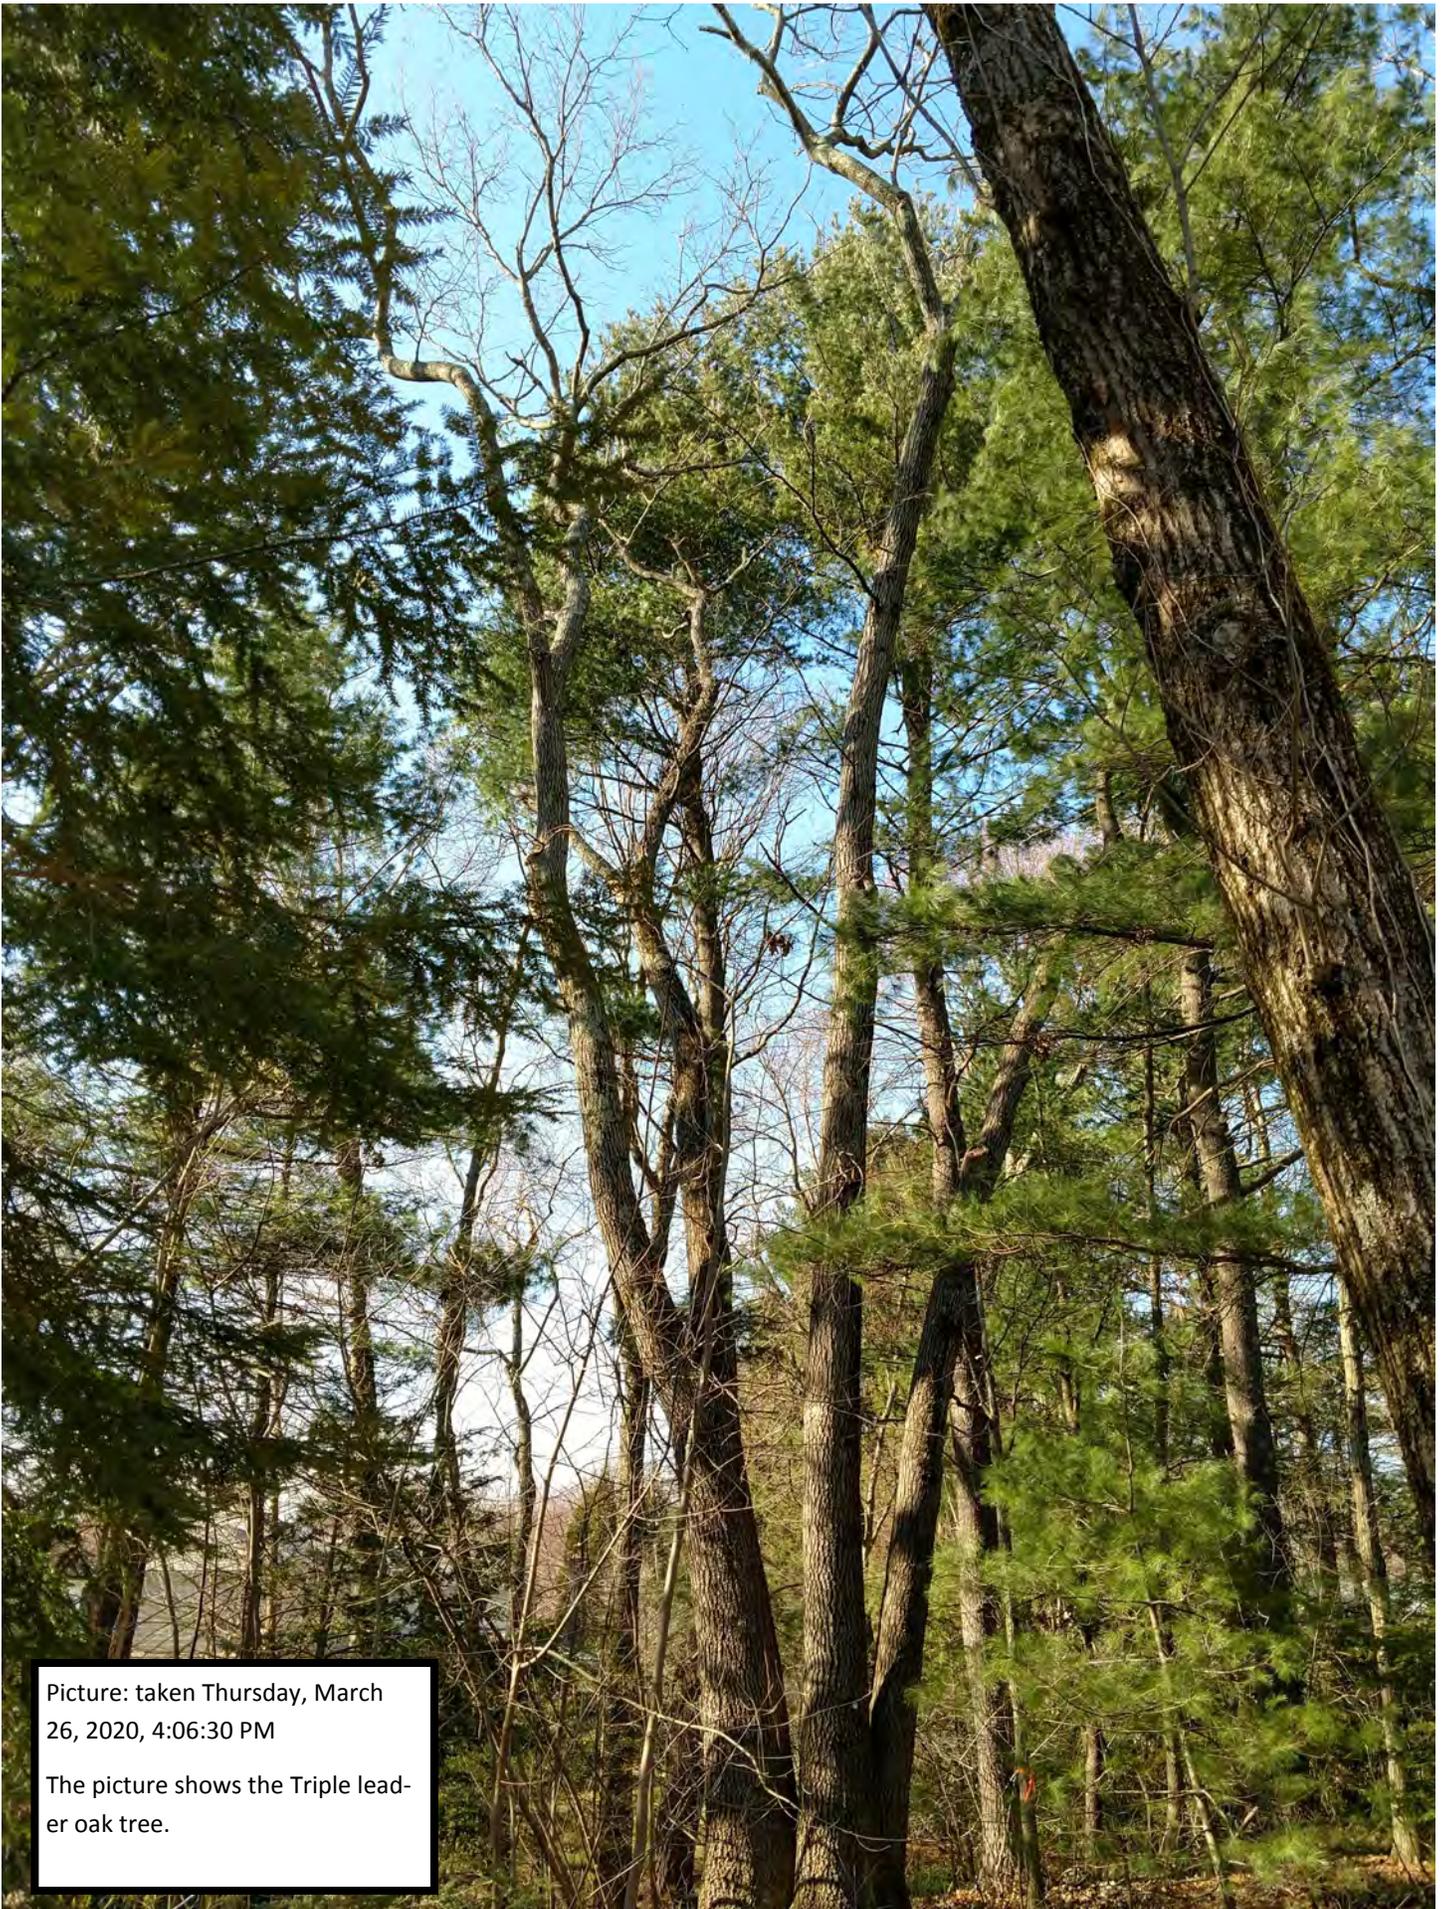
Picture: taken Thursday, March 26, 2020, 4:06:30 PM

The picture shows the Triple leader oak tree.

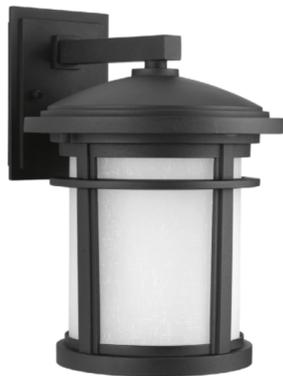
LED wall lantern with etched white linen glass. Includes dark sky shield for full cut-off illumination or remove for a traditional lighting effect. 120V AC replaceable LED module, 1,211 lumens 71.2 lumens/watt per module (source). 3000K color temperature and 90+ CRI.

Width: 9"
 Depth: 10-1/2"
 Height: 12-1/2"
 H/CTR: 3-1/8"

Glass
 Width: 5-5/16"
 Height: 7-3/8"

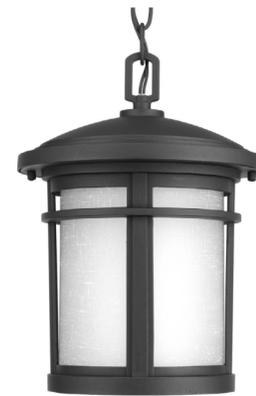
Construction: Aluminum Construction

Glass/Shade: Etched White Linen glass cylindrical diffuser

Diameter: 9"
 Height: 12-1/2"
 Overall Ht. W/Chain: 87-1/2"

Glass
 Width: 6"
 Height: 7-3/8"

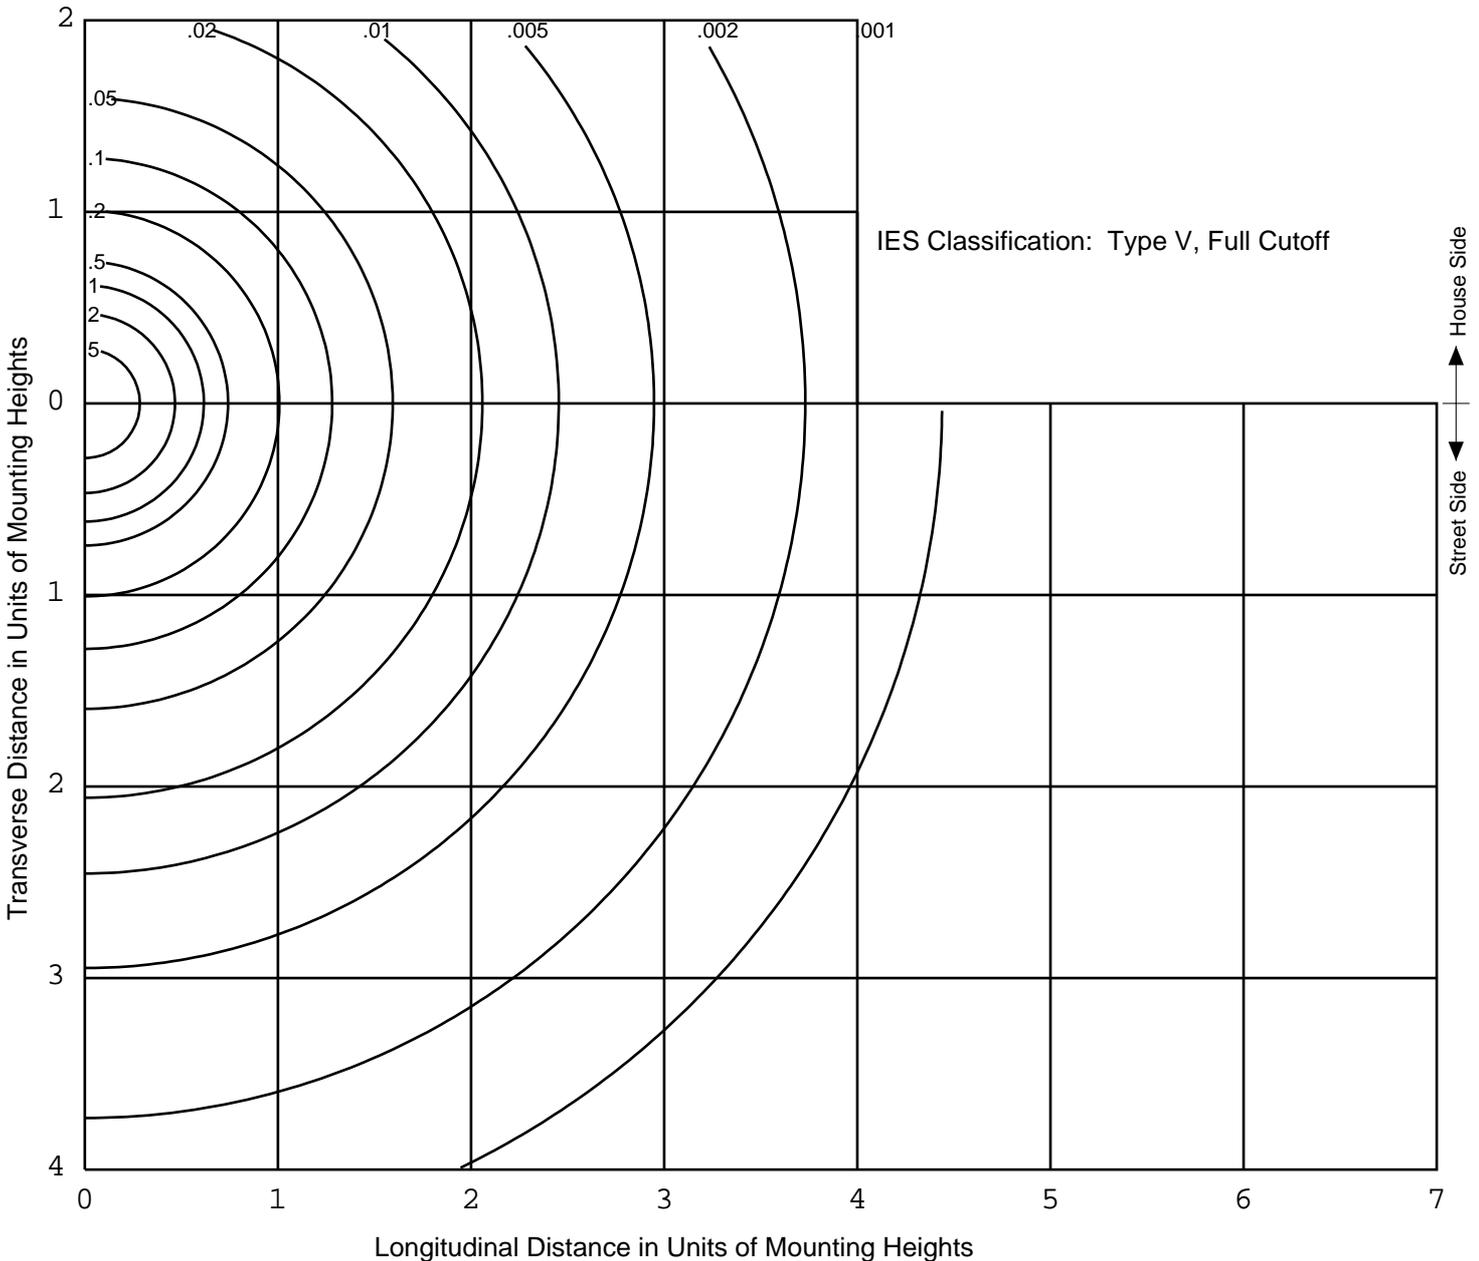
ISOFOOTCANDLE LINES OF HORIZONTAL ILLUMINATION
Values based on 6.6 foot mounting height.

REPORT NUMBER: 15.00828
ISSUE DATE: 05/20/15 PAGE: 2 OF 9
PREPARED FOR: PROGRESS
CATALOG NUMBER: P6085-3130K9
LUMINAIRE: WISH - 1-Lt. Med. LED Wall
Lantern w/ HAL 17W Module
LAMP CAT. NO.: 93047261-4130
LAMP: 40 - NICHIA 3000K LEDs
REFRACTOR: Etched White Linen Glass
Shade Part# 93061284 w/ Metal
Cylinder painted Gloss White insert
MOUNTING: WALL
NOTE: DATA SHOWN IS ABSOLUTE FOR THE
SAMPLE PROVIDED.

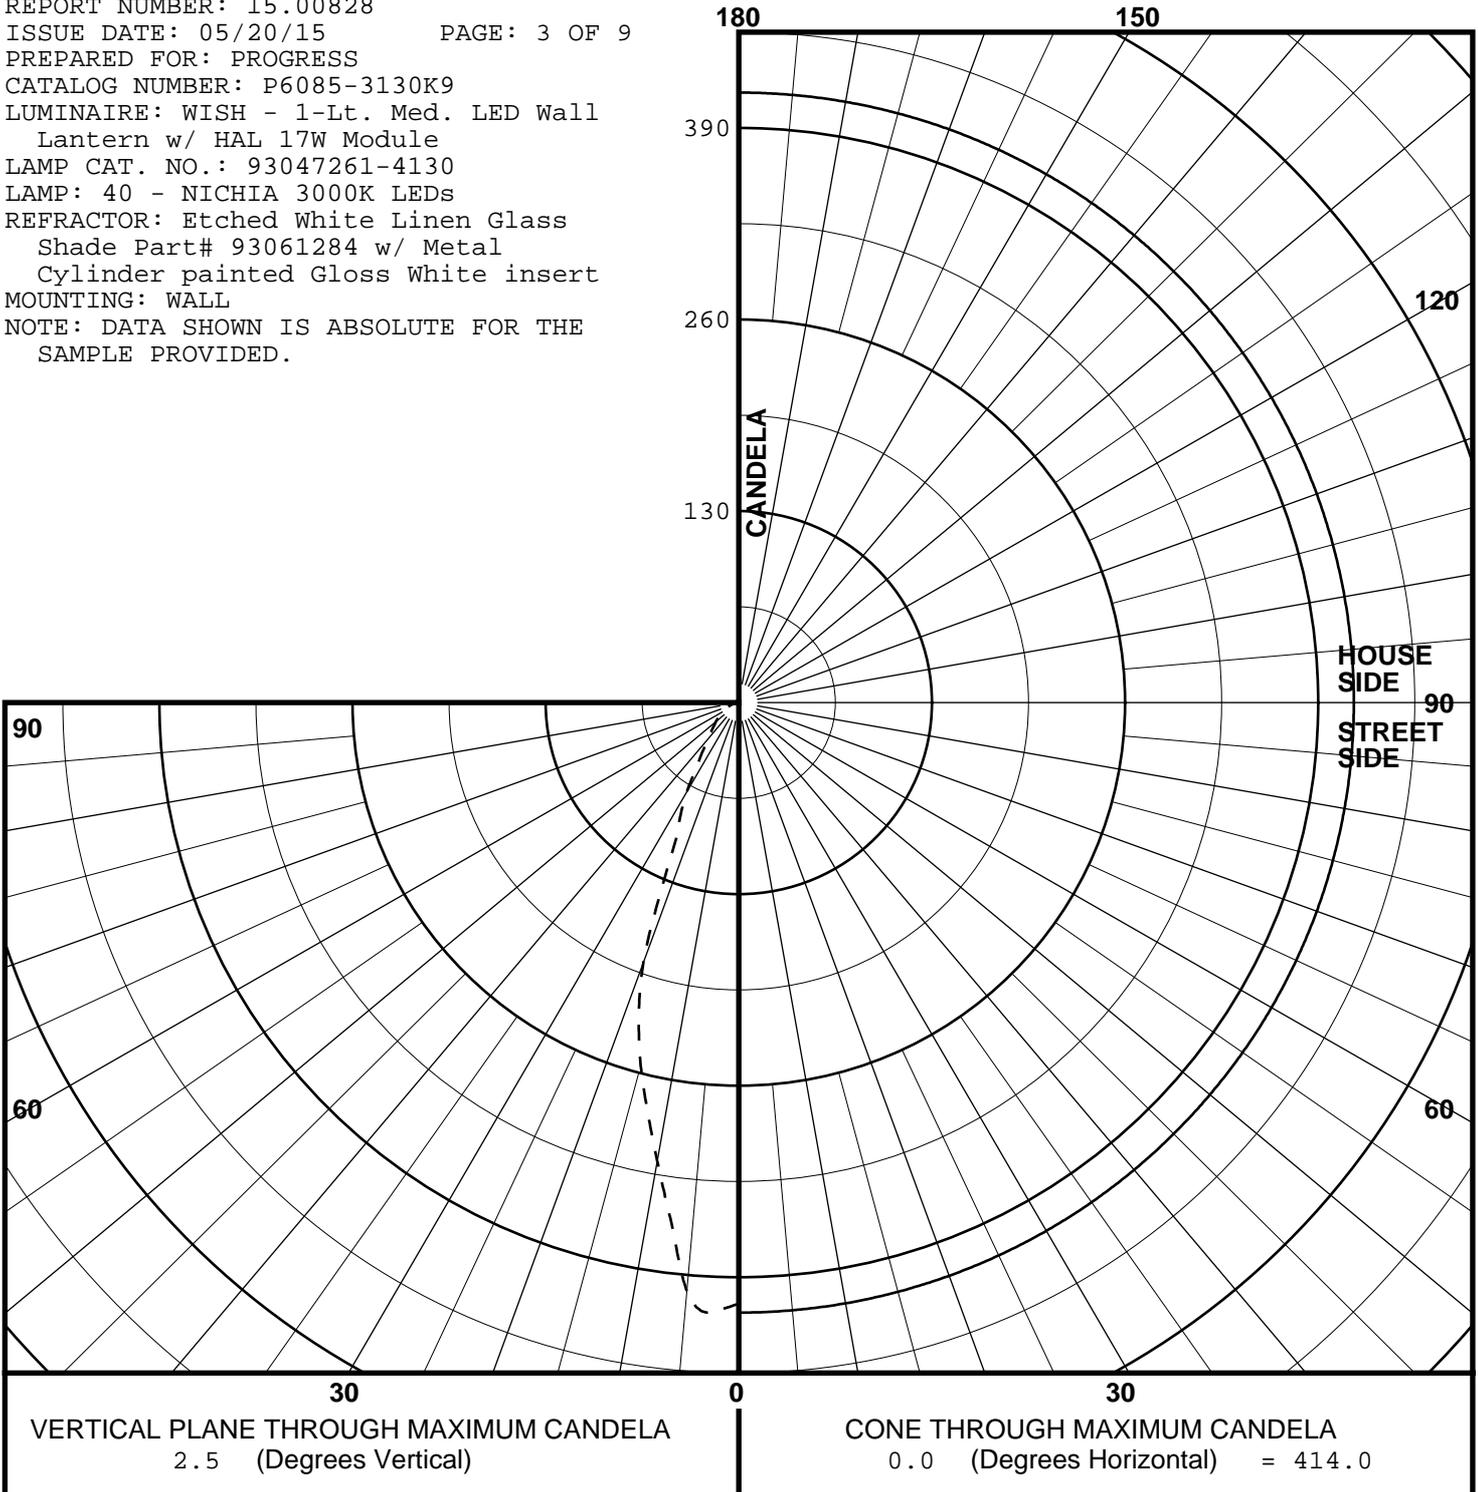
MAXIMUM PLANE AND MAXIMUM CONE PLOTS OF CANDELA

REPORT NUMBER: 15.00828
 ISSUE DATE: 05/20/15 PAGE: 3 OF 9
 PREPARED FOR: PROGRESS
 CATALOG NUMBER: P6085-3130K9
 LUMINAIRE: WISH - 1-Lt. Med. LED Wall
 Lantern w/ HAL 17W Module
 LAMP CAT. NO.: 93047261-4130
 LAMP: 40 - NICHIA 3000K LEDs
 REFRACTOR: Etched White Linen Glass
 Shade Part# 93061284 w/ Metal
 Cylinder painted Gloss White insert
 MOUNTING: WALL
 NOTE: DATA SHOWN IS ABSOLUTE FOR THE
 SAMPLE PROVIDED.

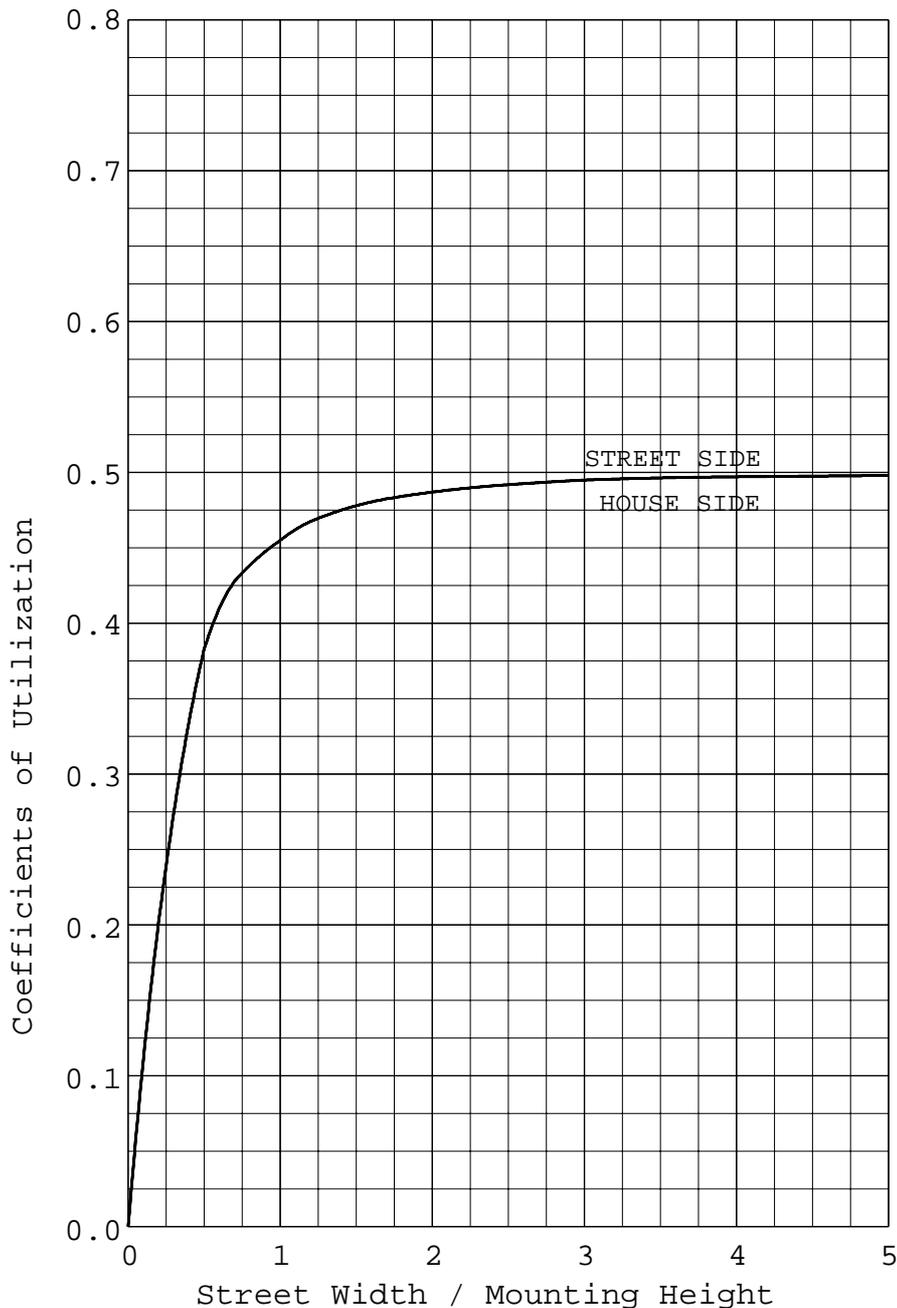
COEFFICIENTS OF UTILIZATION AND FLUX DISTRIBUTION

LUMENS	PERCENT OF FIXTURE
DOWNWARD STREET SIDE	117.	50.0
DOWNWARD HOUSE SIDE	117.	50.0
DOWNWARD TOTAL	234.	100.0
UPWARD STREET SIDE	0.	0.0
UPWARD HOUSE SIDE	0.	0.0
UPWARD TOTAL	0.	0.0
TOTAL FLUX	234.	100.0
TOTAL INPUT WATTS = 16.6		
EFFICACY = 14.1 Lm/W

ALL CANDELA AND LUMENS IN THIS REPORT ARE BASED ON ABSOLUTE PHOTOMETRY. THE COEFFICIENT OF UTILIZATION VALUES ARE BASED ON THE TOTAL ABSOLUTE LUMEN OUTPUT OF THIS LUMINAIRE SAMPLE.
