81 Arnold Road

Wellesley Planning Board Large House Review Application
Applicant: D. Michael Collins
Land Owner: Greta & Matthew Fruhan
Address: 81 Arnold Road

Statement of Intent

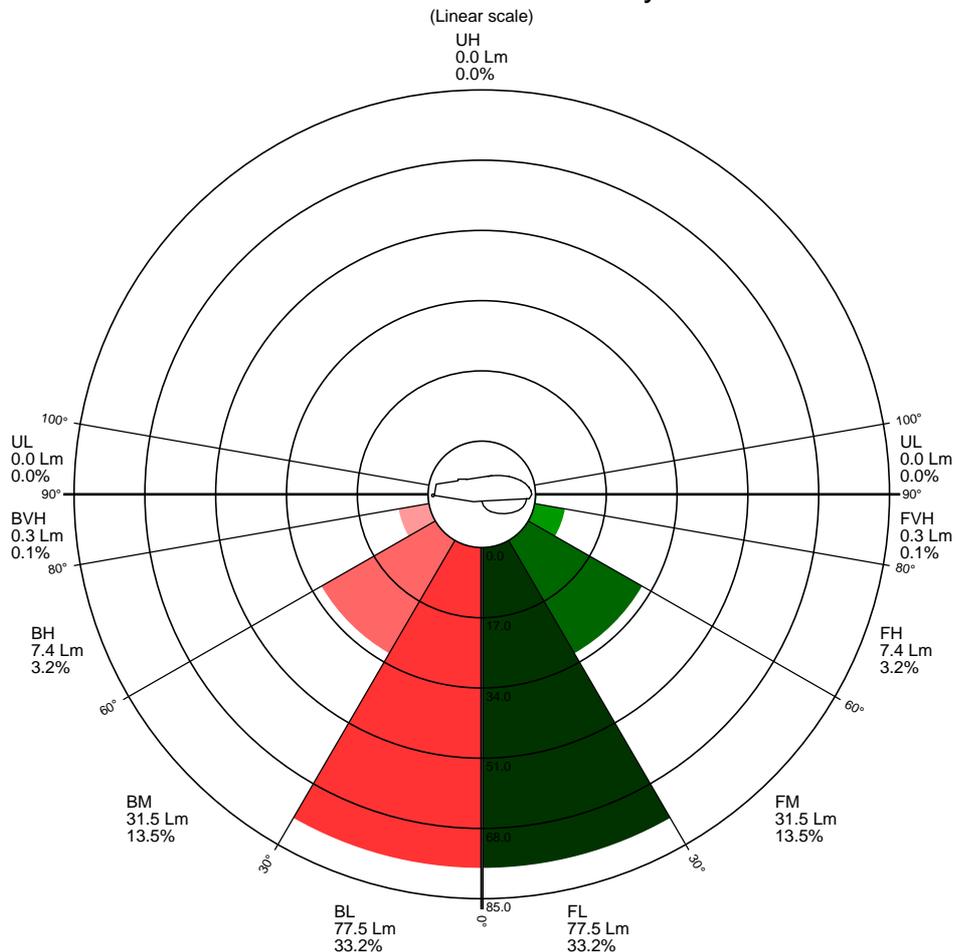
Zonal Lumen Summary

BUG Rating: Zonal Summary	Lumens	% of Fixture	Zone Ratings		
			B	U	G
Forward	117	50.0			
FL (0° - 30°)	77.5	33.2			
FM (30° - 60°)	31.5	13.5			
FH (60° - 80°)	7.4	3.2			G0
FVH (80° - 90°)	0.3	0.1			G0
Backward	117	50.0			
BL (0° - 30°)	77.5	33.2	B0		
BM (30° - 60°)	31.5	13.5	B0		
BH (60° - 80°)	7.4	3.2	B0		G0
BVH (80° - 90°)	0.3	0.1			G0
Upward	0	0.0			
UL (90° - 100°)	0.0	0.0		U0	
UH (100° - 180°)	0.0	0.0		U0	
Trapped Light	0	0.0			
Total Flux	234	100.0
