Owner: Gretta & Matt Fruhan  
Address: 81 Arnold Rd.  
Applicant: D. Michael Collins Architect

# 81 Arnold Road

SUPPLEMENTAL STORMWATER REPORT  
REQUESTED DATA

Large House Review  
81 Arnold Road  
Wellesley, MA

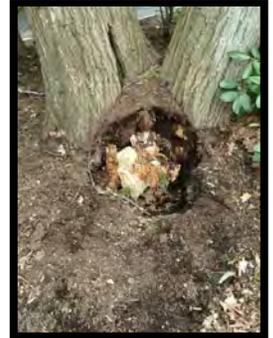
Show the leader that was leaning over the driveway toward the house after failure during the wind storm. It is clear from the pictures that the tree has been negatively impacted by the driveway, prior construction, and maintenance. The failure revealed the extent of the decay present in the base of the tree. It is likely that the other two leaders are in similar structural condition.

**Picture top left:** taken Thursday, March 26, 2020, 1:49:14 PM. Yellow arrow is pointing to the lack of trunk flare indicating that the grade was raised around this tree at some point in the past. The red arrow is indicating the proximity of the cobble stones and the edge of the driveway to the base of the tree. It is very likely that the root system of the tree has been damaged and is compromised in some way.

**Picture top right:** taken Thursday, March 26, 2020, 1:50:36 PM. Yellow arrow is pointing to the lack of trunk flare. The Green arrow is pointing to the trunk of the tree indicating past mechanical damage.

**Picture bottom left:** taken Thursday, March 26, 2020, 1:49:52 PM. The red arrow is indicating the seem with included bark between the leaders.

**Picture bottom left:** taken Thursday, March 26, 2020, 1:49:32 PM. Red arrow pointing to the included bark between the two leaders. Blue arrow indicating the mulch and composted material built up in the area between the leaders. This material holds moisture against the trunk of the tree. The green arrow is indicating mechanical damage to the trunk of the tree where there is an open cavity. The mulch and decomposing material between the trunks of the tree holds moisture against the trunk and any damage on the trunk providing a good environment for the decay fungi.

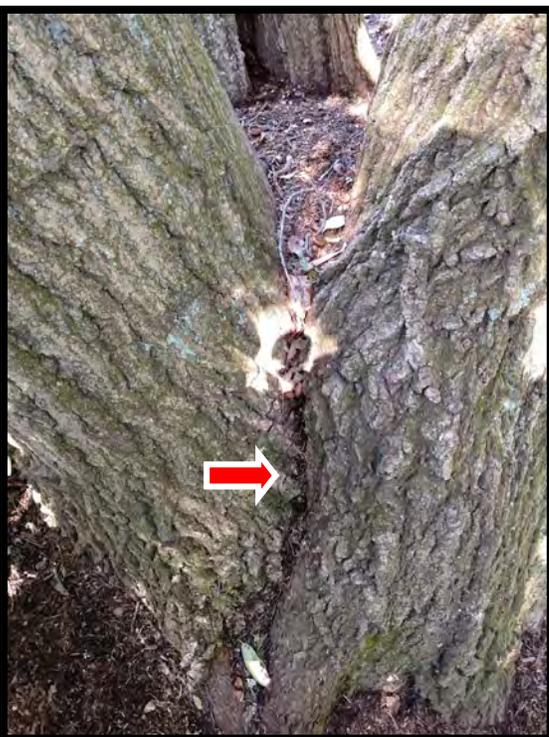
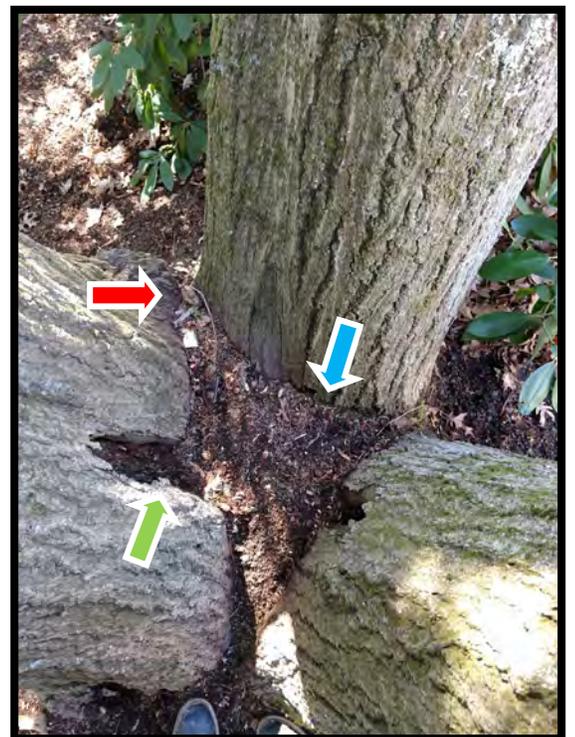
**Picture:** taken Thursday, March 26, 2020, 1:52:38 PM. The red arrow is pointing to the bifurcation in the trunk with an acute angle and included bark. The swelling is the production of reaction wood produced by the tree to compensate for the increased force generated at the point of attachment between the two leaders.

**Picture bottom left:** taken Thursday, March 26, 2020, 1:52:38 PM. The red arrow is pointing to a close-up of the seam between the two leaders.

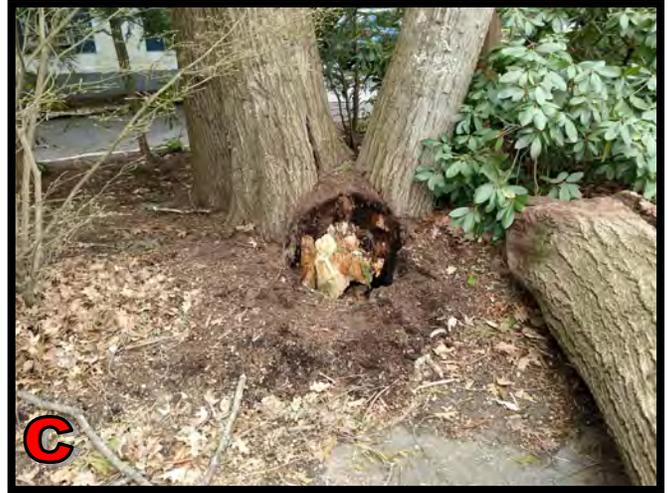
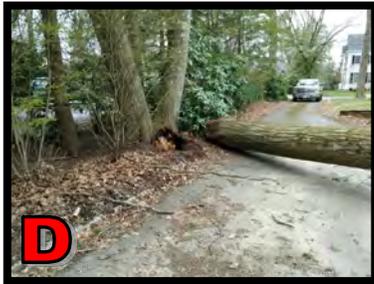
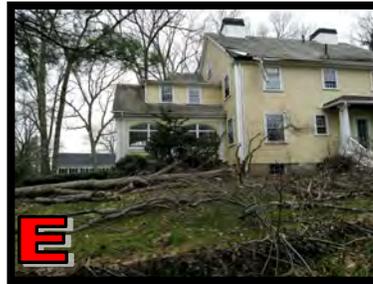
A. Picture taken: Monday, April 20, 2020: Picture of the base of the tree showing the decay where the trunk failed. Notice there is no fiber tear or roots pulled out of the ground. The decay is quite extensive.

B. Picture taken: Monday, April 20, 2020: The red arrow is indicating the soil line on the trunk of the tree. The soil line is an indication of the amount of grade change around the tree. Notice there are no roots attached to the trunk.

E. Picture taken: Monday, April 20, 2020: Picture of the back of the house and the damage caused by the tree.

F. Picture taken: Monday, April 20, 2020: Close up of the base of the tree. Green arrow pointing to the mechanical damage. The blue arrow pointing to the soil line on the trunk. The yellow arrow pointing to the discoloration. The orange arrow pointing to the included bark where the trunks of the tree grow together.

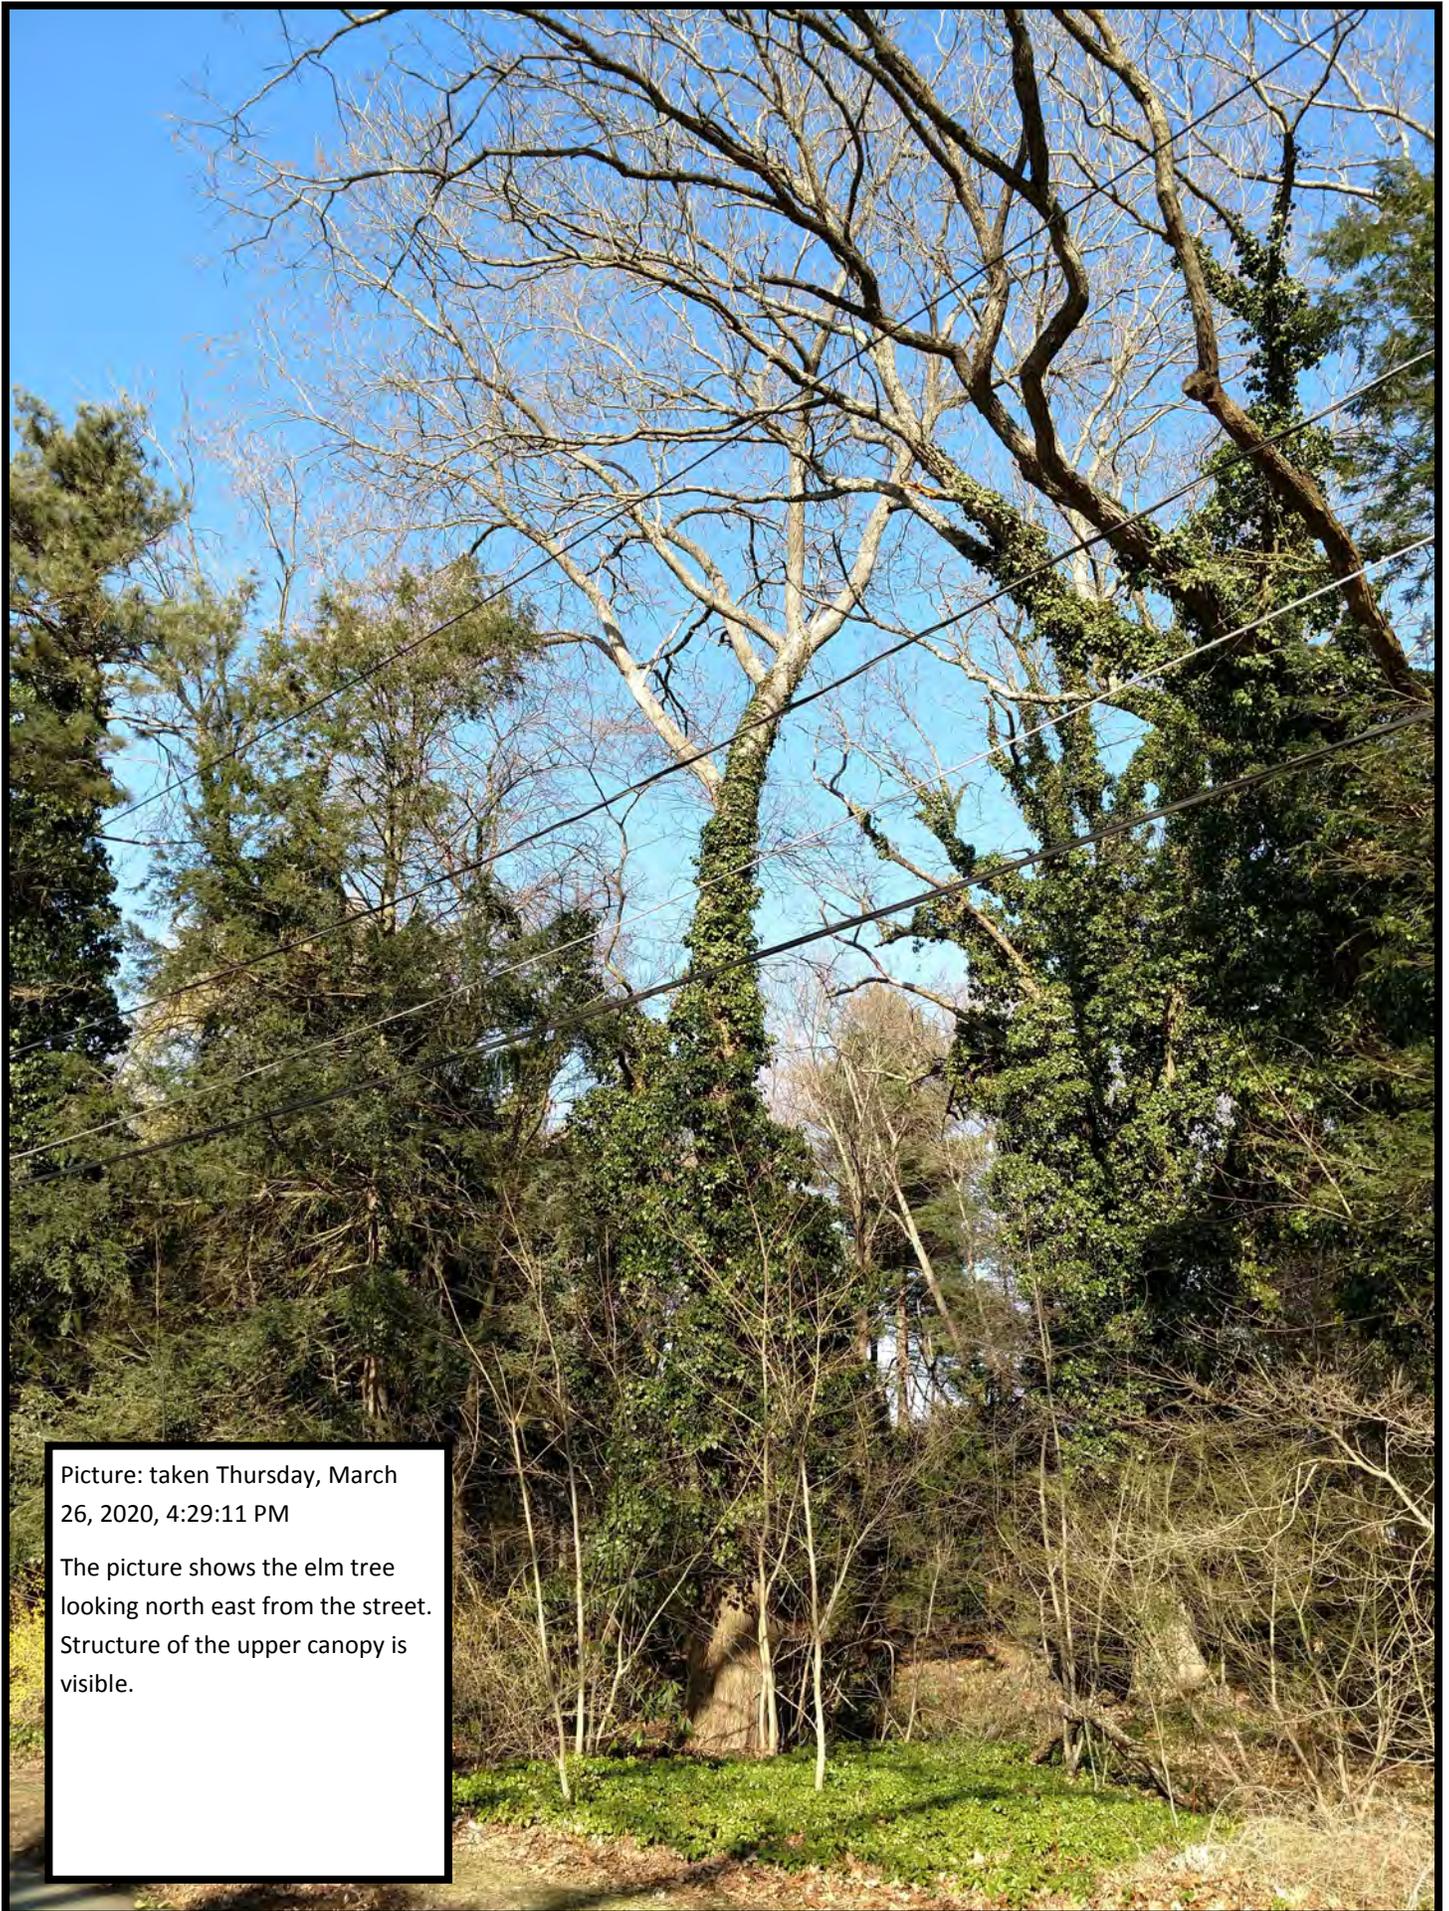
Picture: taken Thursday, March 26, 2020, 4:29:11 PM

The picture shows the elm tree looking north east from the street. Structure of the upper canopy is visible.

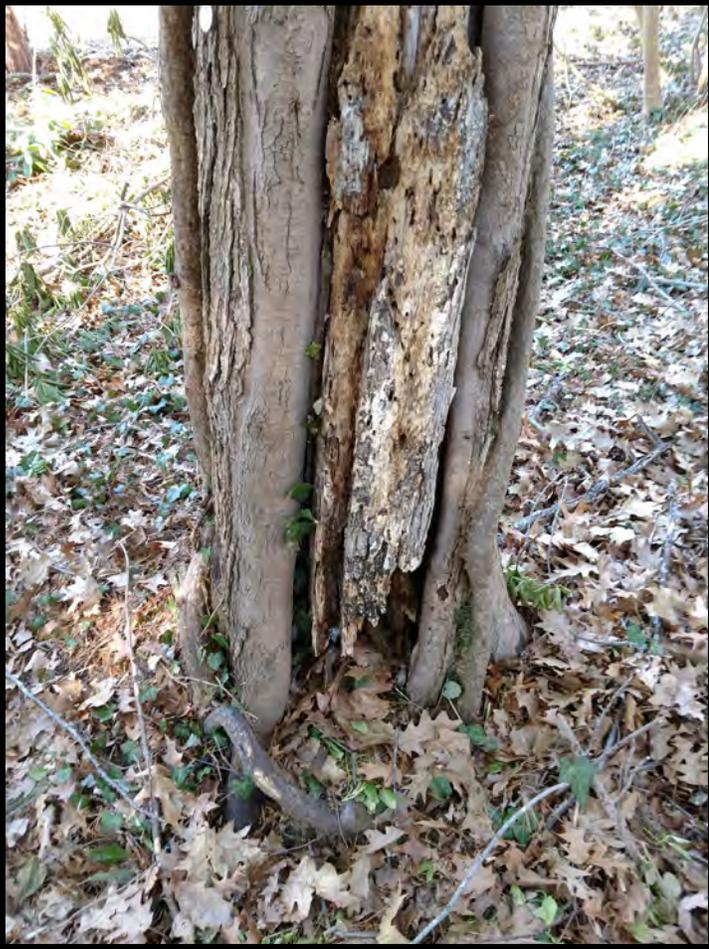
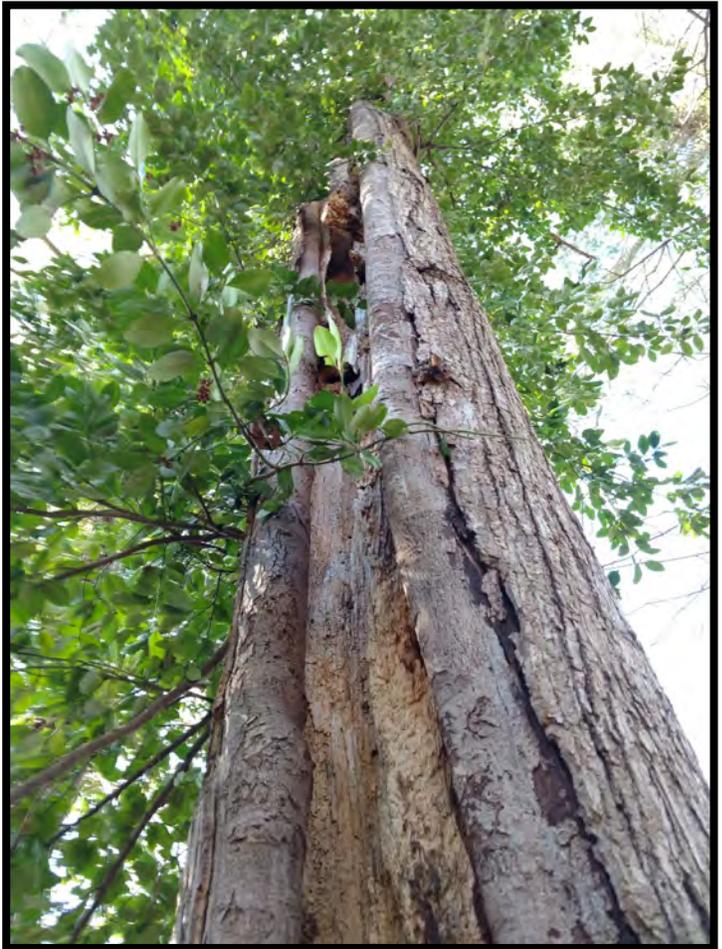
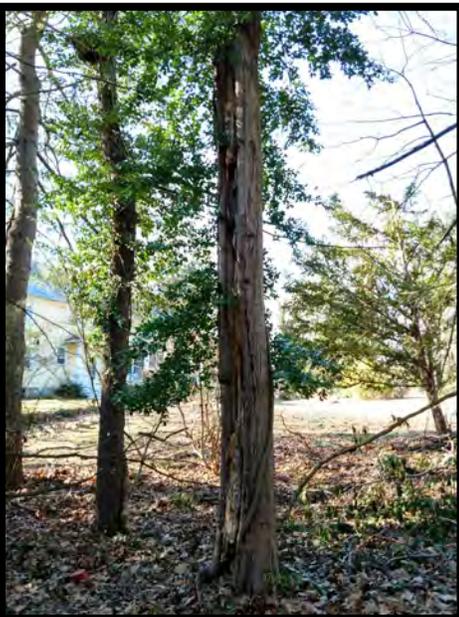
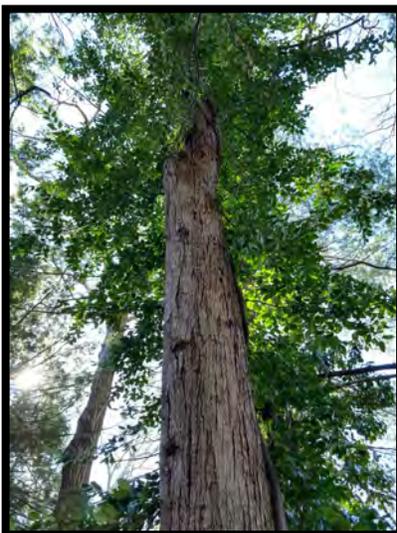
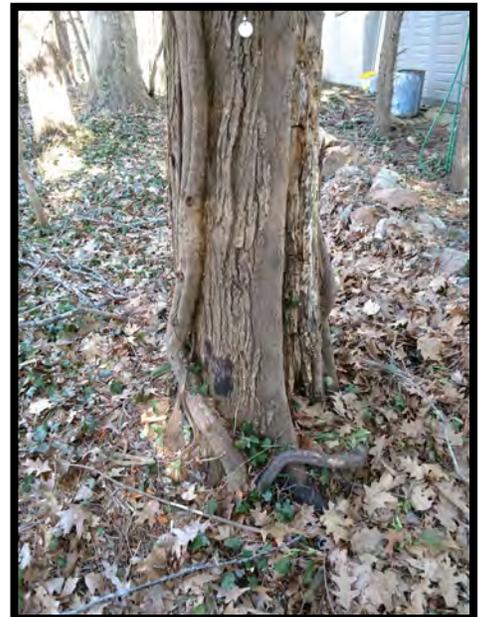
Picture top left: taken Thursday, March 26, 2020, 3:27:27 PM. Shows the decay at the base of the tree.

Picture top right: taken Thursday, March 26, 2020, 3:33:12 PM. Shows the tear down the side of the trunk and the decay

Picture bottom middle: Thursday, March 26, 2020, 3:32:39 PM. Shows trunk and euonymus.

Picture bottom right: Thursday, March 26, 2020, 3:37:27 PM. Shows the damage at the base of the tree.

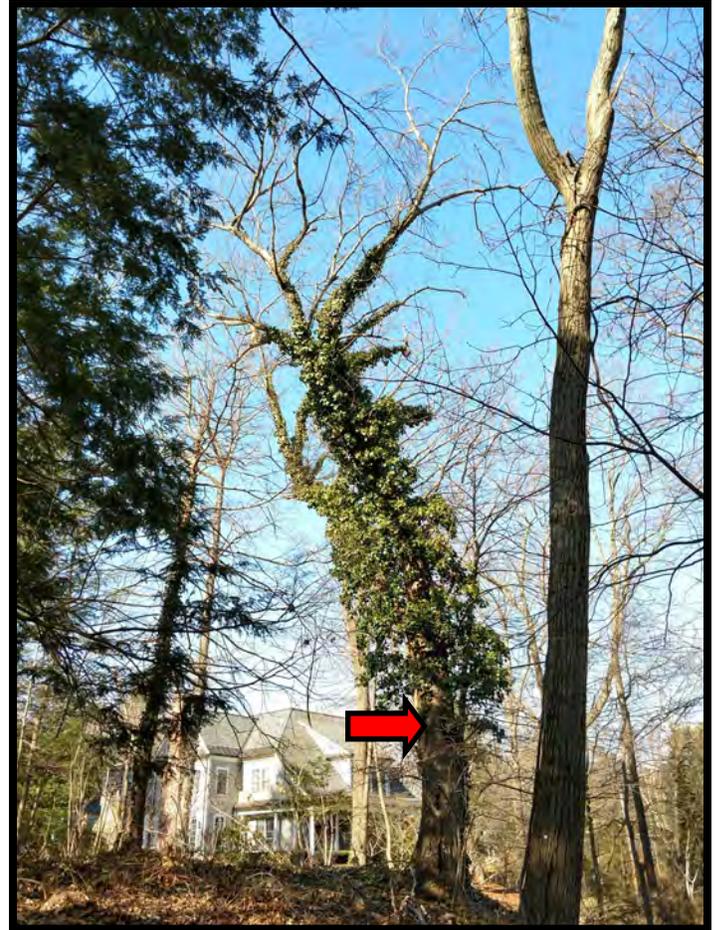
Picture Top left: taken Thursday, March 26, 2020, 3:45:58 PM. The picture shows the cavity in the side of the trunk. The extent of the decay is not known. An off center open cavity can affect the structural stability of the trunk.

Picture Top right: taken Thursday, March 26, 2020, 3:46:31 PM. Shows the tree leaning toward the neighbors yard. The red arrow is pointing to the location of the cavity.

Picture Bottom left: taken Thursday, March 26, 2020, 3:43:21 PM. Shows how much of the tree is covered by ivy. Eventually the ivy will grow to the top of the canopy. The picture also shows the lean of the tree.

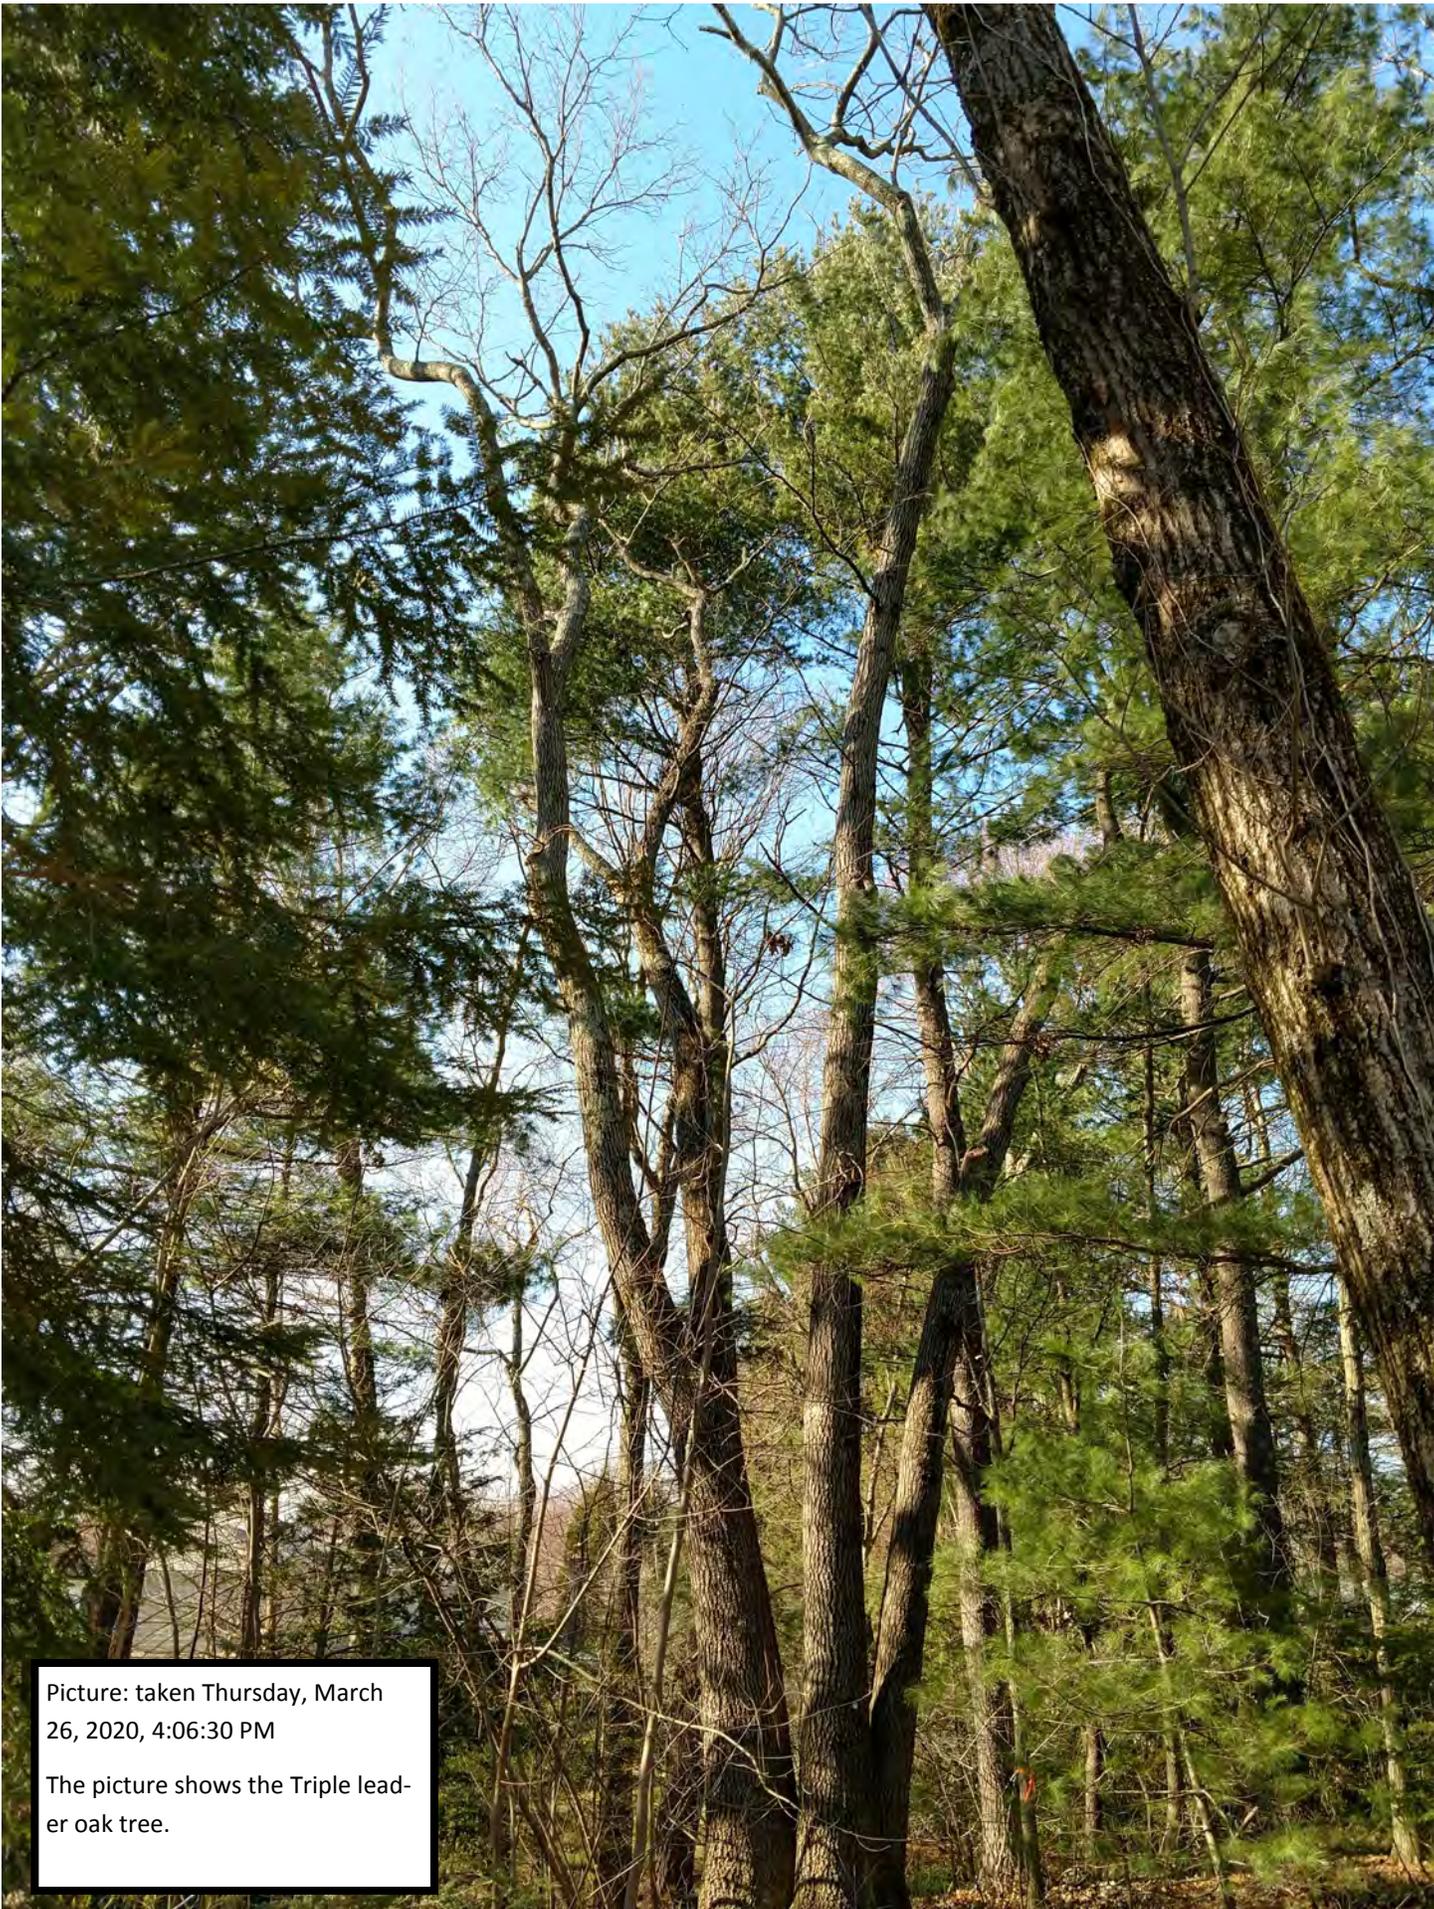
Picture: taken Thursday, March 26, 2020, 4:06:30 PM

The picture shows the Triple leader oak tree.

The tree is located on the north side of the lot in a wooded area. This triple leader oak tree has structural characteristics known to increase the likelihood of failure. There is "included bark" present at the junctions of all 3 leaders. This characteristic is known to affect the structural stability of the tree. In addition to the codominant leaders there are mushrooms growing at two locations on the base of the tree. The mushrooms are unidentified, however they are usually an indication of decay. Some types of fungi only produce mushrooms at an advanced state of decay while others produce mushrooms much earlier in the process. The extent of the decay is unknown. Due to the existing conditions it is my opinion that this tree is a poor candidate for retention.

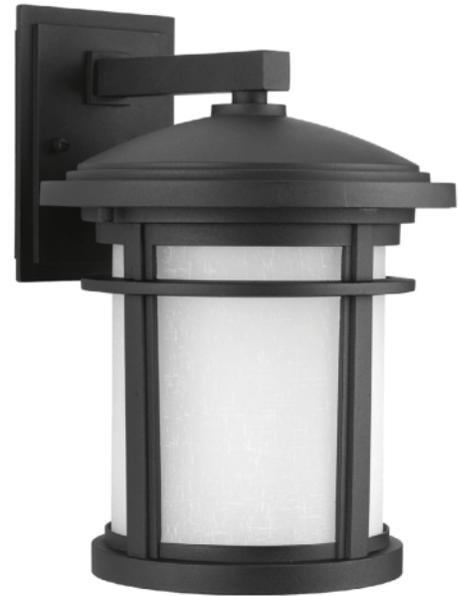
### Images:

LED wall lantern with etched white linen glass. Includes dark sky shield for full cut-off illumination or remove for a traditional lighting effect. 120V AC replaceable LED module, 1,211 lumens 71.2 lumens/watt per module (source). 3000K color temperature and 90+ CRI.

- Black (-31) (powder coat paint)
- Aluminum Construction
- Etched White Linen glass cylindrical diffuser
- LED Module is replaceable (part # 93053641)
- Etched white linen glass.
- Includes removable dark sky shield for full cut-off illumination.
- Powder coated finish.
- 1,211 lumens 71.2 lumens/watt per module (source)
- 3000K color temperature, 90+ CRI.
- Dimmable to 10% brightness (See Dimming Notes)
- Back plate covers a standard 4" octagonal recessed outlet box
- Mounting strap for outlet box included
- 6" of wire supplied
- ENERGY STAR® qualified
- Meets California Title 24 high efficacy requirements for outdoor use only

Width: 9"  
Depth: 10-1/2"  
Height: 12-1/2"  
H/CTR: 3-1/8"

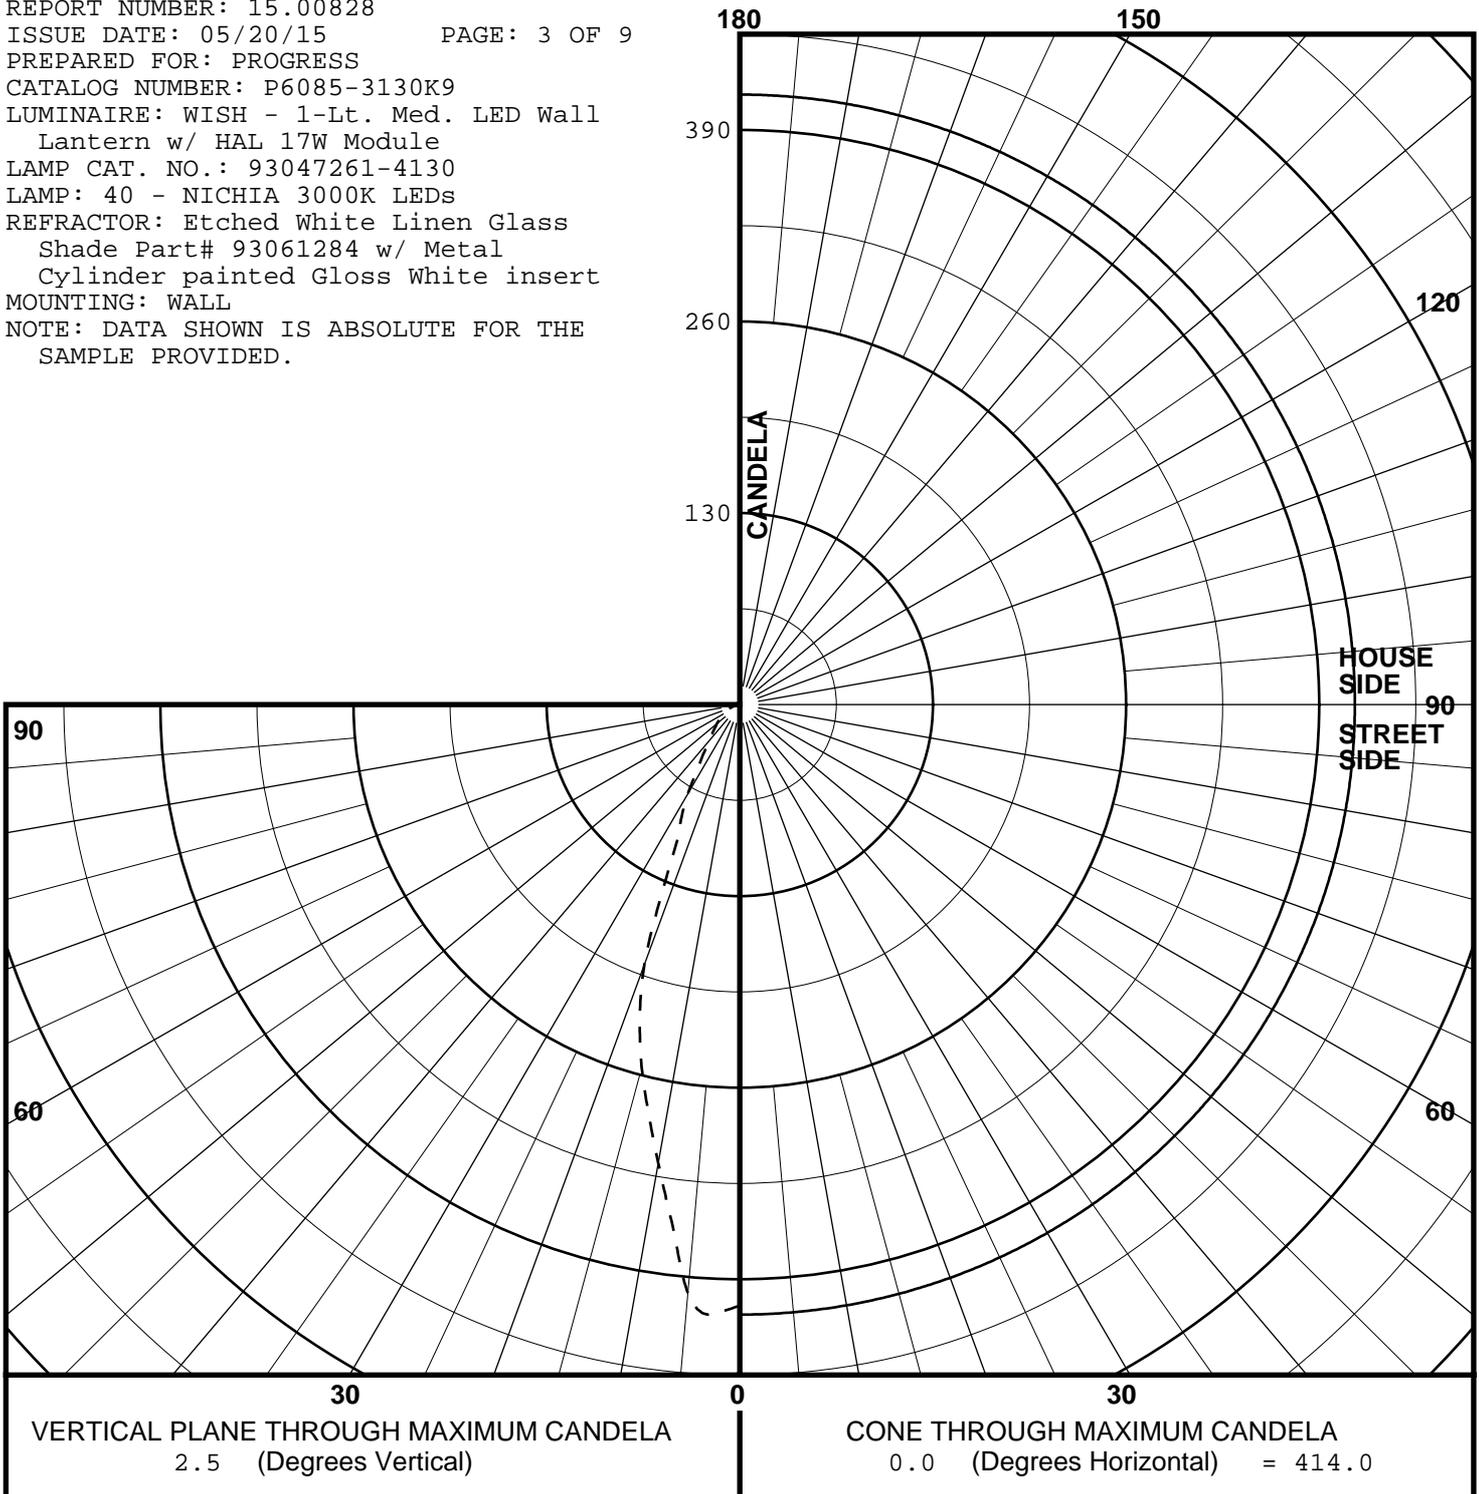
MAXIMUM PLANE AND MAXIMUM CONE PLOTS OF CANDELA

REPORT NUMBER: 15.00828  
 ISSUE DATE: 05/20/15 PAGE: 3 OF 9  
 PREPARED FOR: PROGRESS  
 CATALOG NUMBER: P6085-3130K9  
 LUMINAIRE: WISH - 1-Lt. Med. LED Wall  
 Lantern w/ HAL 17W Module  
 LAMP CAT. NO.: 93047261-4130  
 LAMP: 40 - NICHIA 3000K LEDs  
 REFRACTOR: Etched White Linen Glass  
 Shade Part# 93061284 w/ Metal  
 Cylinder painted Gloss White insert  
 MOUNTING: WALL  
 NOTE: DATA SHOWN IS ABSOLUTE FOR THE  
 SAMPLE PROVIDED.

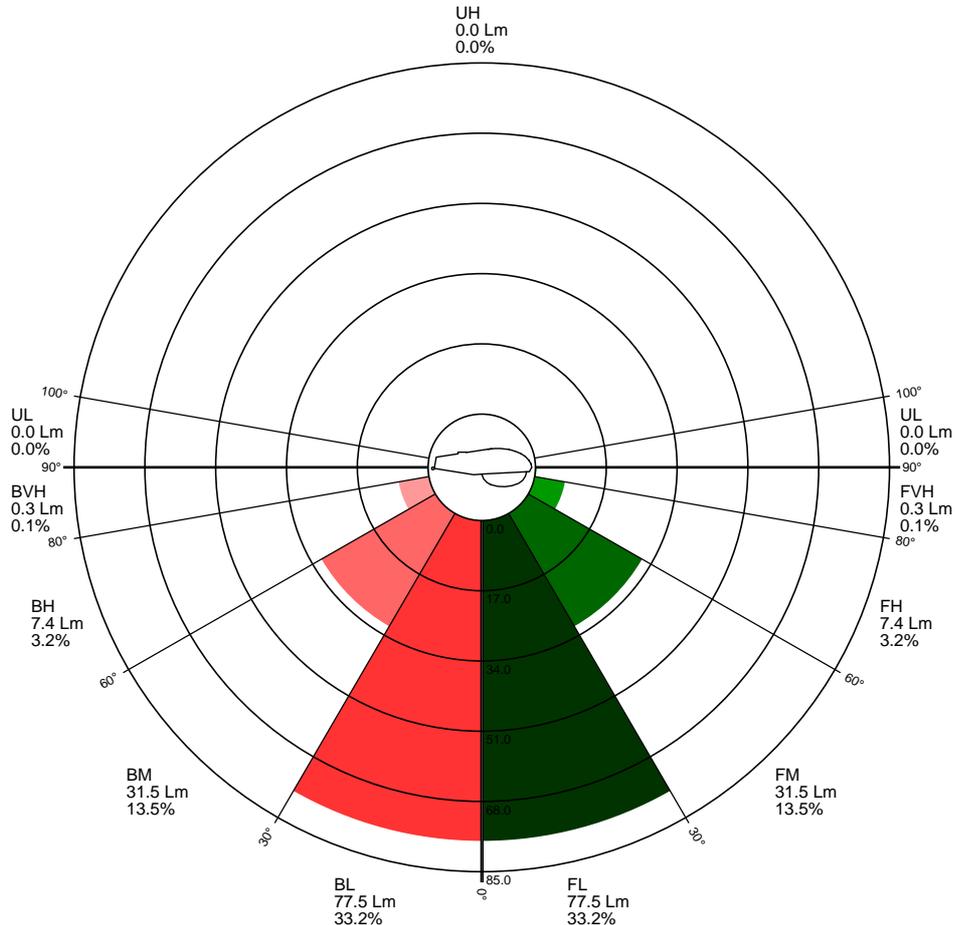
**Zonal Lumen Summary**

(Linear scale)

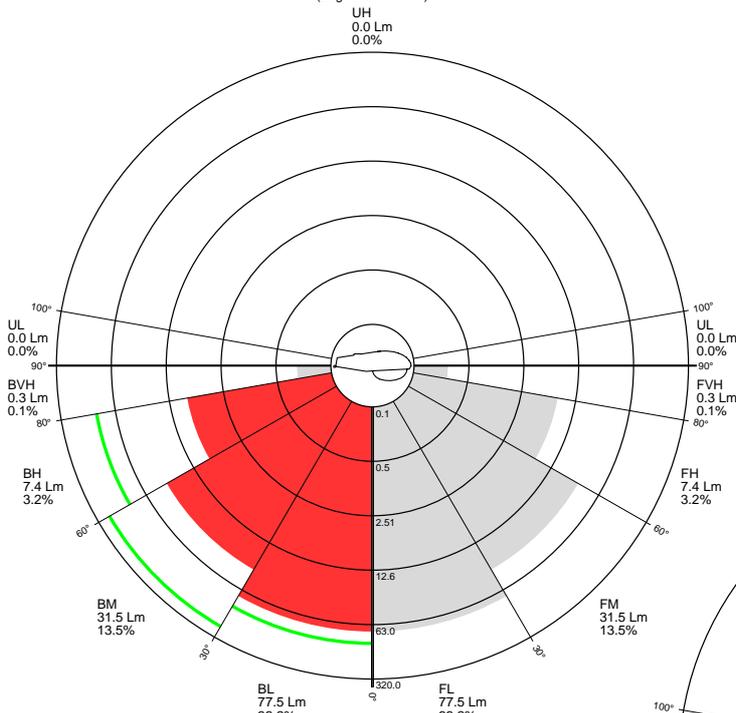
**Backlight Rating Details**

(Logarithmic scale)

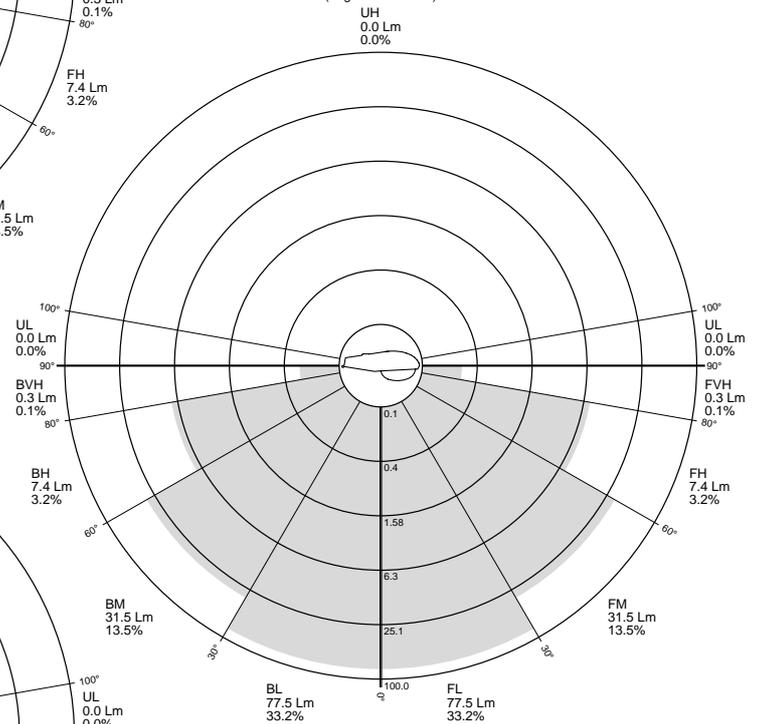
**Uplight Rating Details**

(Logarithmic scale)

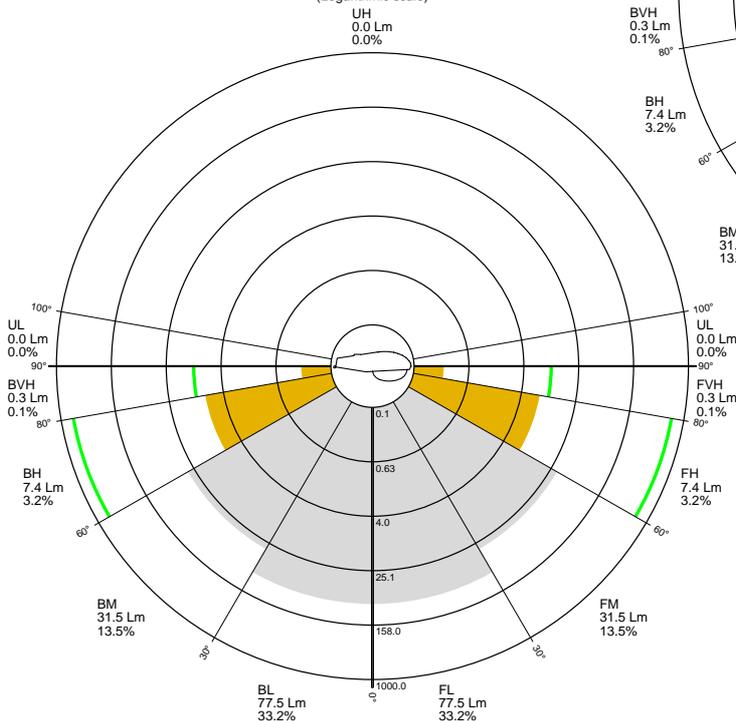
**Glare Rating Details**

(Logarithmic scale)
