MORSES POND BEACH & BATHHOUSE IMPROVEMENTS
SUPPLEMENTARY FEASIBILITY STUDY
TASK 7: BUILDING LOCATION ANALYSIS

EXISTING CONDITIONS PLAN: **SITE HISTORY AS A TOWN BEACH**

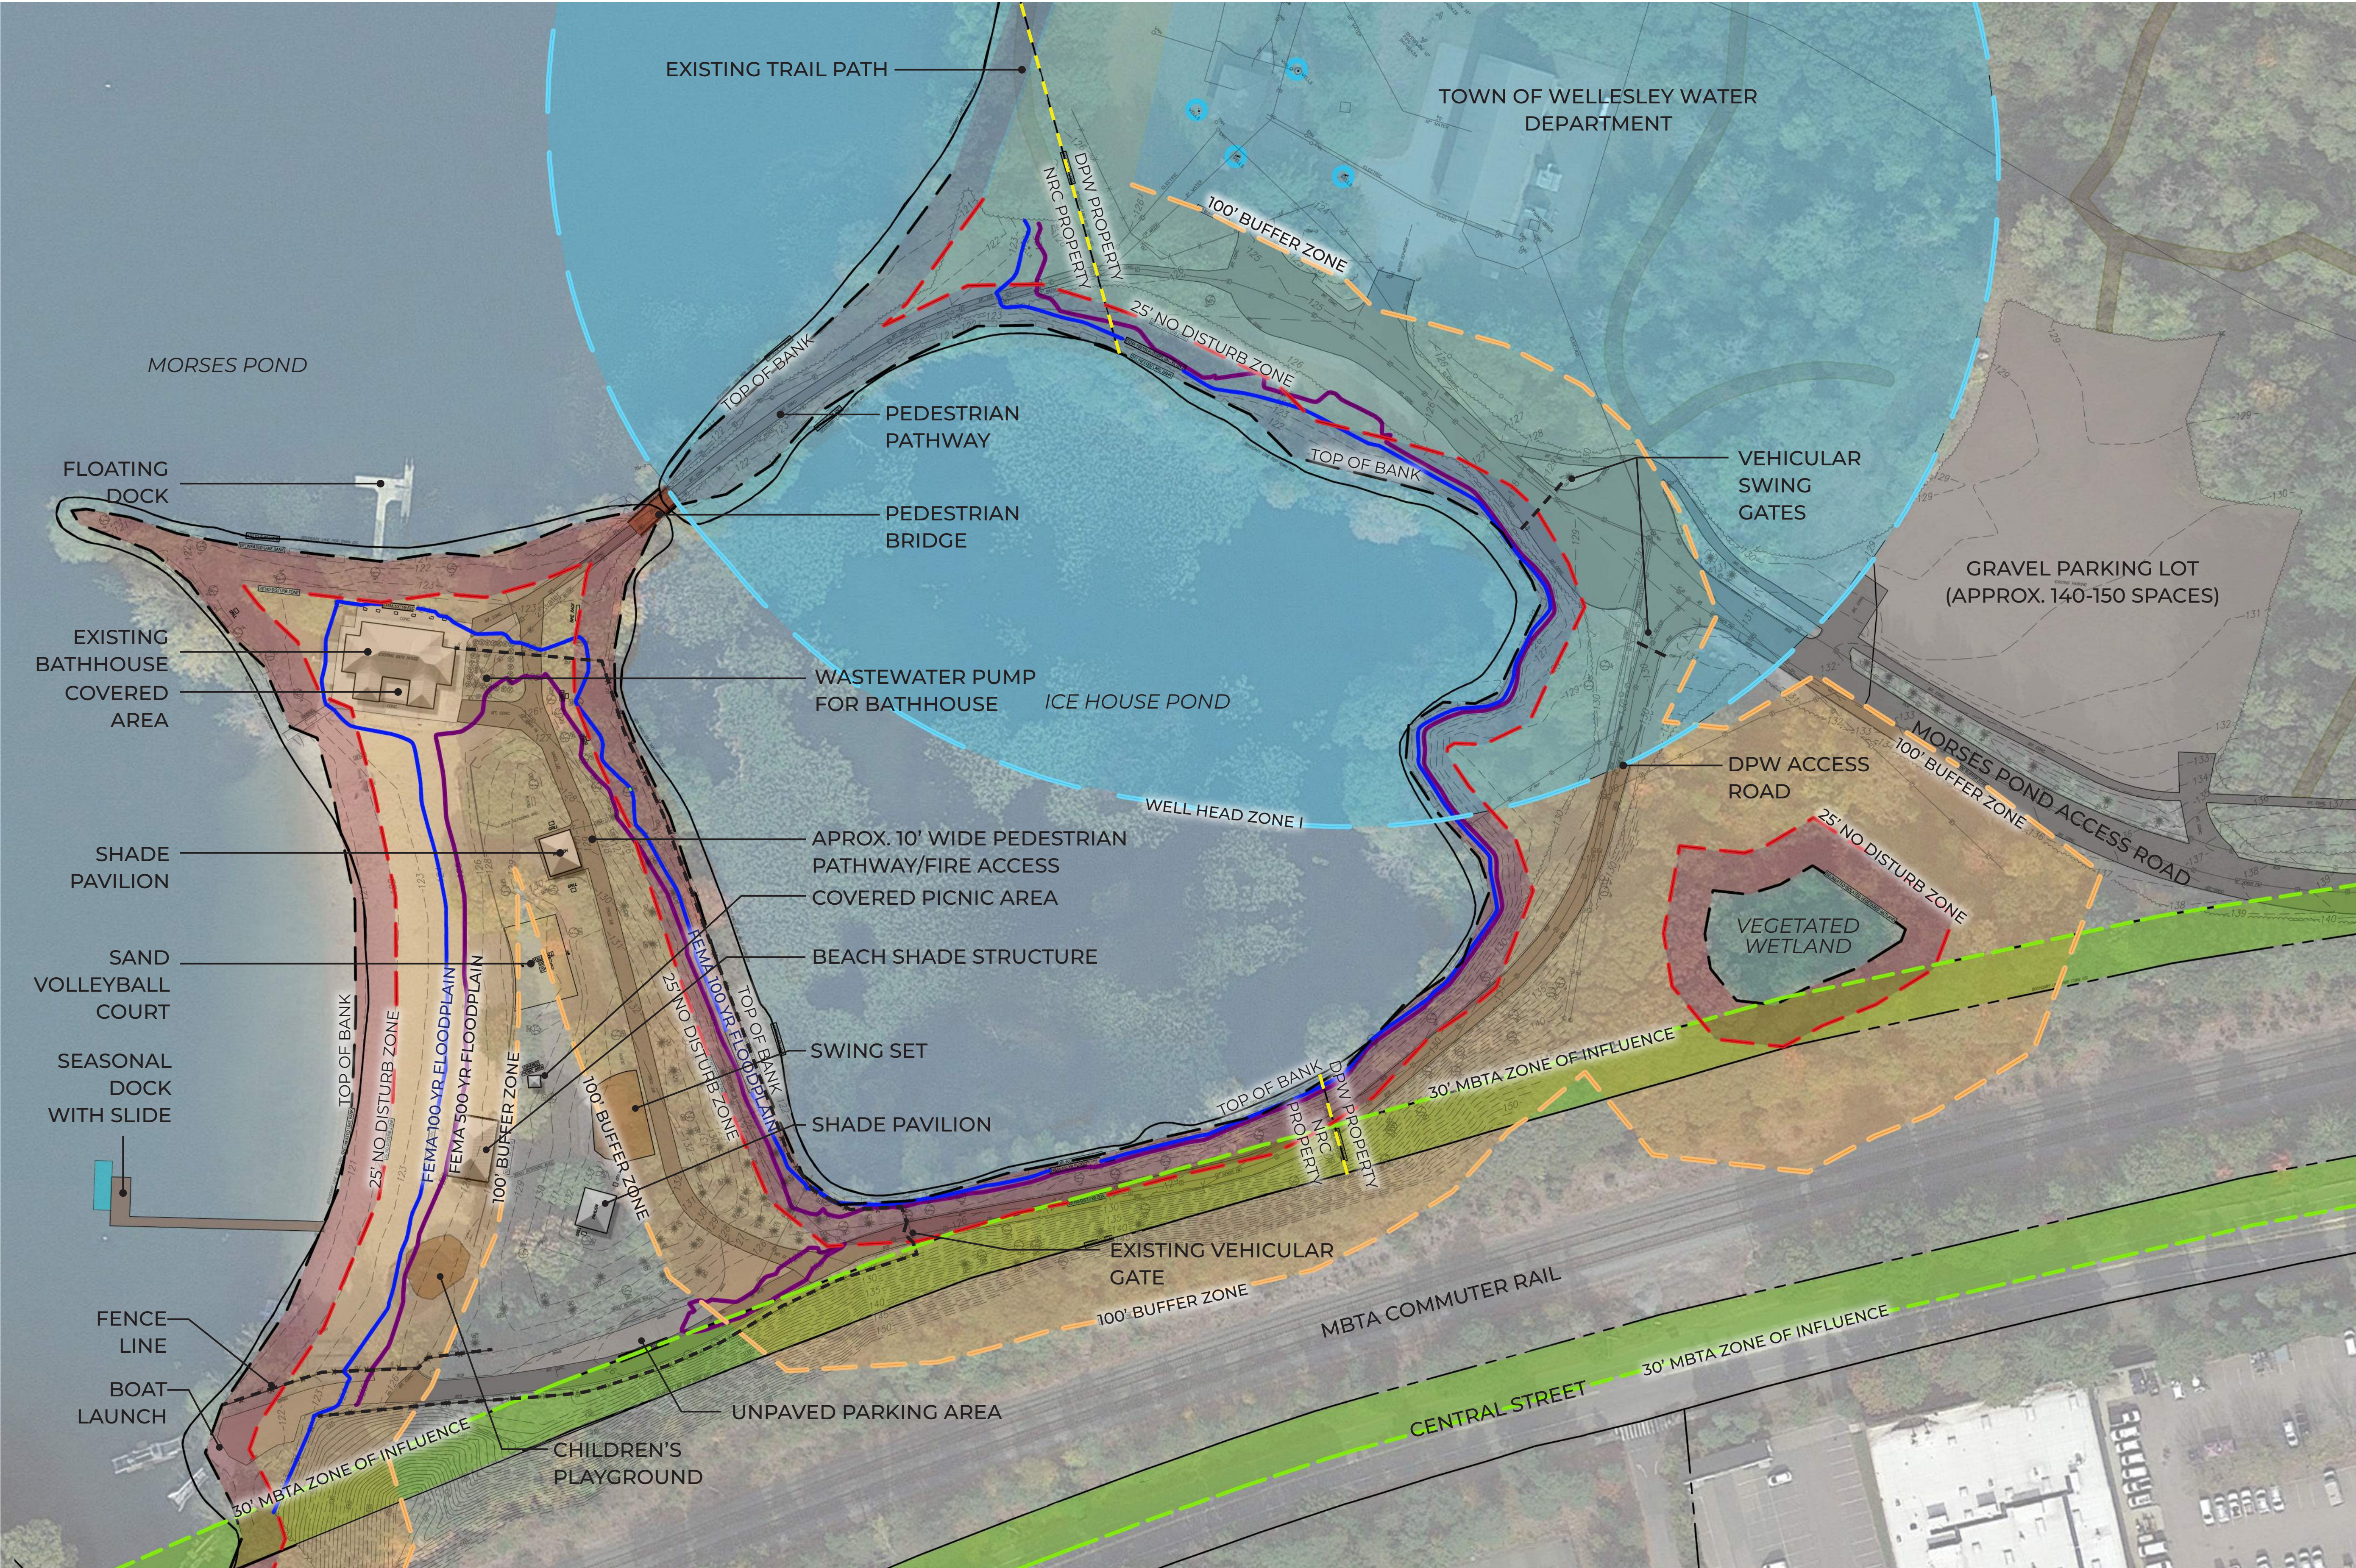
EXISTING CONDITIONS PLAN: **PERMITTING OFFSETS**

PERMIT / KEYS
REGS. OUTCOMES

Zone I Wellhead Zone

Avoid Work in zone. No new land uses are permitted unless they are for water supply or shown to have no significant impact. Occasional parking may be allowable with precautions.

MBTA Zone of Influence

Avoid Work in Zone. Work within 30' of MBTA property requires a license and extensive coordination with MBTA.

Wetlands

Local Notice of Intent (NOI) for work in the Bordering Land Subject to Flooding (BLSF). Required under WPA and Wellesley Wetlands Bylaw for work in the BLSF and buffer zones.

- Compensatory flood storage is required if fill occurs below **100 -year FEMA flood elevation** (124.2' NAVD88). Must match floodwater displacement volume.
- **25-foot No Disturb Zone** must remain intact.
- Work in **100-foot buffer zone** must preserve habitat; tree removal requires native species replacement or mitigation plan.

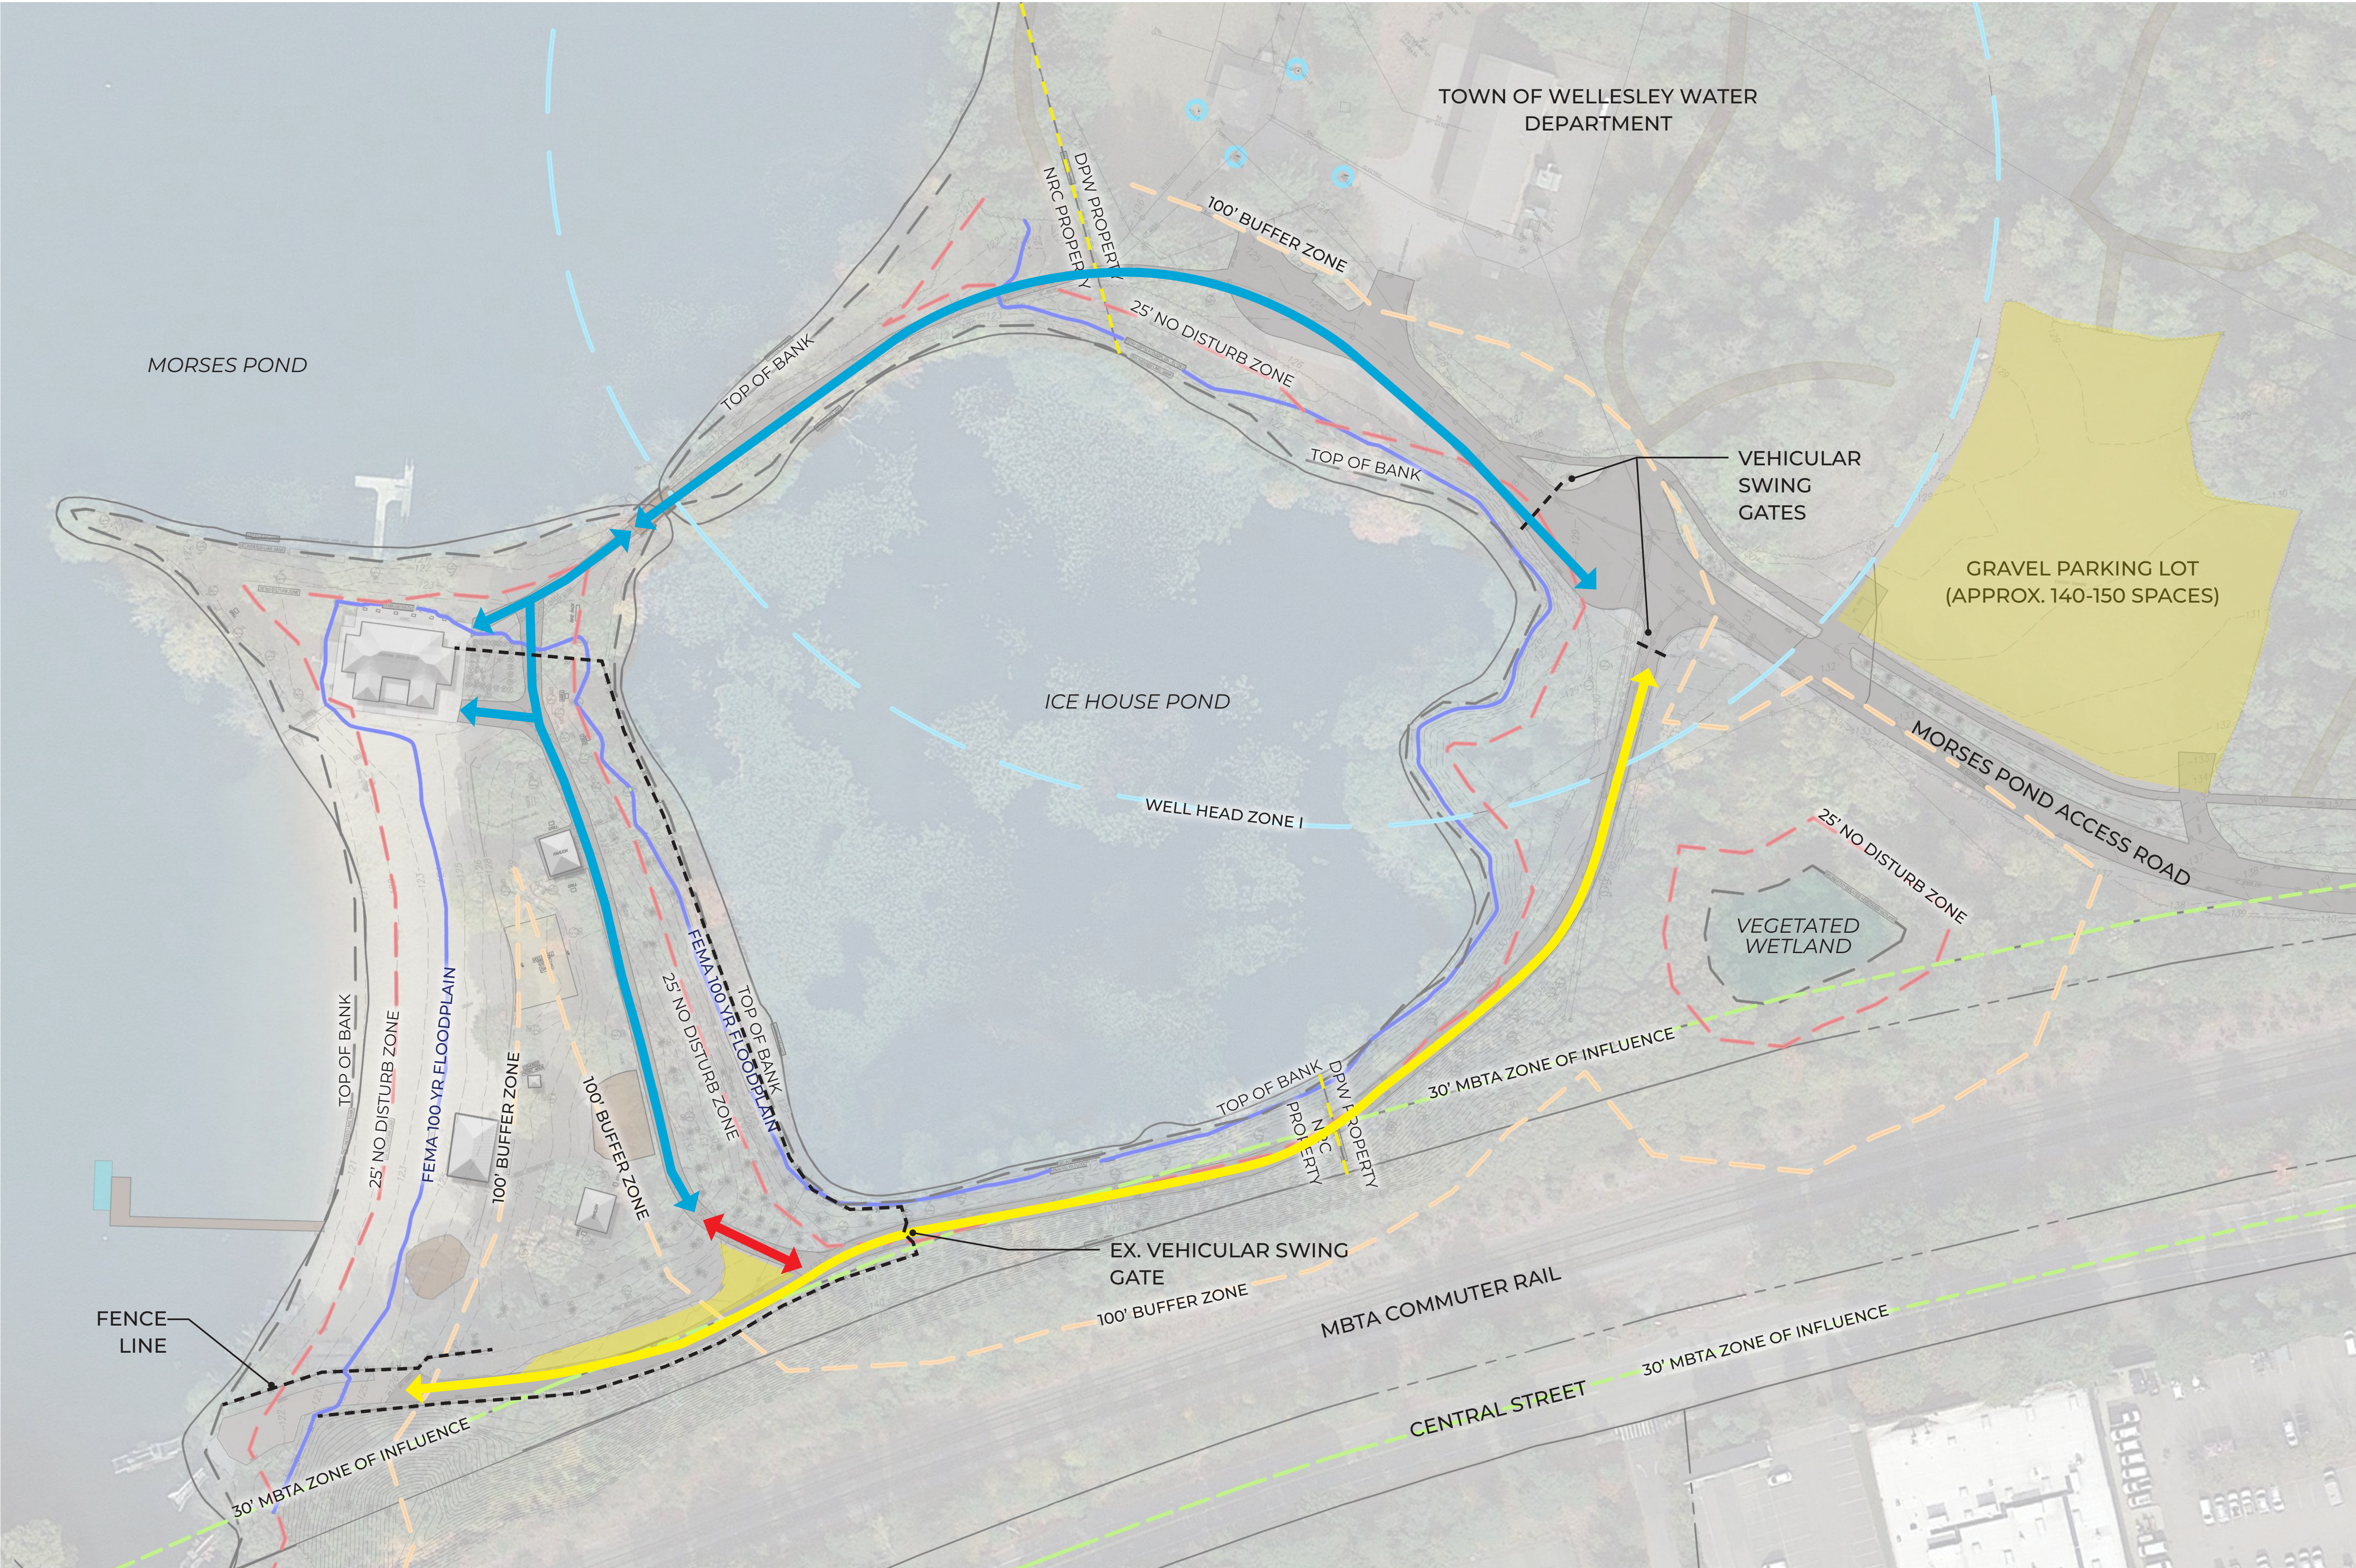
EXISTING CONDITIONS PLAN: **PEDESTRIAN AND VEHICULAR CIRCULATION**

- EX. FENCE LINE
- ↔ ACCESSIBLE PEDESTRIAN ROUTE (< 5%)
- ↔ NON-ACCESSIBLE PEDESTRIAN ROUTE (> 5%)
- ↔ VEHICULAR ROUTE

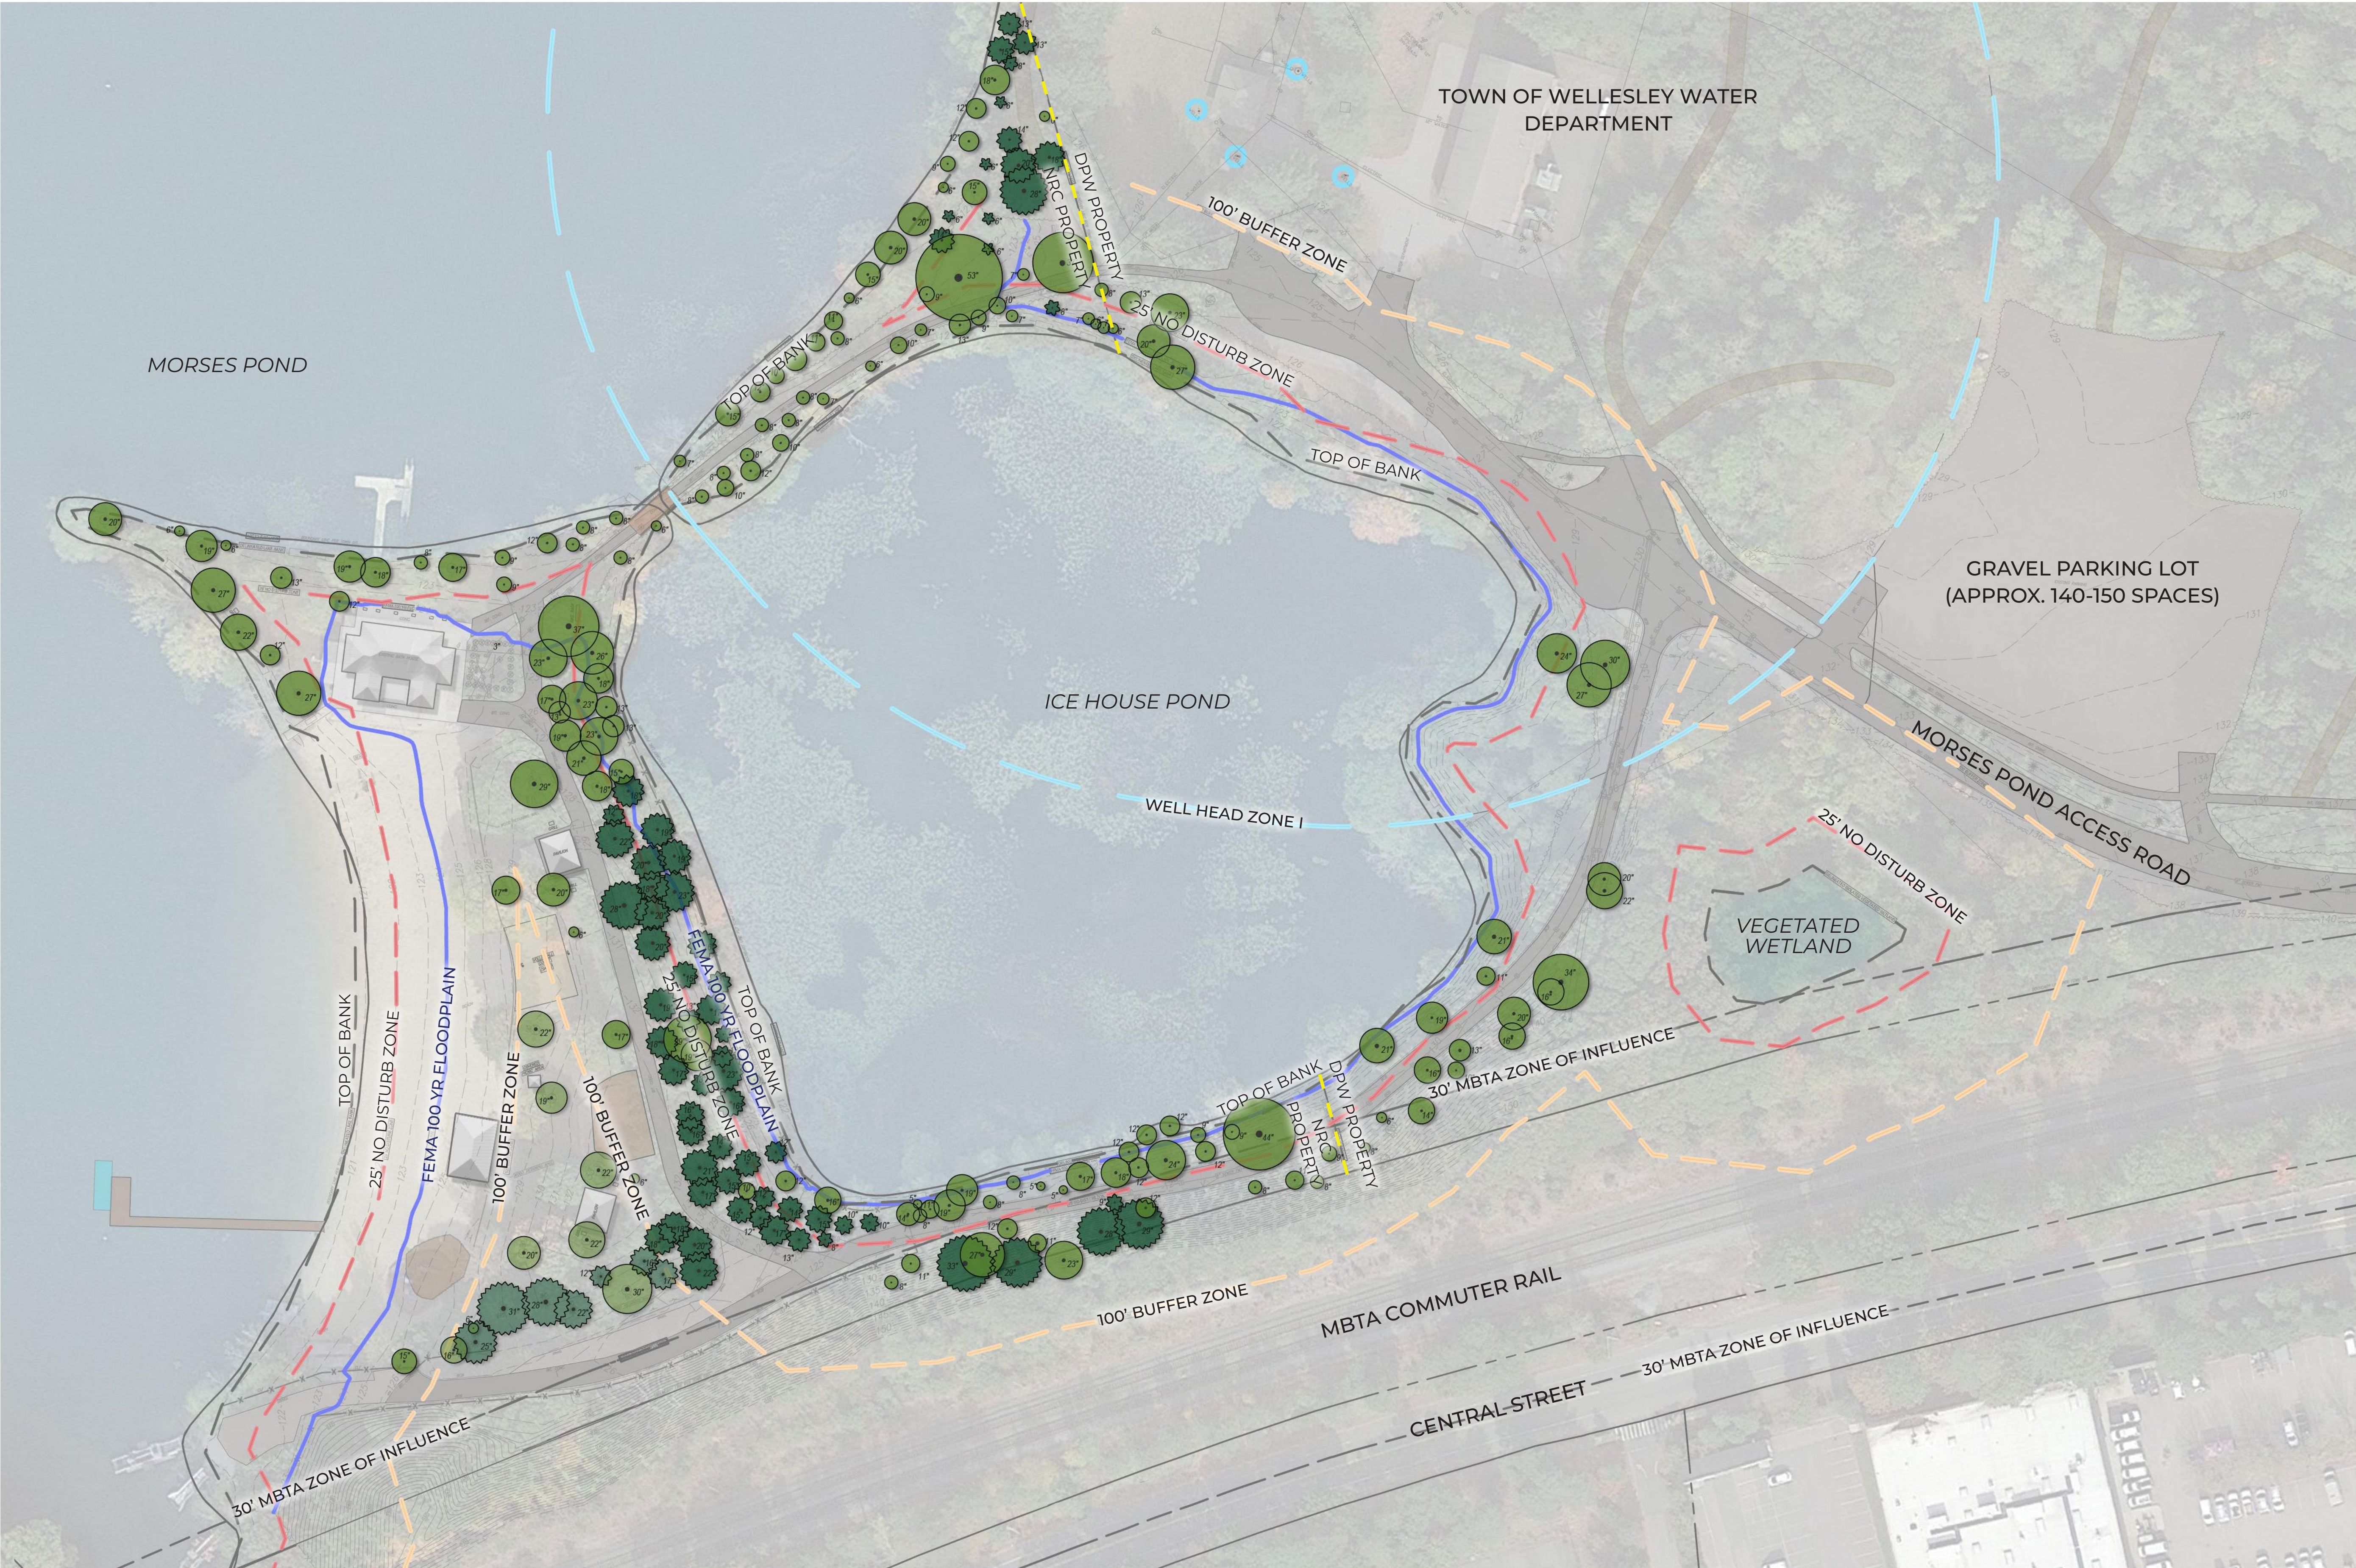
EXISTING CONDITIONS PLAN: **EXISTING SIGNIFICANT TREES**

CALIPER	# OF DECIDUOUS	# OF EVERGREEN
< 6	3	0
6 - 18	107	50
> 18	47	23
TOTAL:	157	73

The tree inventory was conducted by Hartney Greymont on August 6, 2025 by a Massachusetts Certified Arborist.

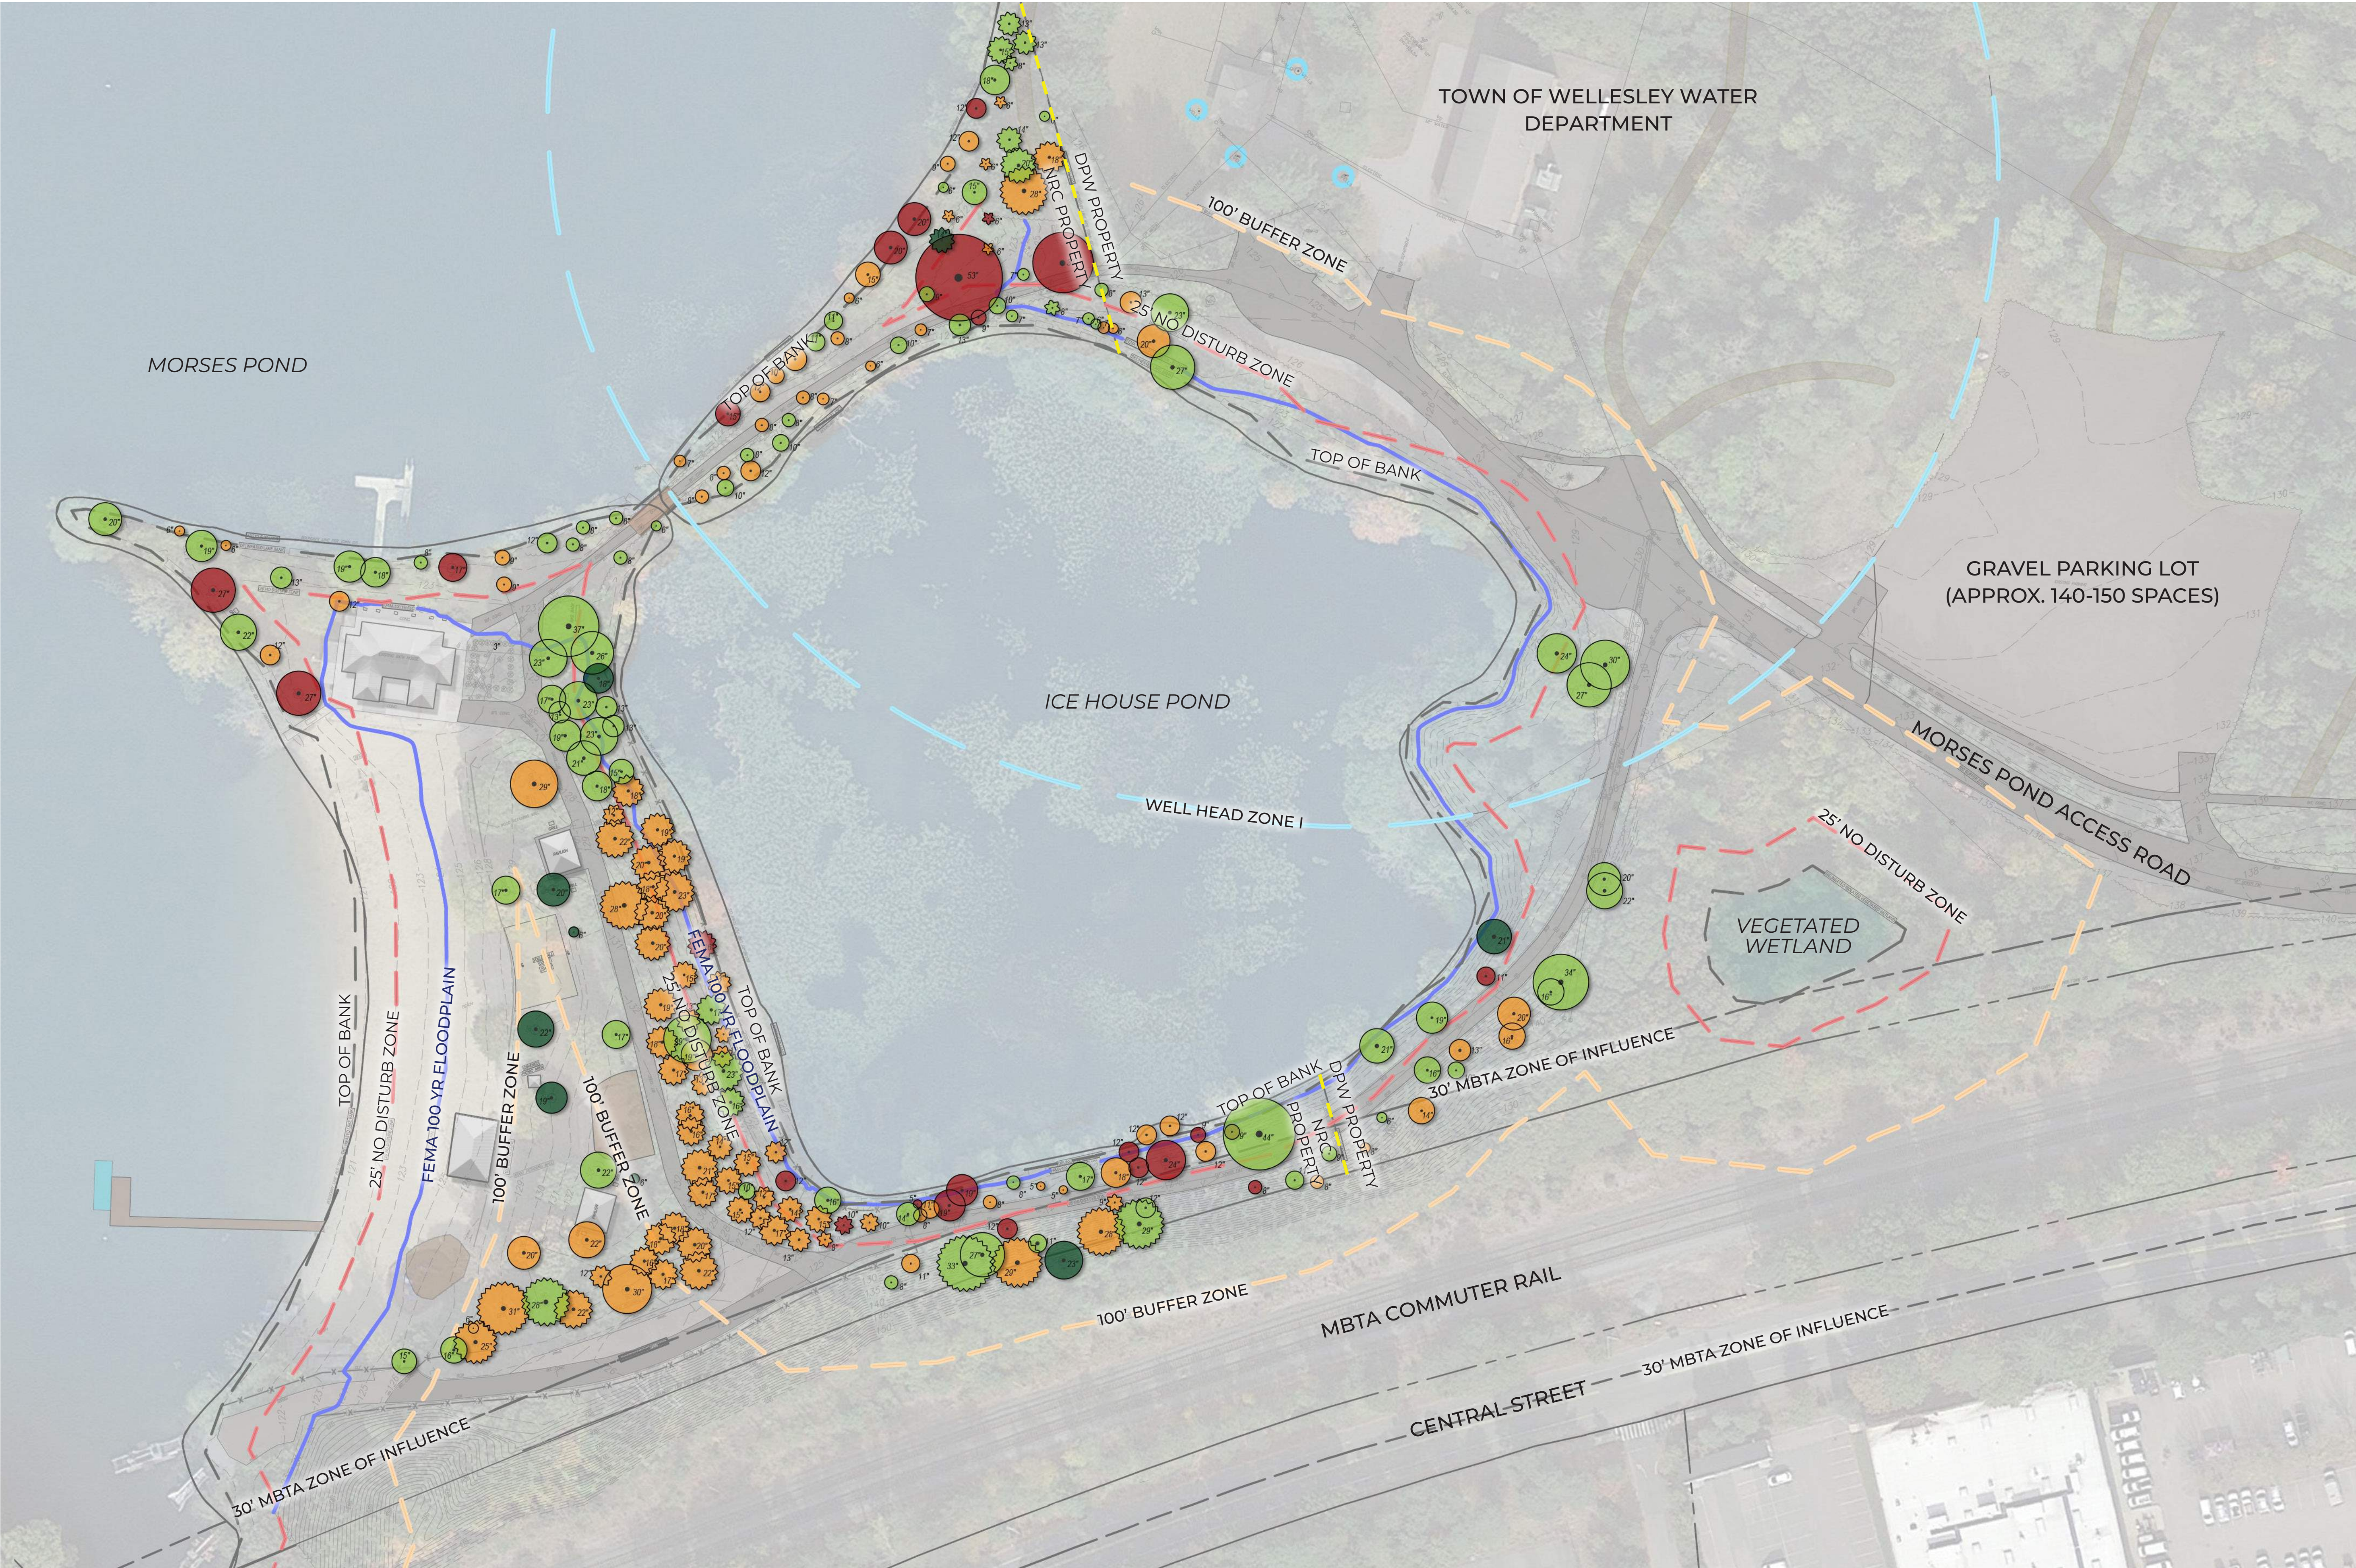
EXISTING CONDITIONS PLAN: **EXISTING TREE CONDITIONS**

CONDITION KEY	# OF DECIDUOUS
EXCELLENT	Tree is in excellent condition. May have unique value or be aesthetically desirable.
GOOD	Tree is desirable and in moderately good health.
FAIR	Tree may show some signs of minor health issues
POOR	Tree is unsound, high risk, unhealthy, or undesirable.

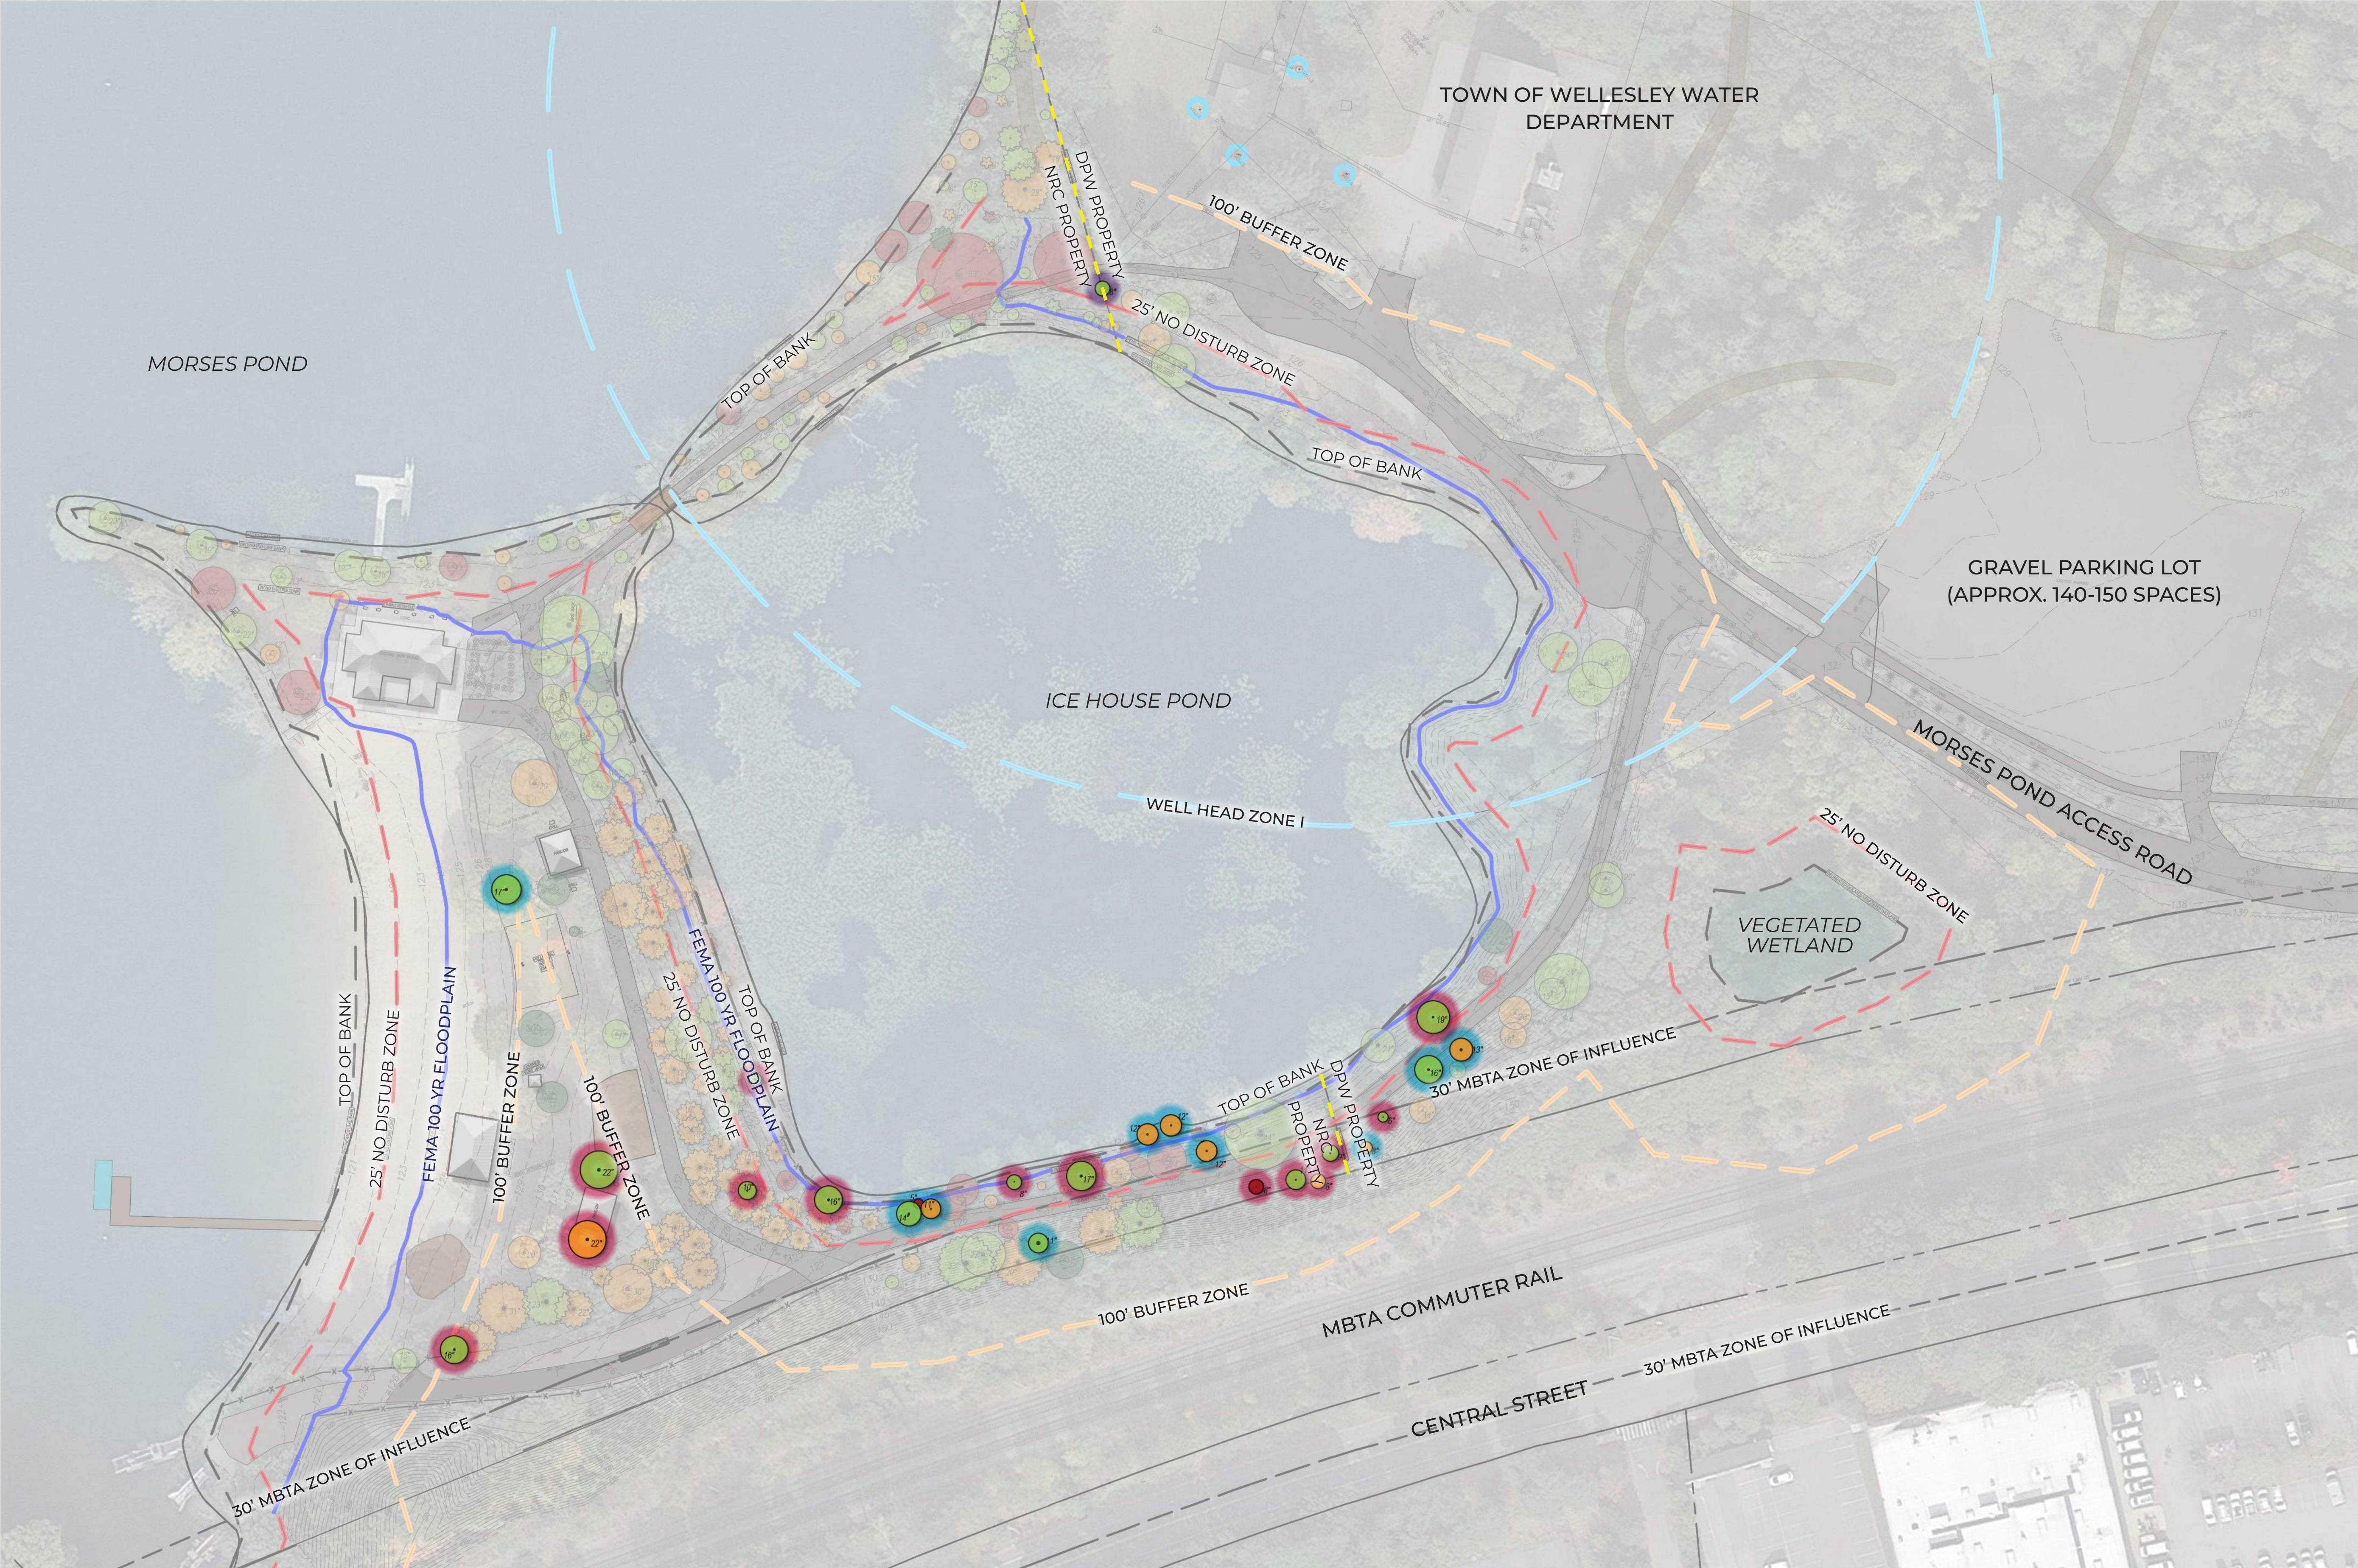
EXISTING CONDITIONS PLAN: **EXISTING INVASIVE TREES**

- 0** EX. TREE: EXCELLENT CONDITION
- 16** EX. TREE: GOOD CONDITION
- 8** EX. TREE: FAIR CONDITION
- 2** EX. TREE: POOR CONDITION

CONDITION	# OF BL	# OF NM	# OF TOH
EXCELLENT	0	0	0
GOOD	4	11	1
FAIR	6	2	0
POOR	1	1	0
TOTAL:	11	14	1

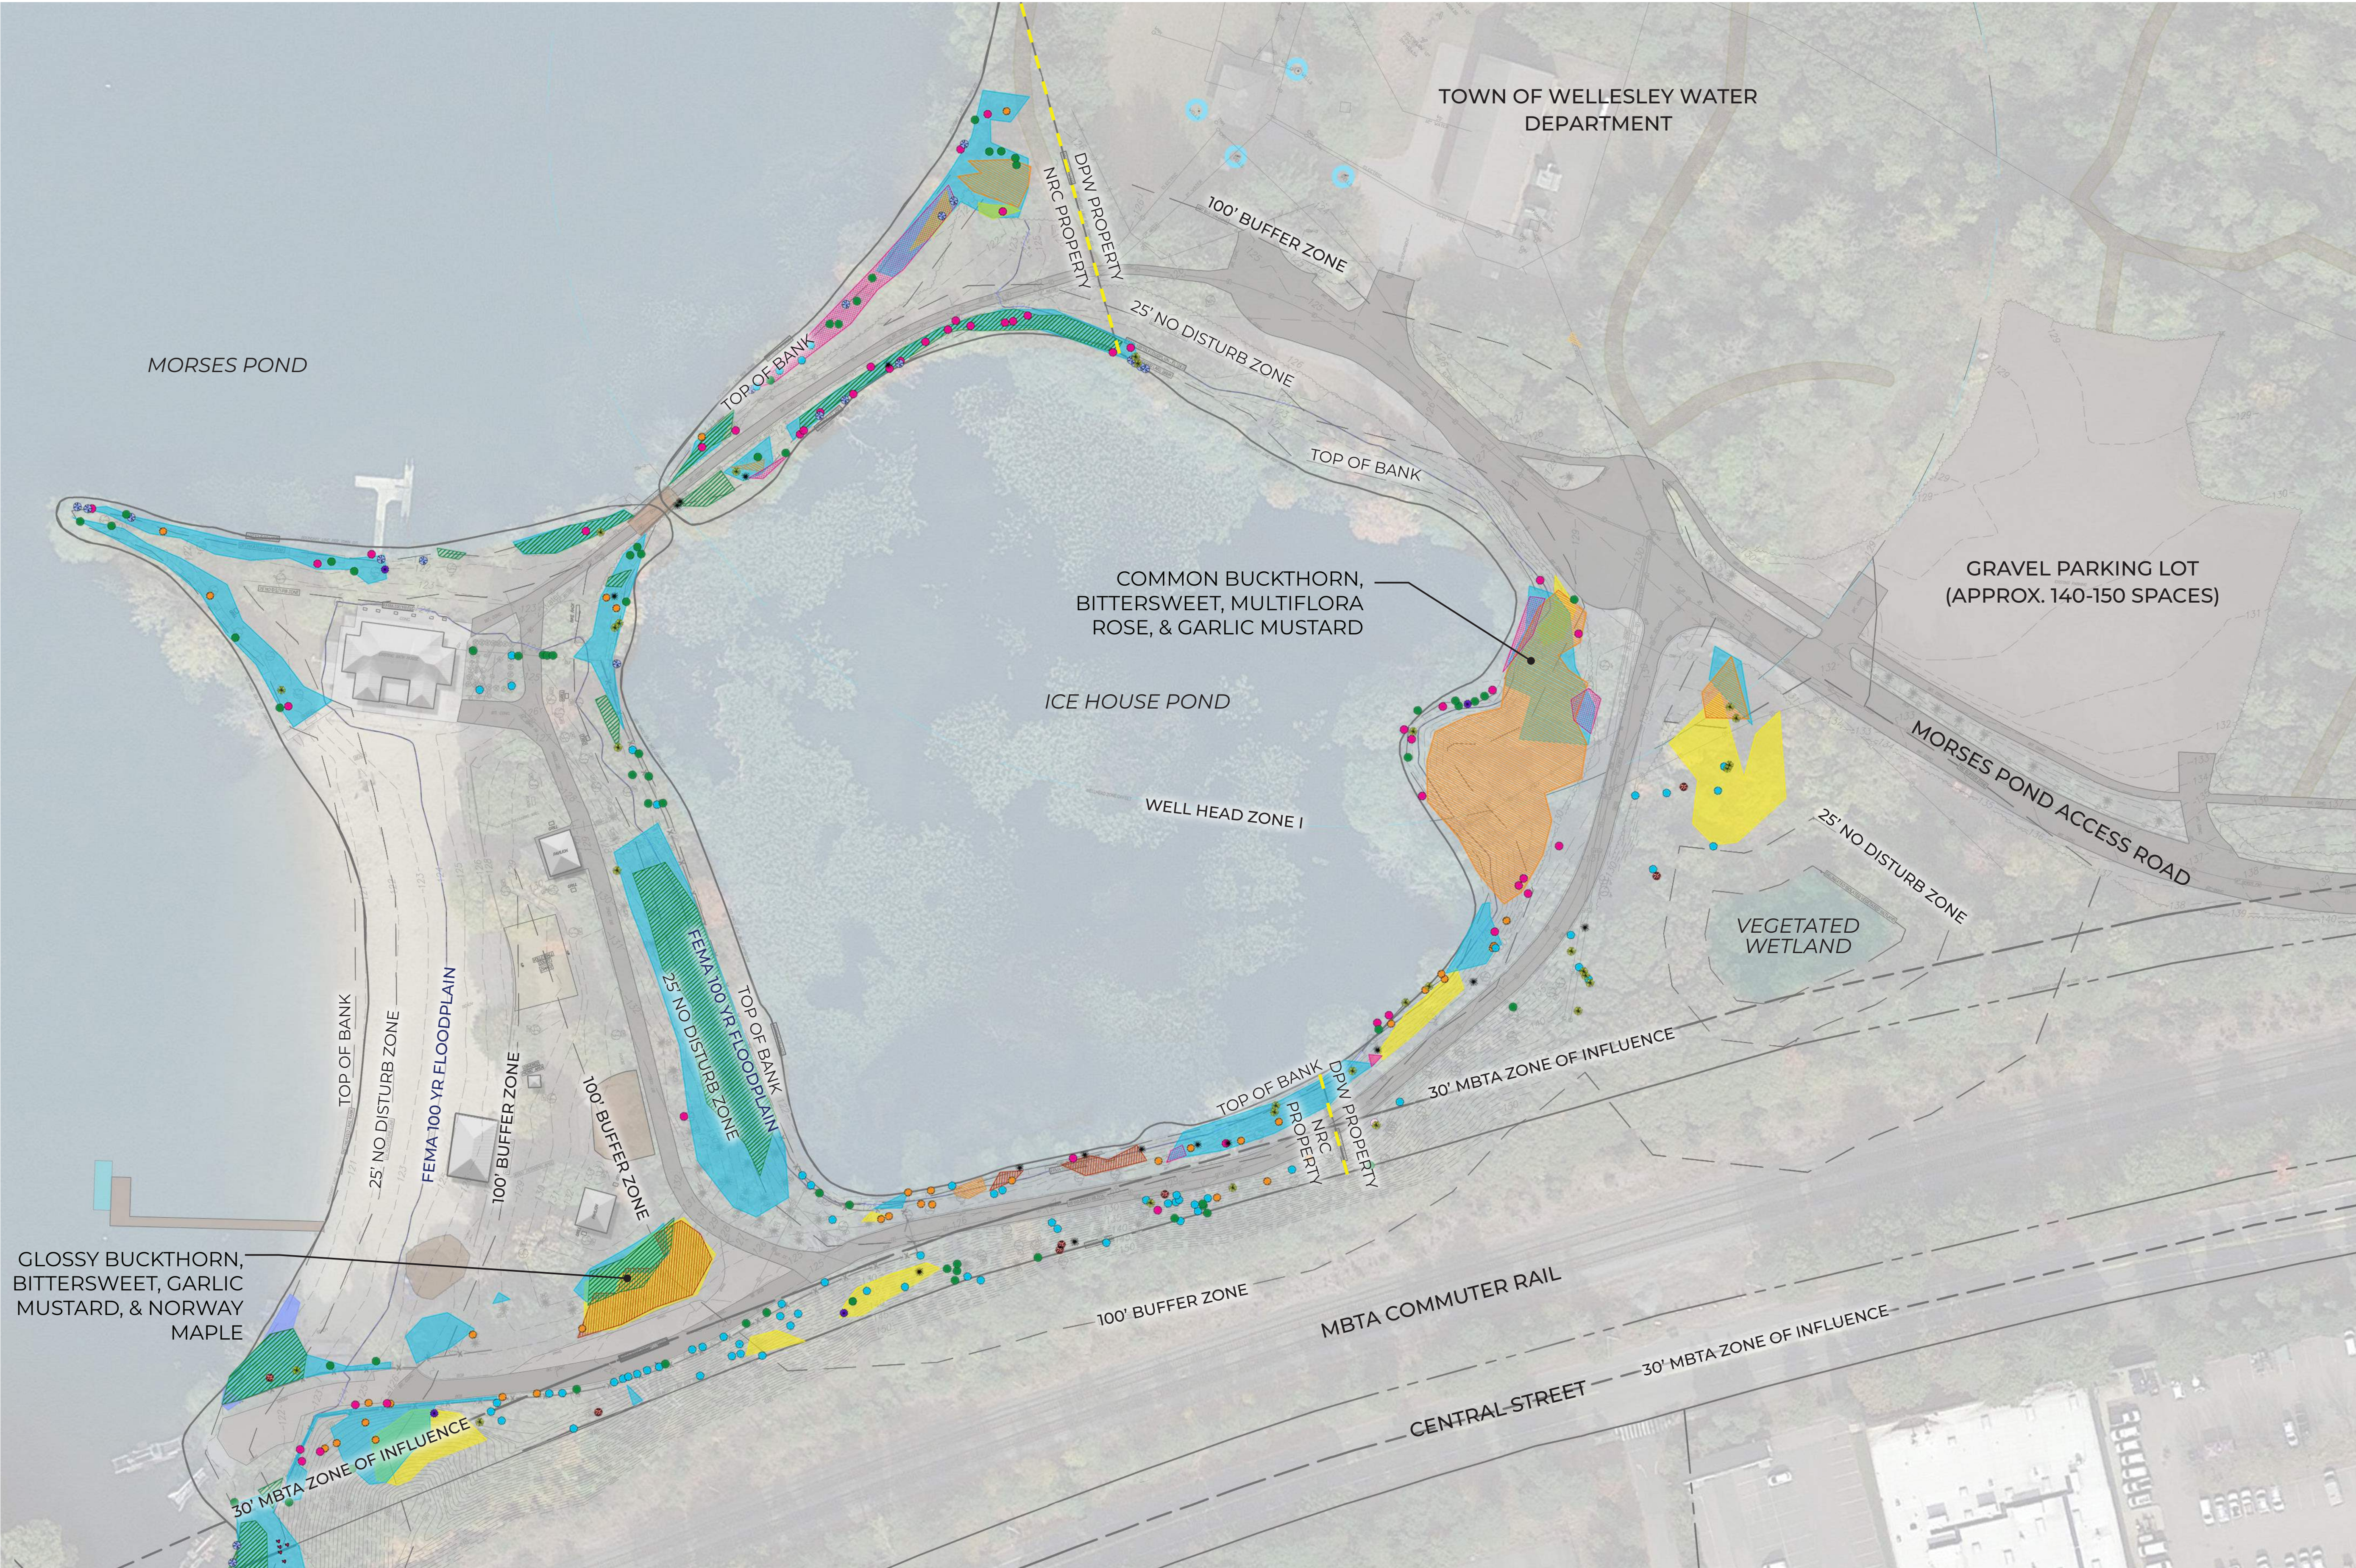
EXISTING CONDITIONS PLAN: **EXISTING INVASIVE PLANTS**

- BARBERRY
- BITTERSWEET
- BURNING BUSH
- COMMON BUCKTHORN
- GLOSSY BUCKTHORN
- JAPANESE HONEYSUCKLE
- KNOTWEED
- MULTIFLORA ROSE
- PRIVET
- PURPLE LOOSESTRIFE

- BITTERSWEET
- COMMON BUCKTHORN
- GLOSSY BUCKTHORN
- GARLIC MUSTARD
- JAPANESE HONEYSUCKLE
- KNOTWEED
- MULTIFLORA ROSE
- NORWAY MAPLE
- PURPLE LOOSESTRIFE
