MORSES POND BEACH & BATHHOUSE IMPROVEMENTS
SUPPLEMENTARY FEASIBILITY STUDY
TASK 7: BUILDING LOCATION ANALYSIS

EXISTING CONDITIONS PLAN: **SITE HISTORY AS A TOWN BEACH**

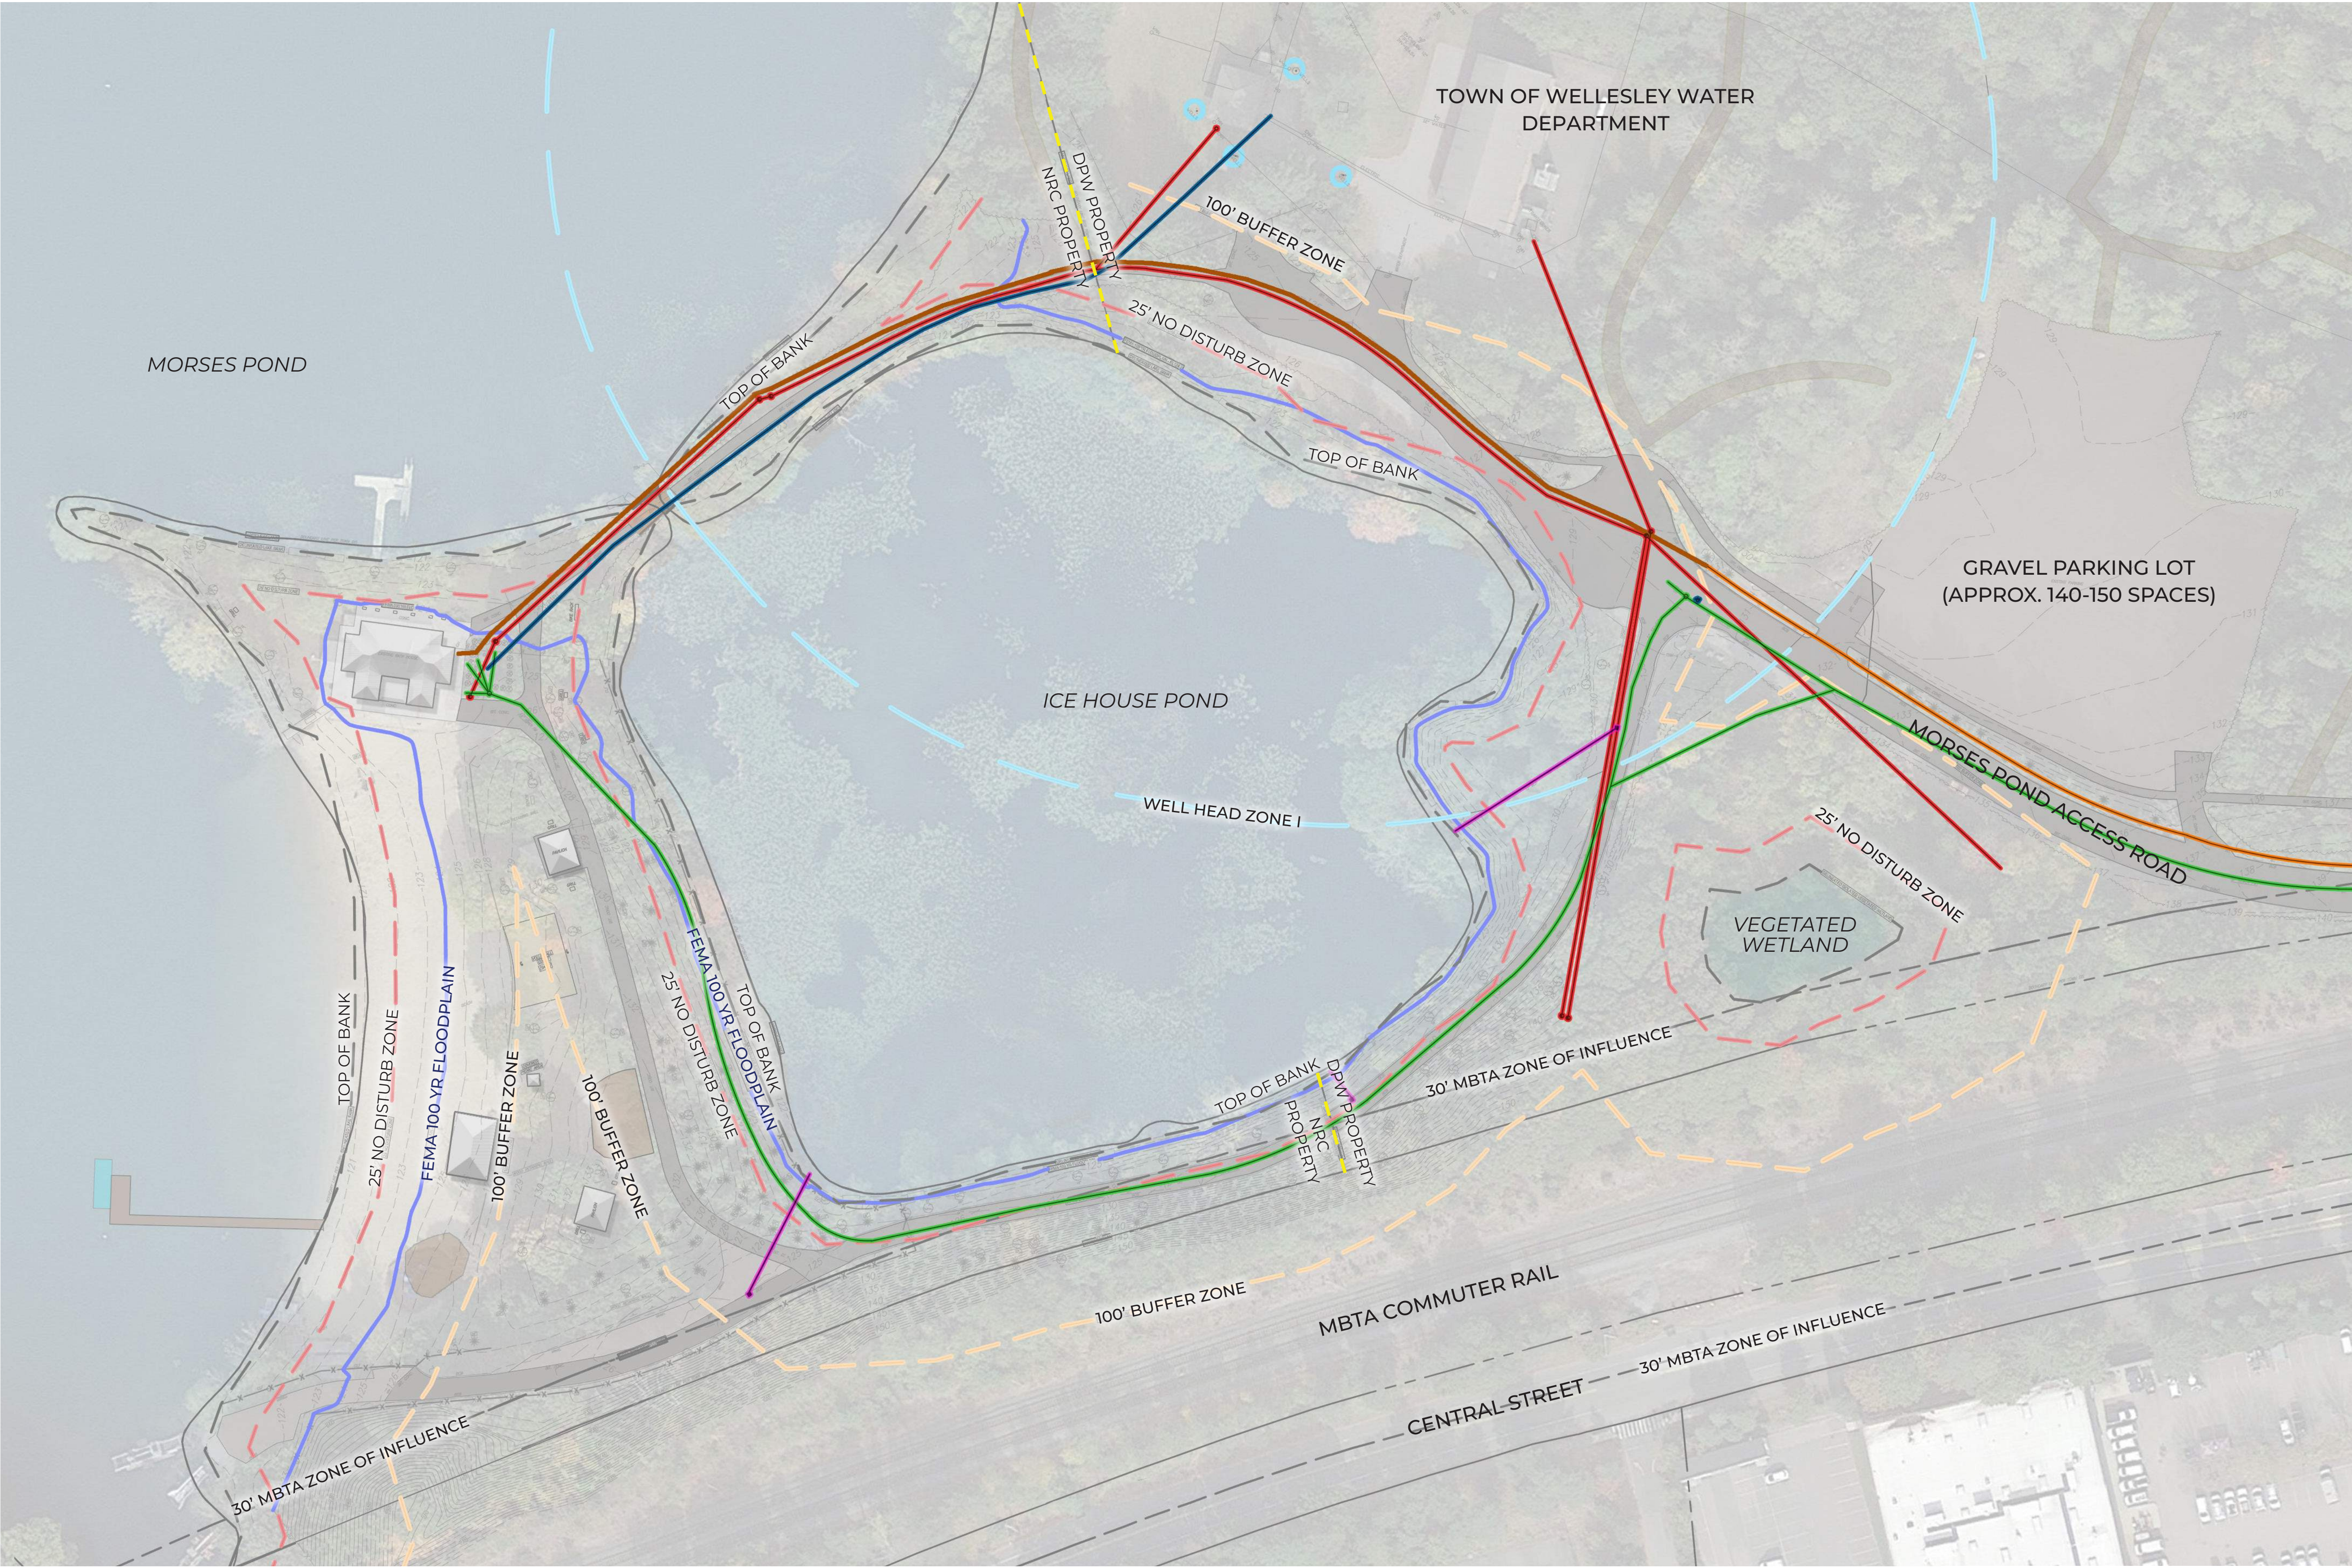
EXISTING CONDITIONS PLAN: **EXISTING UTILITIES**

WATER	EX. WATER LINE
SEWER	EX. SANITARY SEWER LINE
STORM	EX. STORM DRAINAGE
ELECTRICAL	EX. ELECTRICAL CONDUIT
COMMUNICATIONS	EX. COMMUNICATIONS LINE
CABLE	EX. CABLE LINE FOR INTERNET

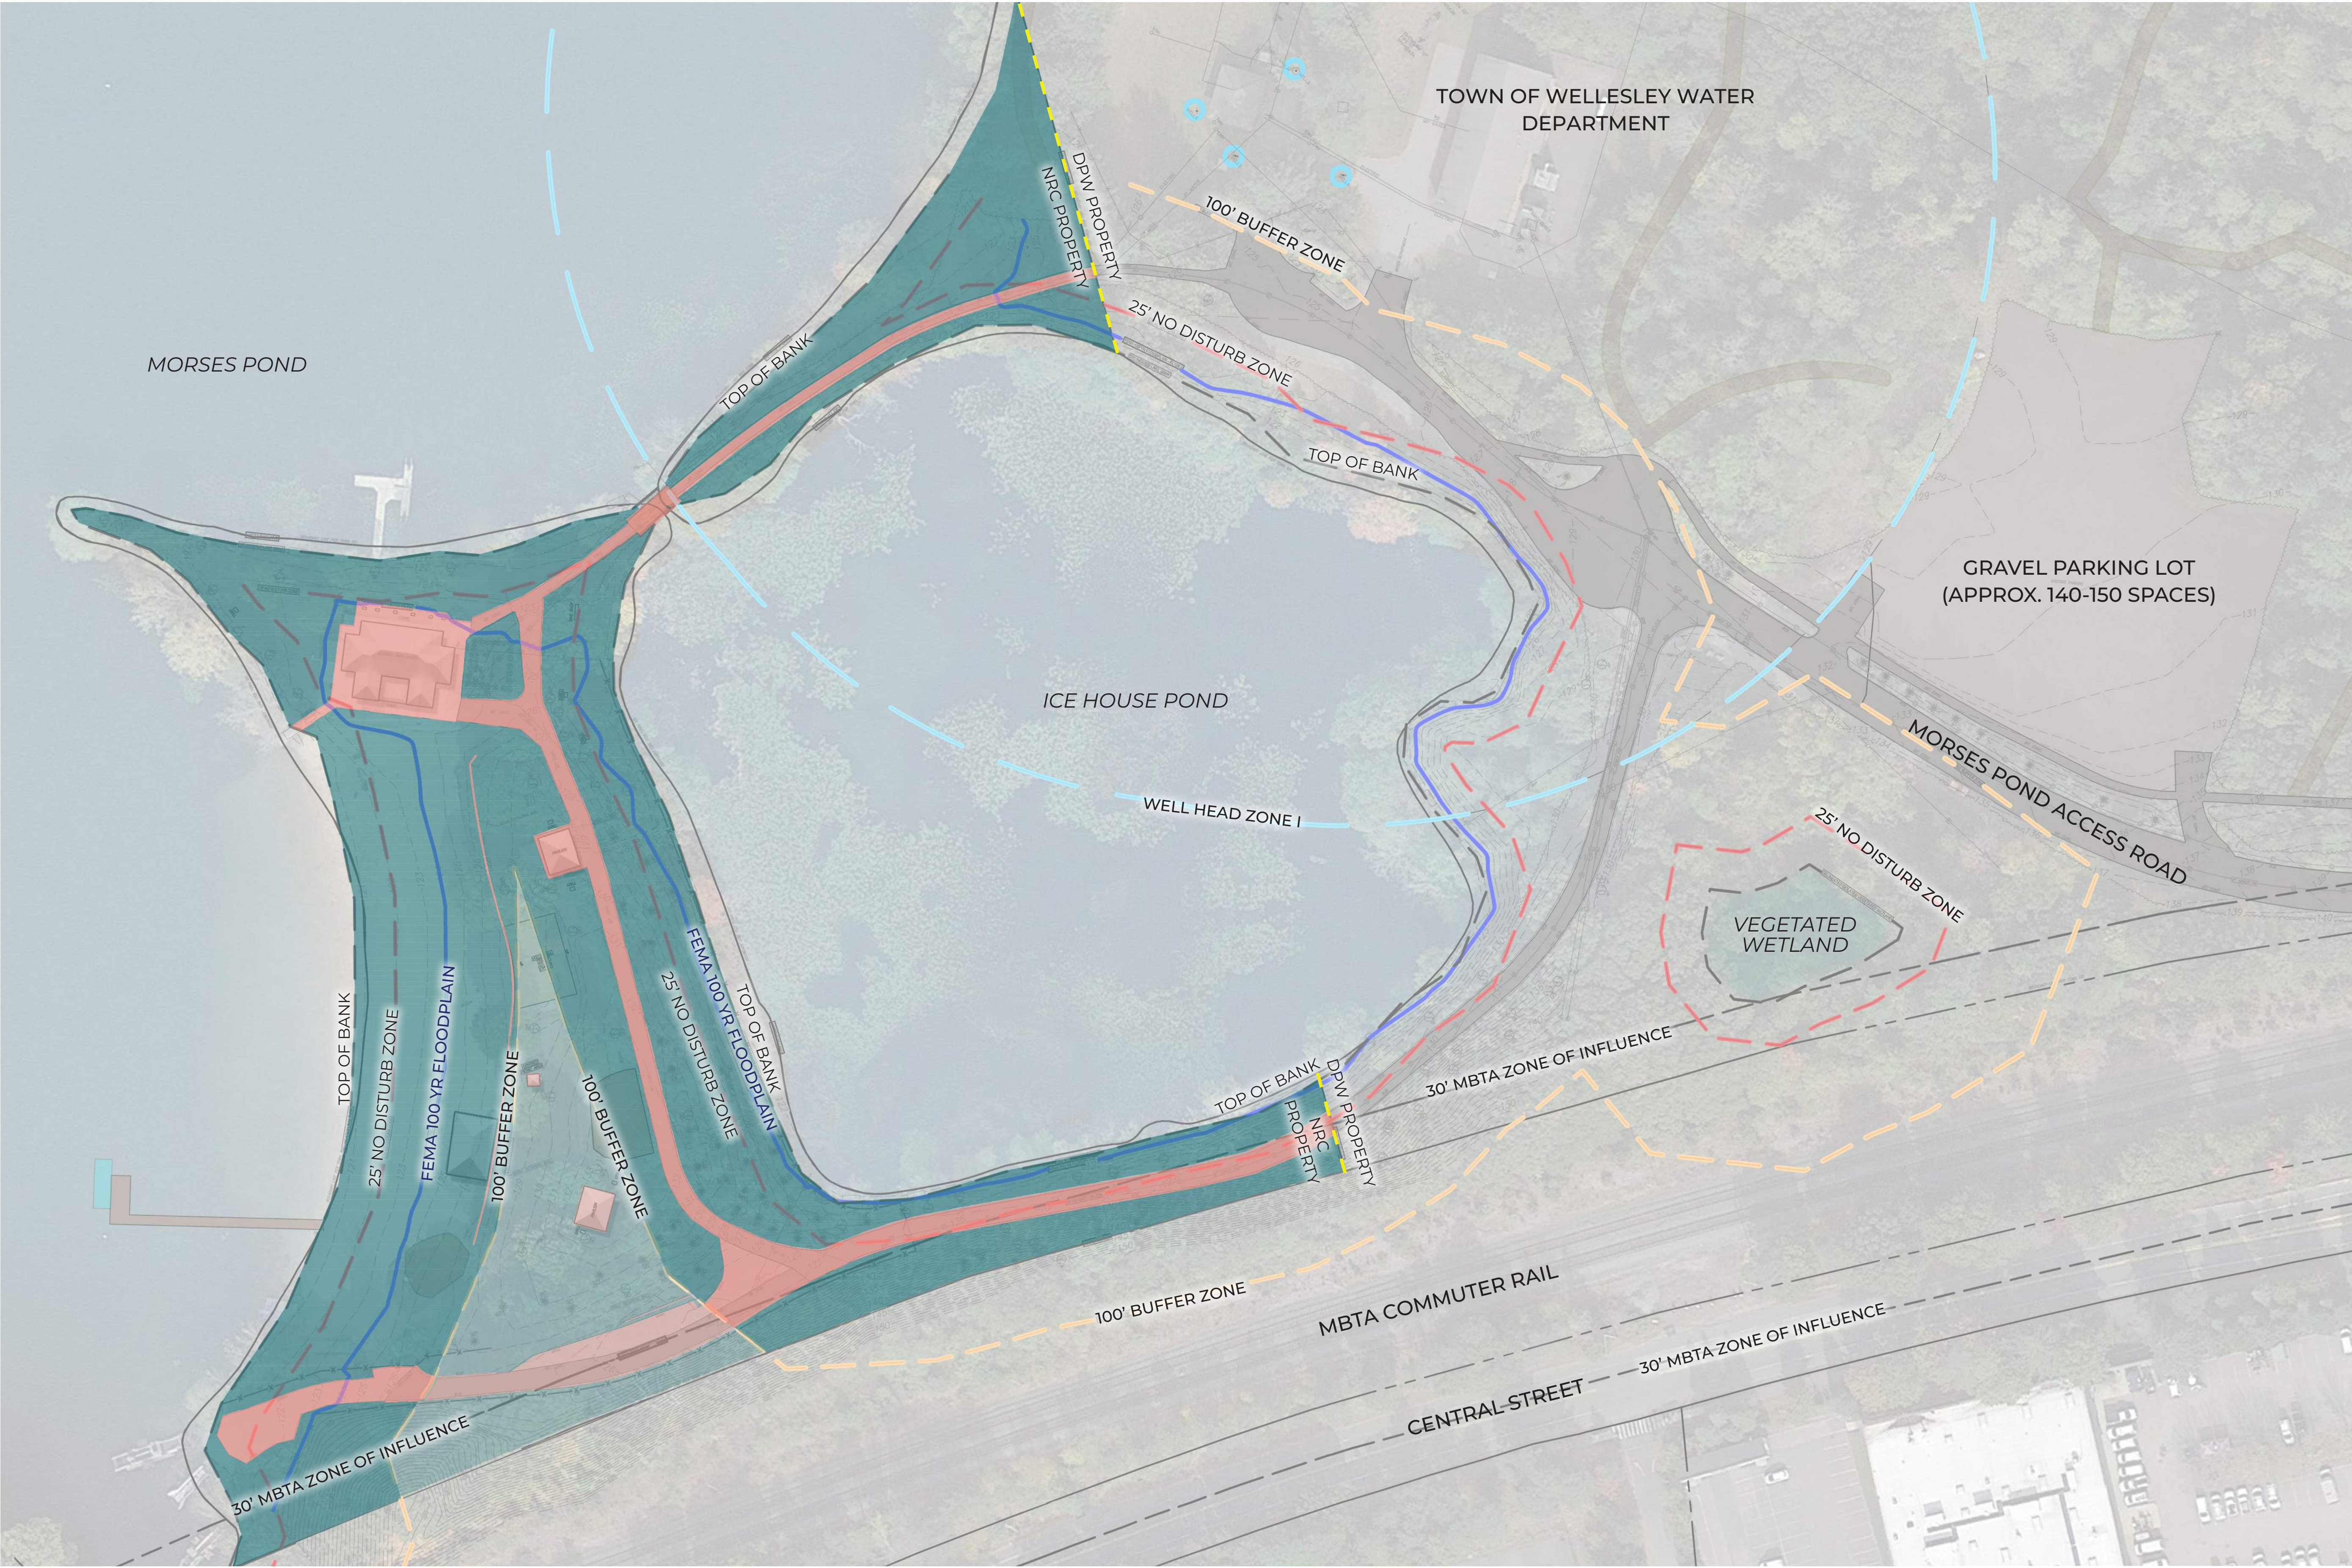
EXISTING CONDITIONS PLAN: IMPERVIOUS / PERVIOUS COVER

LEGEND	
24,074 sf	IMPERVIOUS AREA - INSIDE 100' WETLAND BUFFER
4,641 sf	IMPERVIOUS AREA - OUTSIDE 100' WETLAND BUFFER
134,501 sf	PERVIOUS AREA - INSIDE 100' WETLAND BUFFER
24,144 sf	PERVIOUS AREA - OUTSIDE 100' WETLAND BUFFER

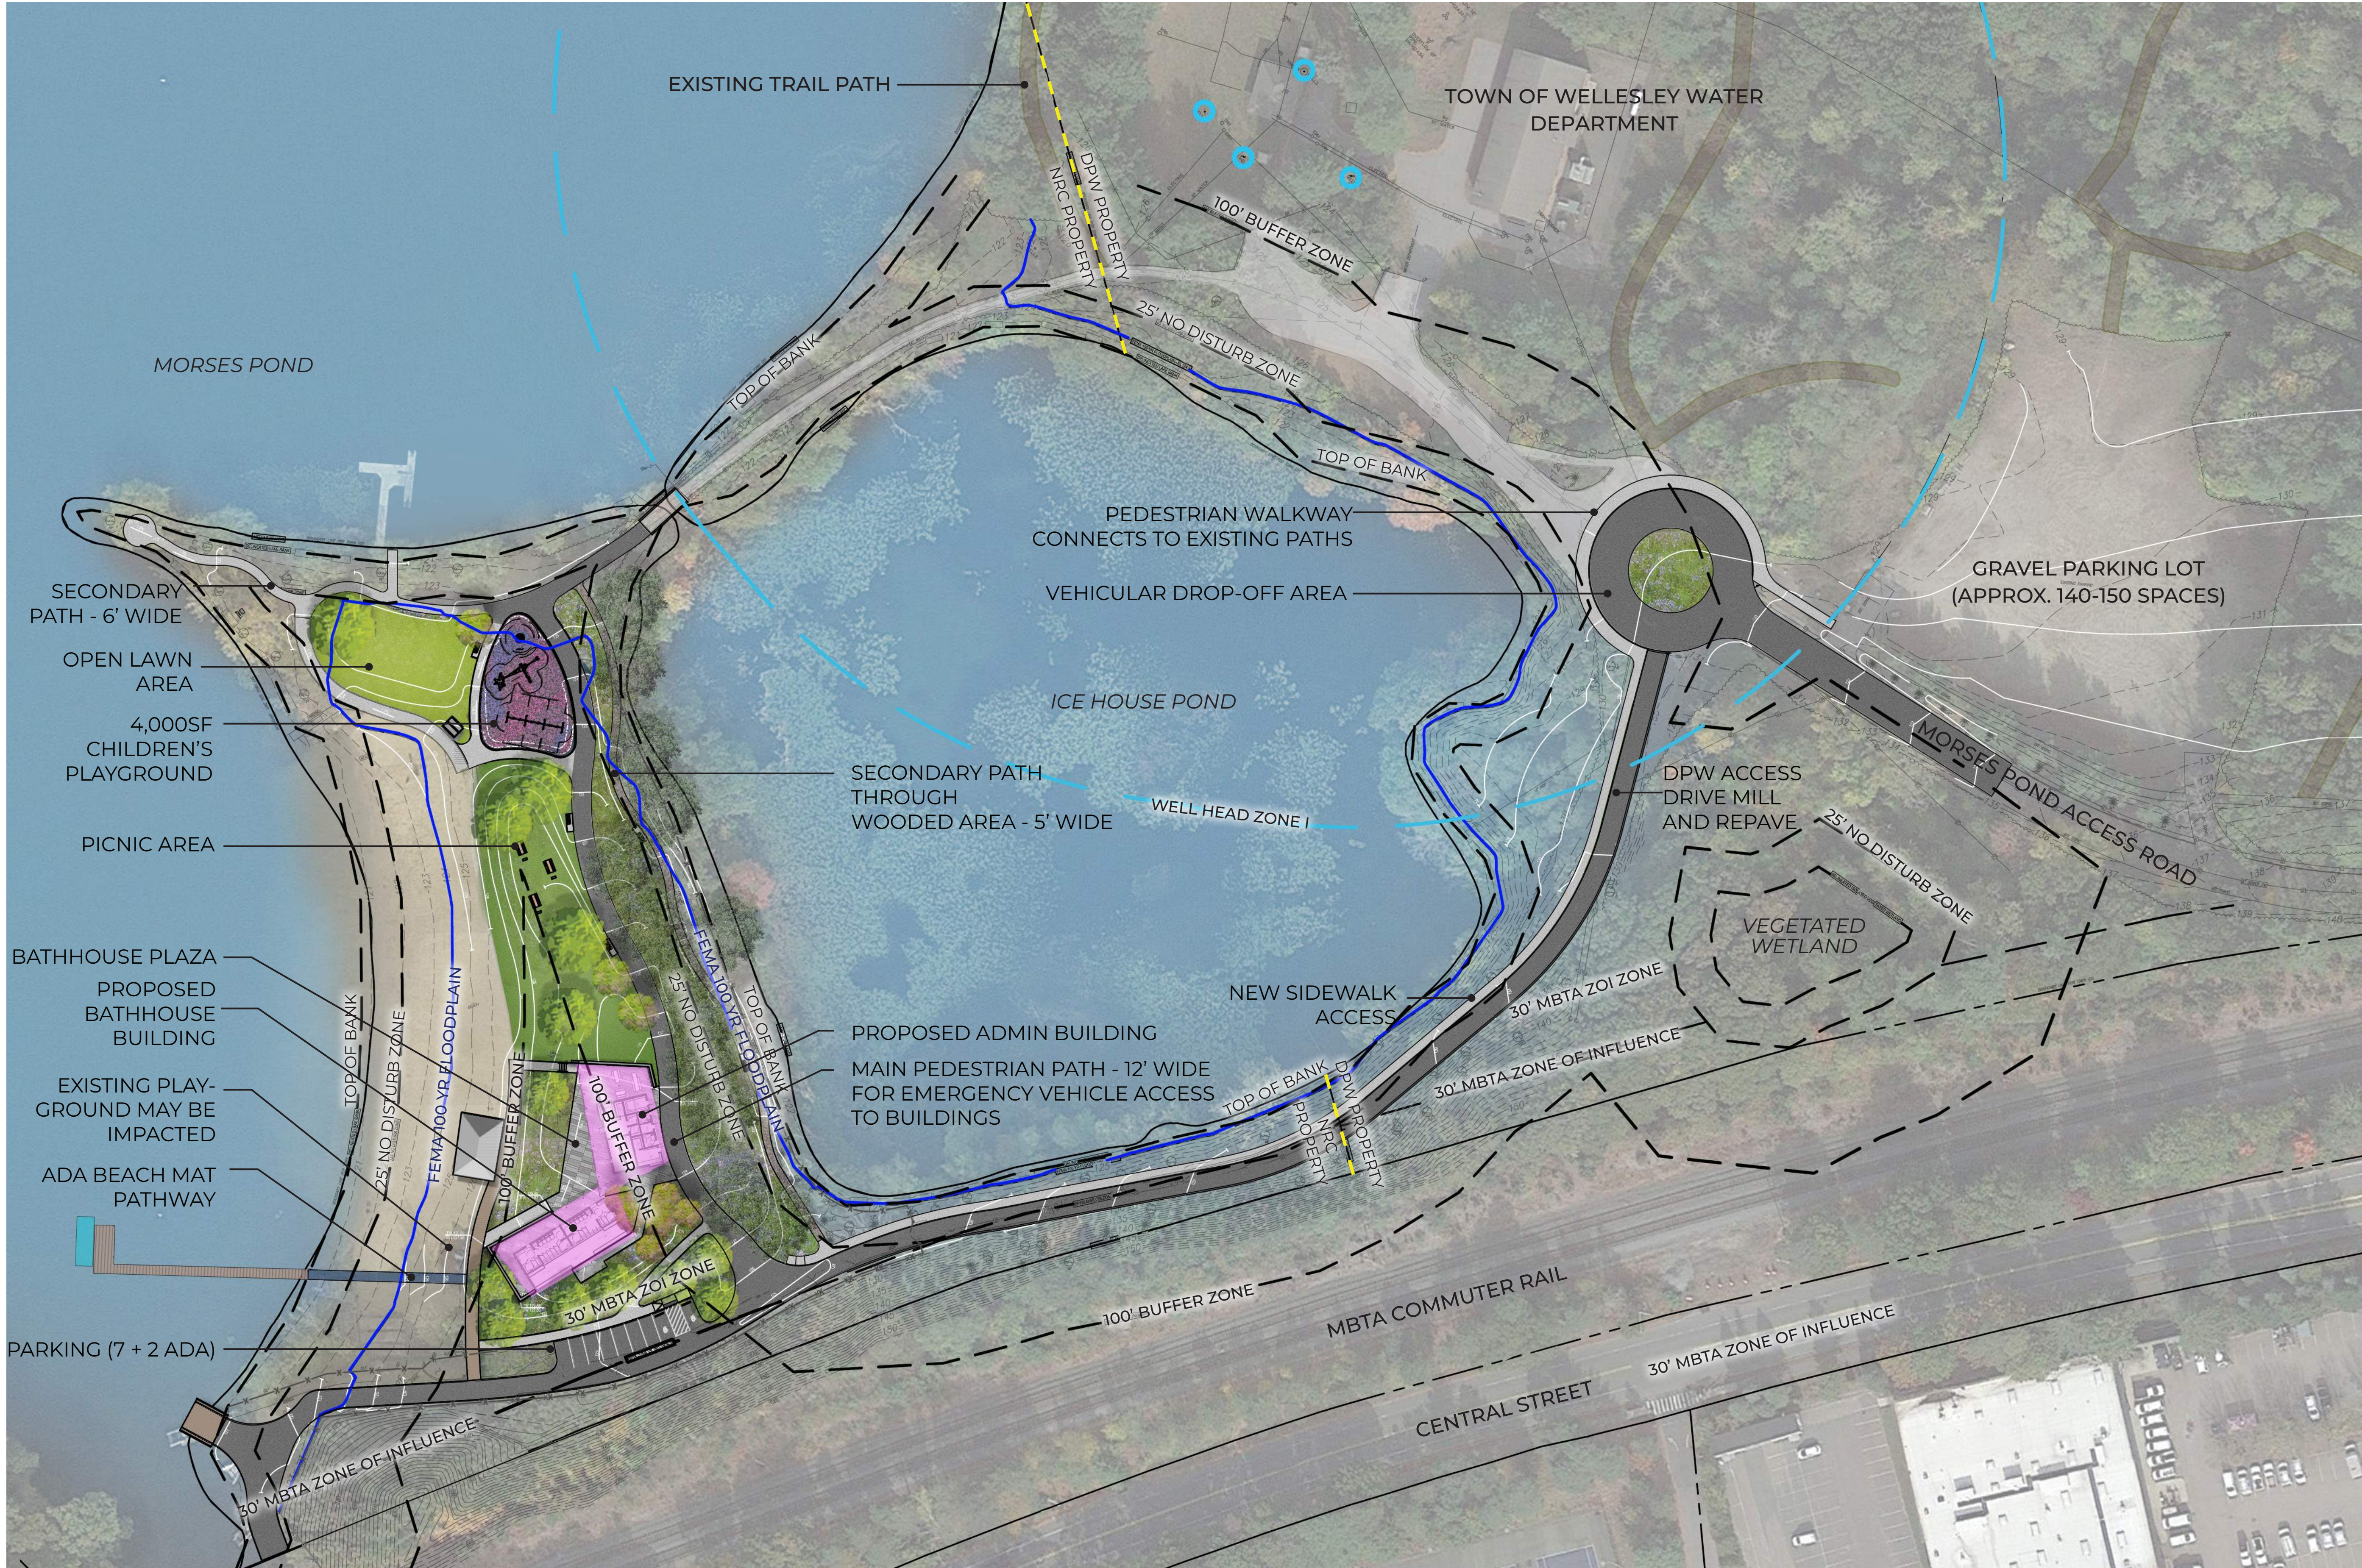
The Master Plan produced during the 2024 study was completed prior to the realignment of the seasonal dock location. Additionally, the boardwalk along the beach was value engineered out of the design after the study was finalized.

The Master Plan to the left reflects the new location of the seasonal dock and the removal of the previously proposed boardwalk to make up what is now referred to as the Current Master Plan. Permitting offsets have also been included on this plan.

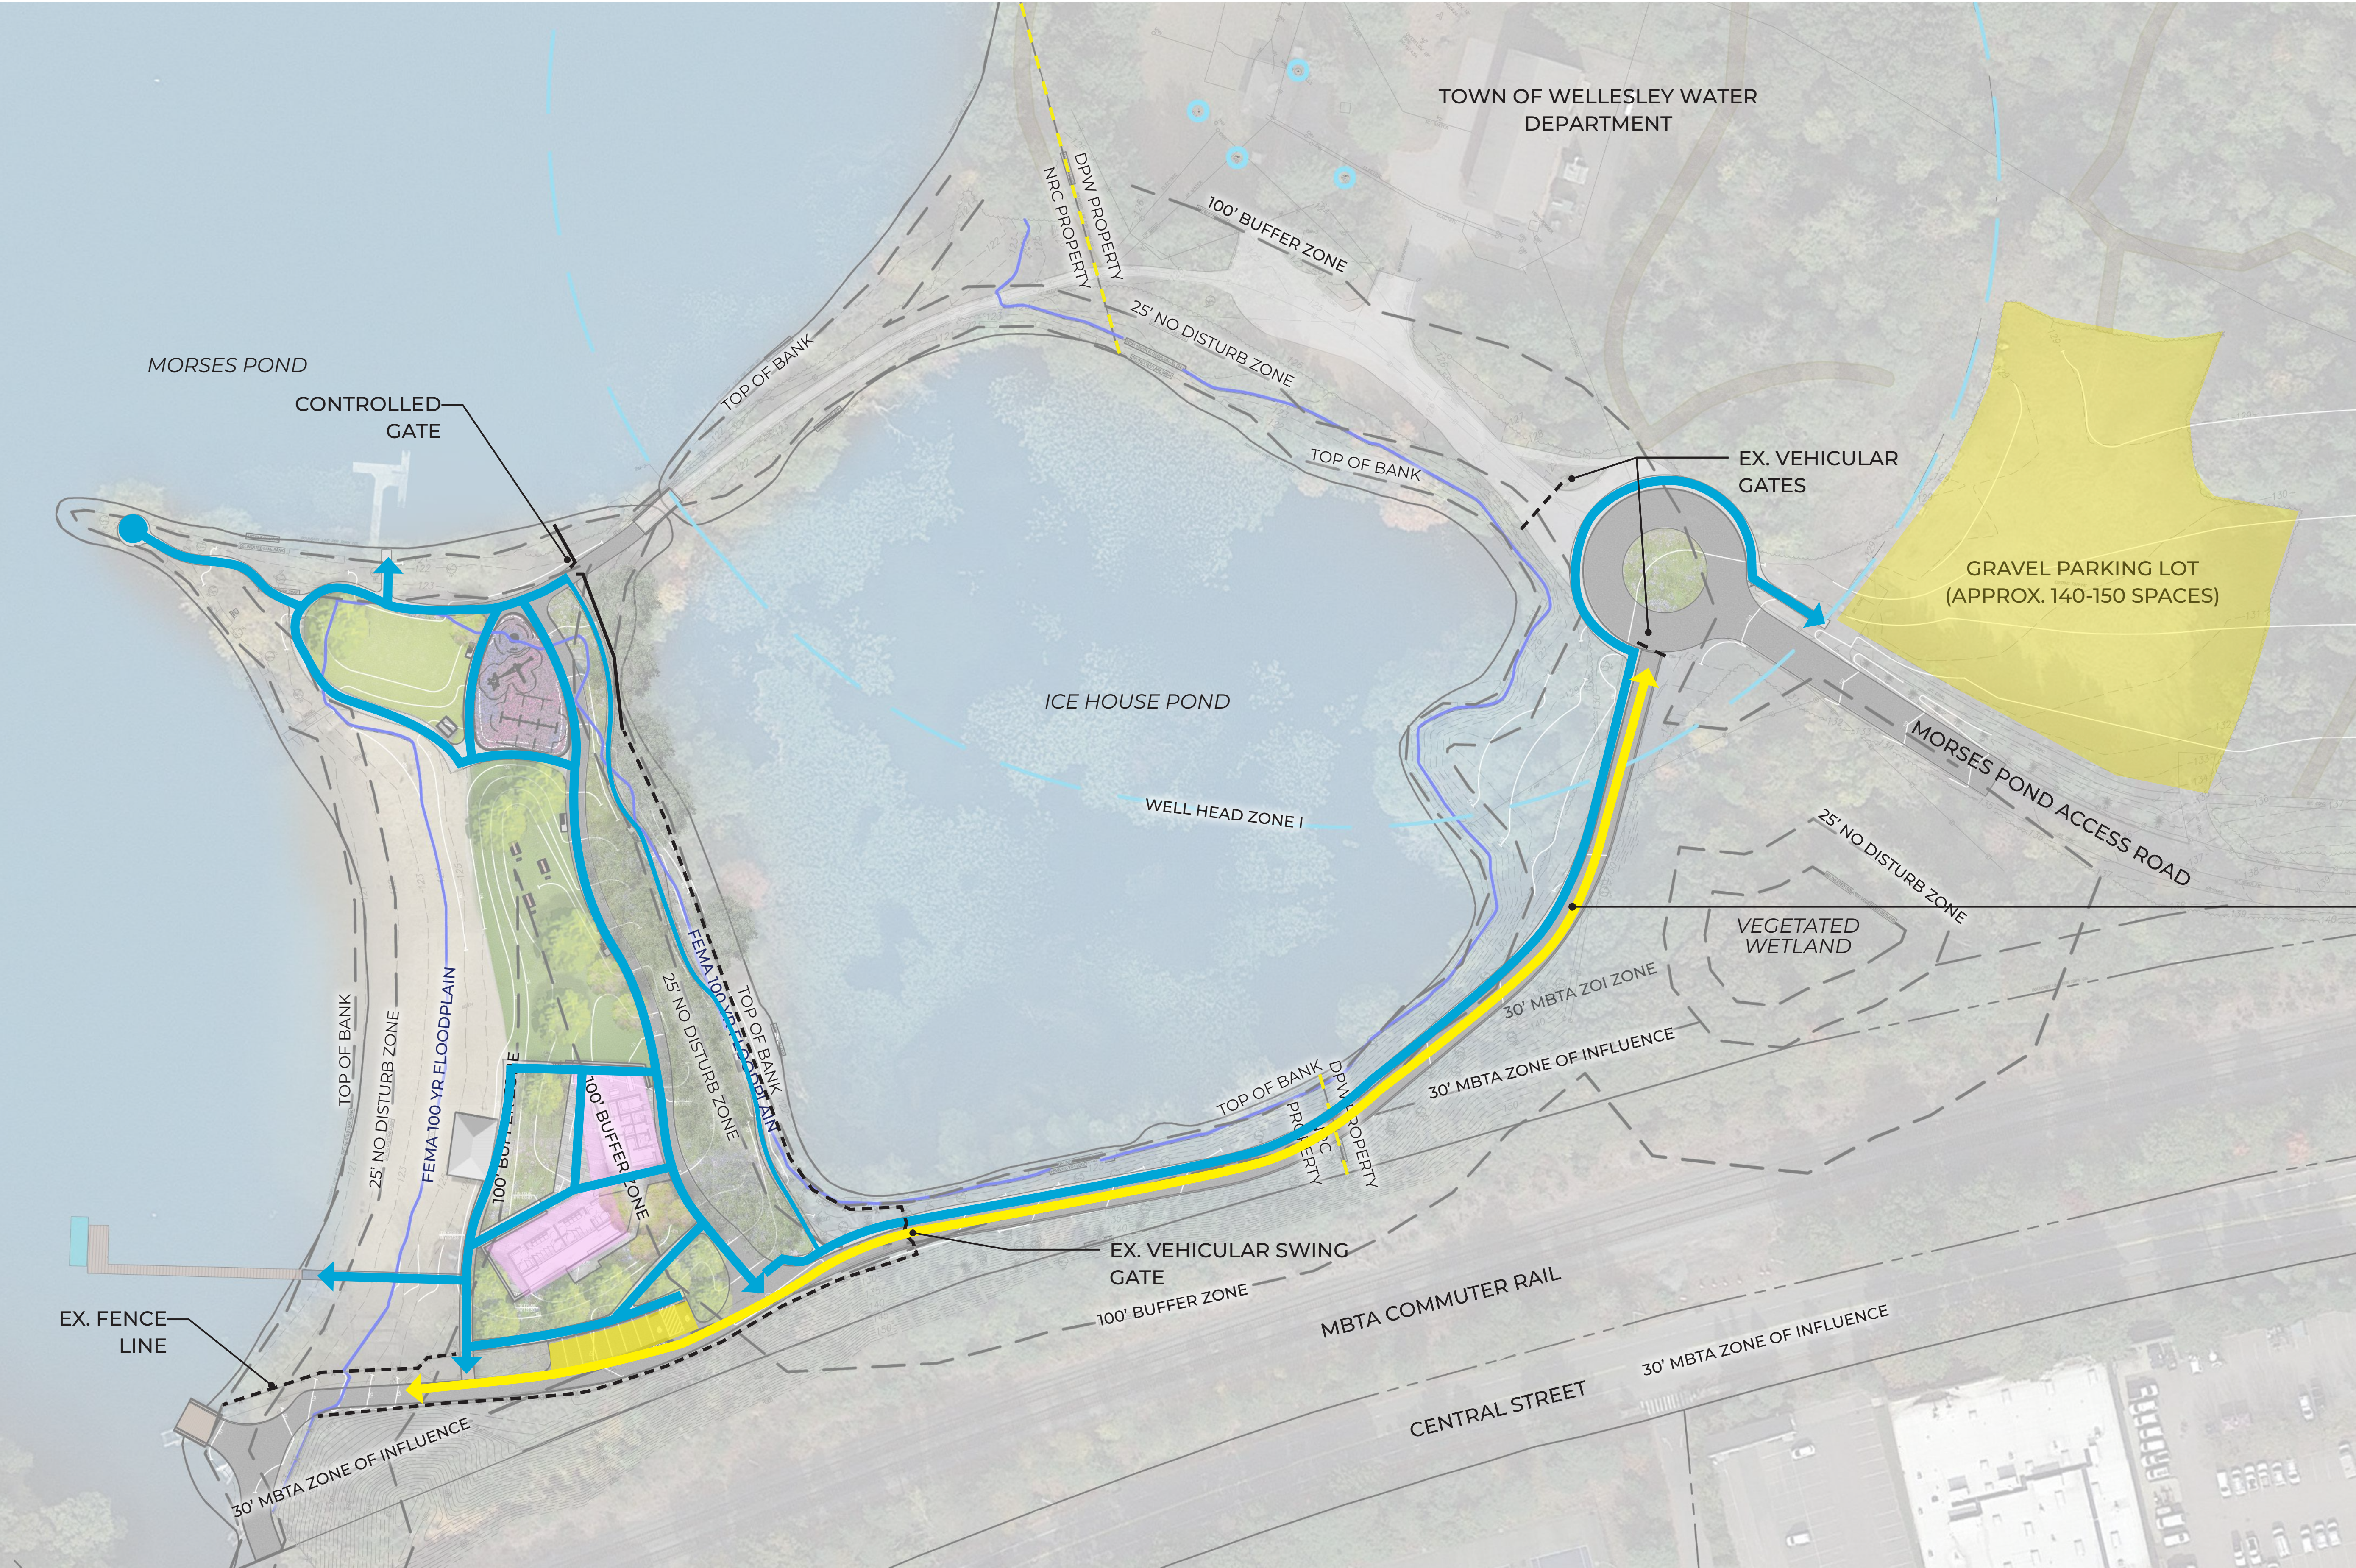
CURRENT MASTER PLAN: **PEDESTRIAN AND VEHICULAR CIRCULATION**

- EX. FENCE LINE
- ↔ ACCESSIBLE PEDESTRIAN ROUTE (< 5%)
- ↔ NON-ACCESSIBLE PEDESTRIAN ROUTE (> 5%)
- ↔ VEHICULAR ROUTE
- EX. PARKING AREA
- PROPOSED ACCESSIBLE PARKING
- PR. FENCELINE

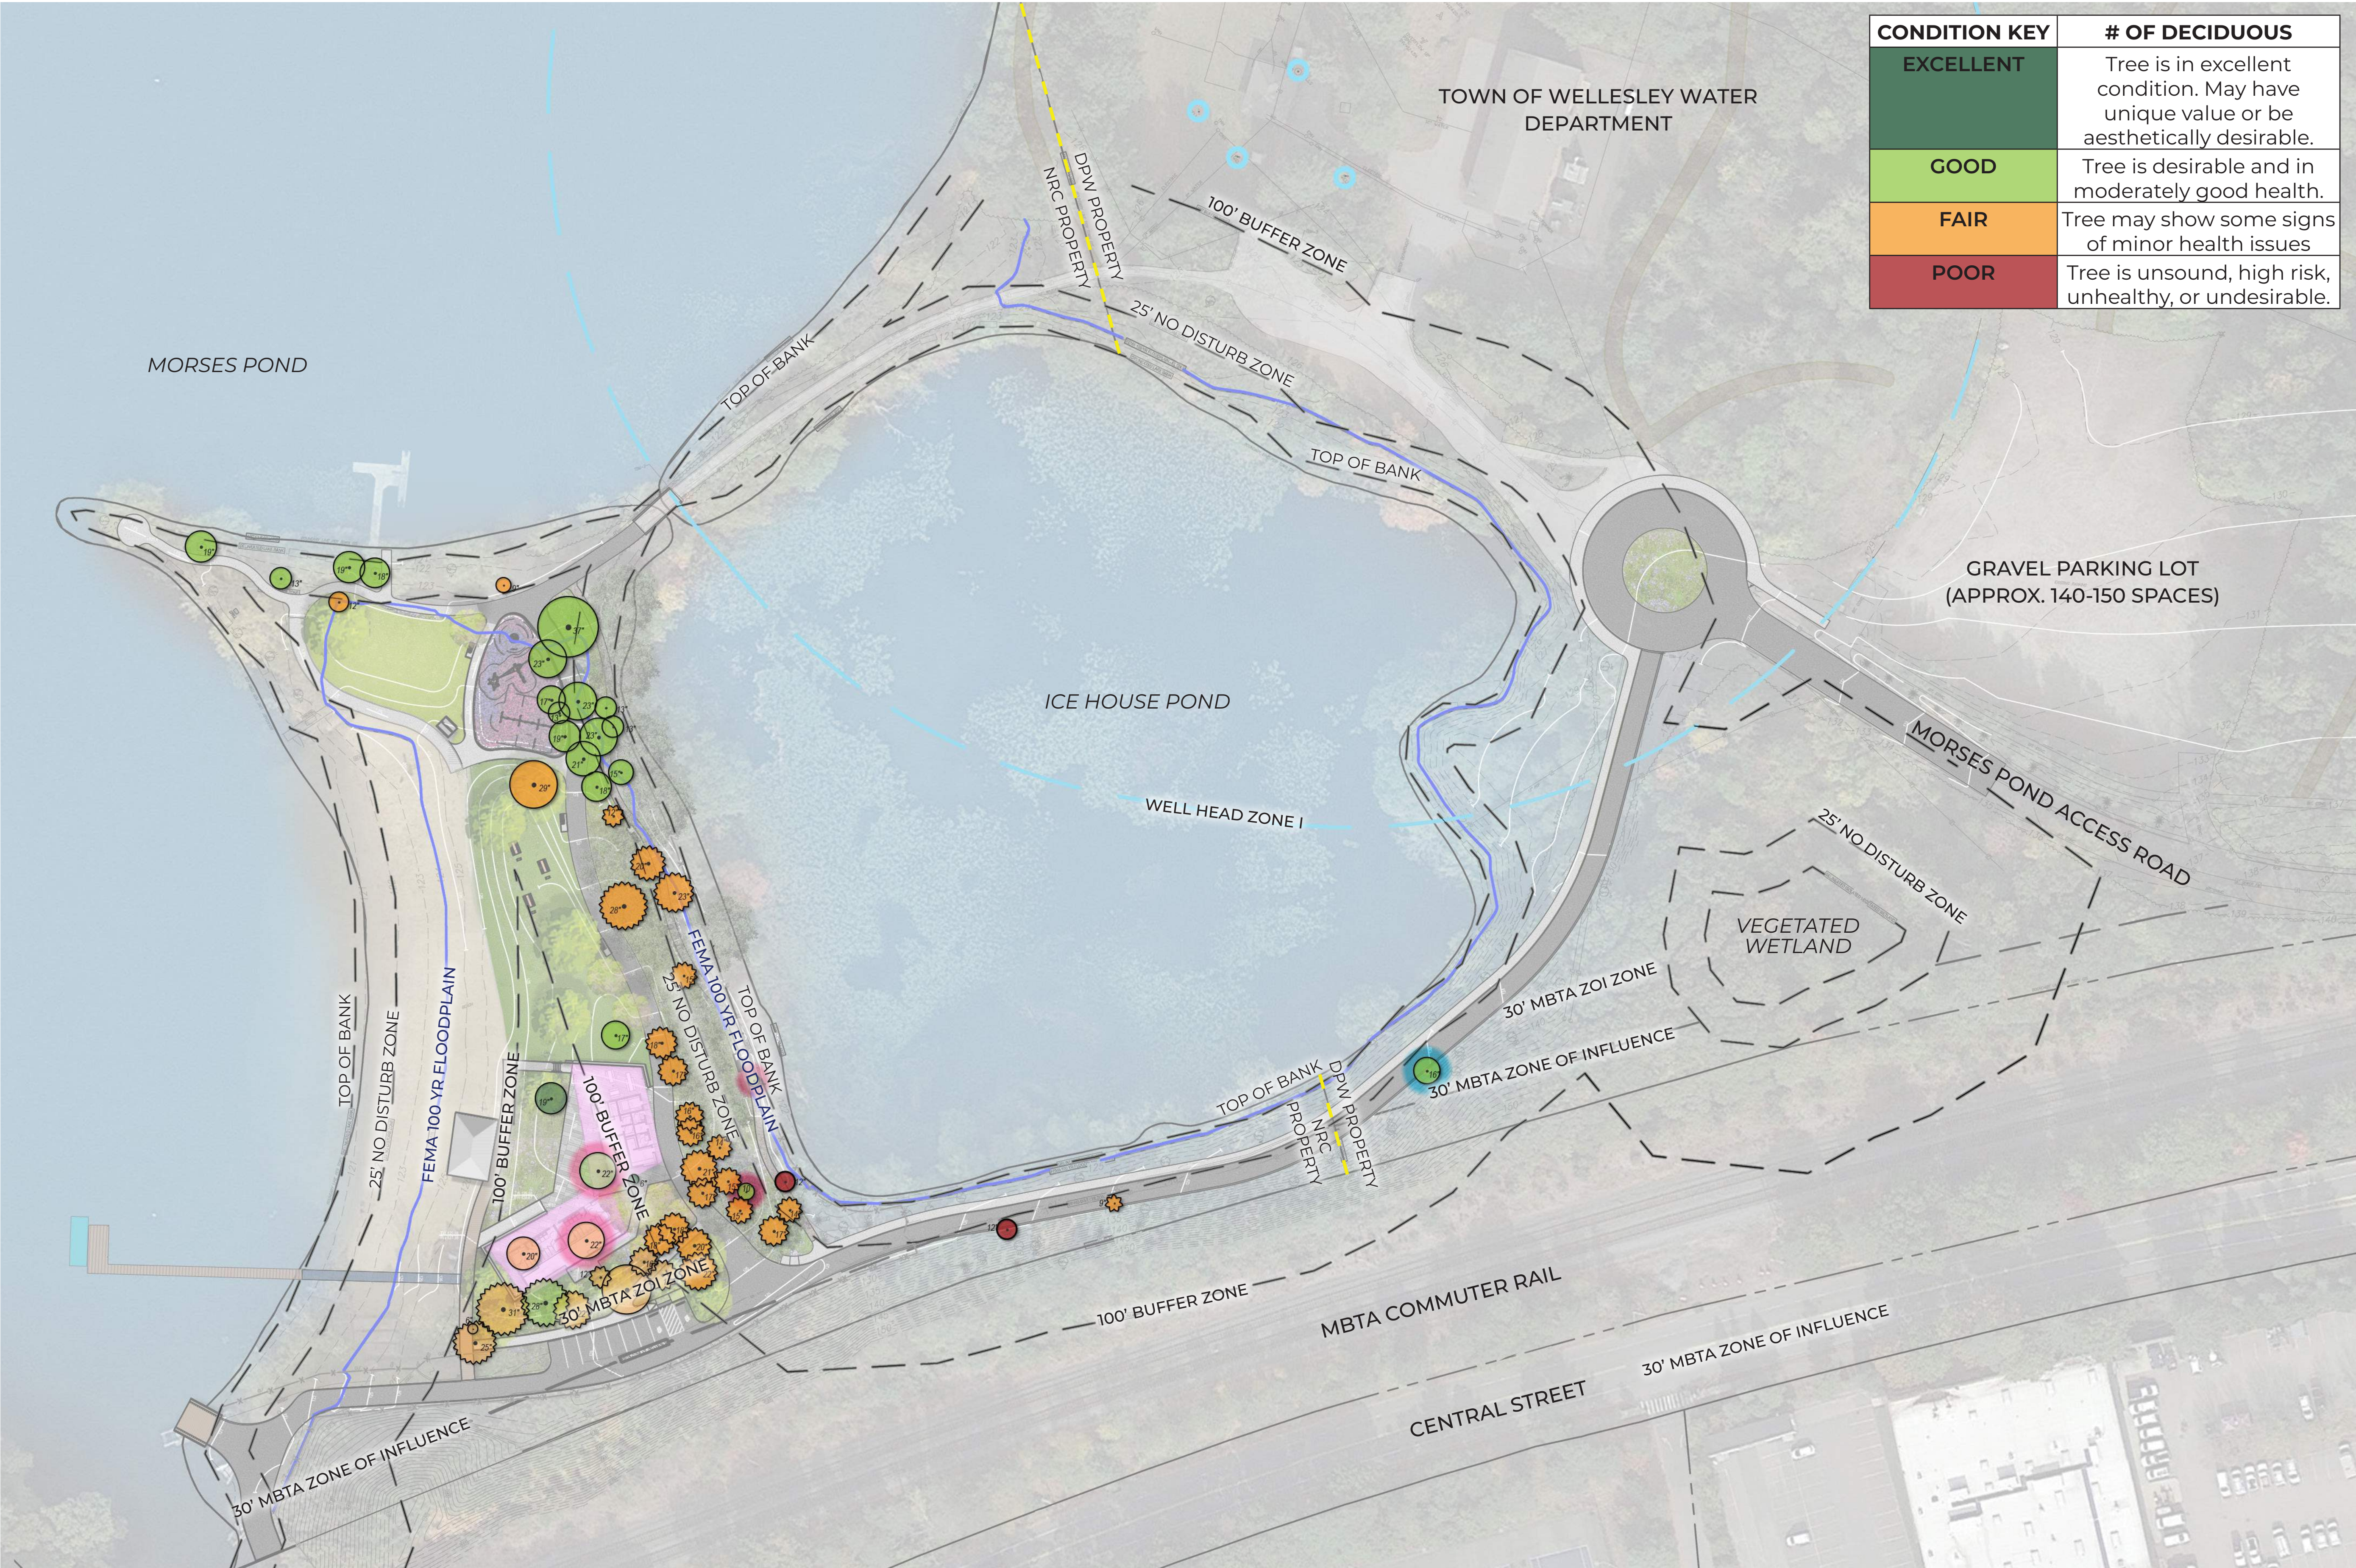
CURRENT MASTER PLAN: TREE IMPACTS

CONDITION KEY	# OF DECIDUOUS
EXCELLENT	Tree is in excellent condition. May have unique value or be aesthetically desirable.
GOOD	Tree is desirable and in moderately good health.
FAIR	Tree may show some signs of minor health issues
POOR	Tree is unsound, high risk, unhealthy, or undesirable.

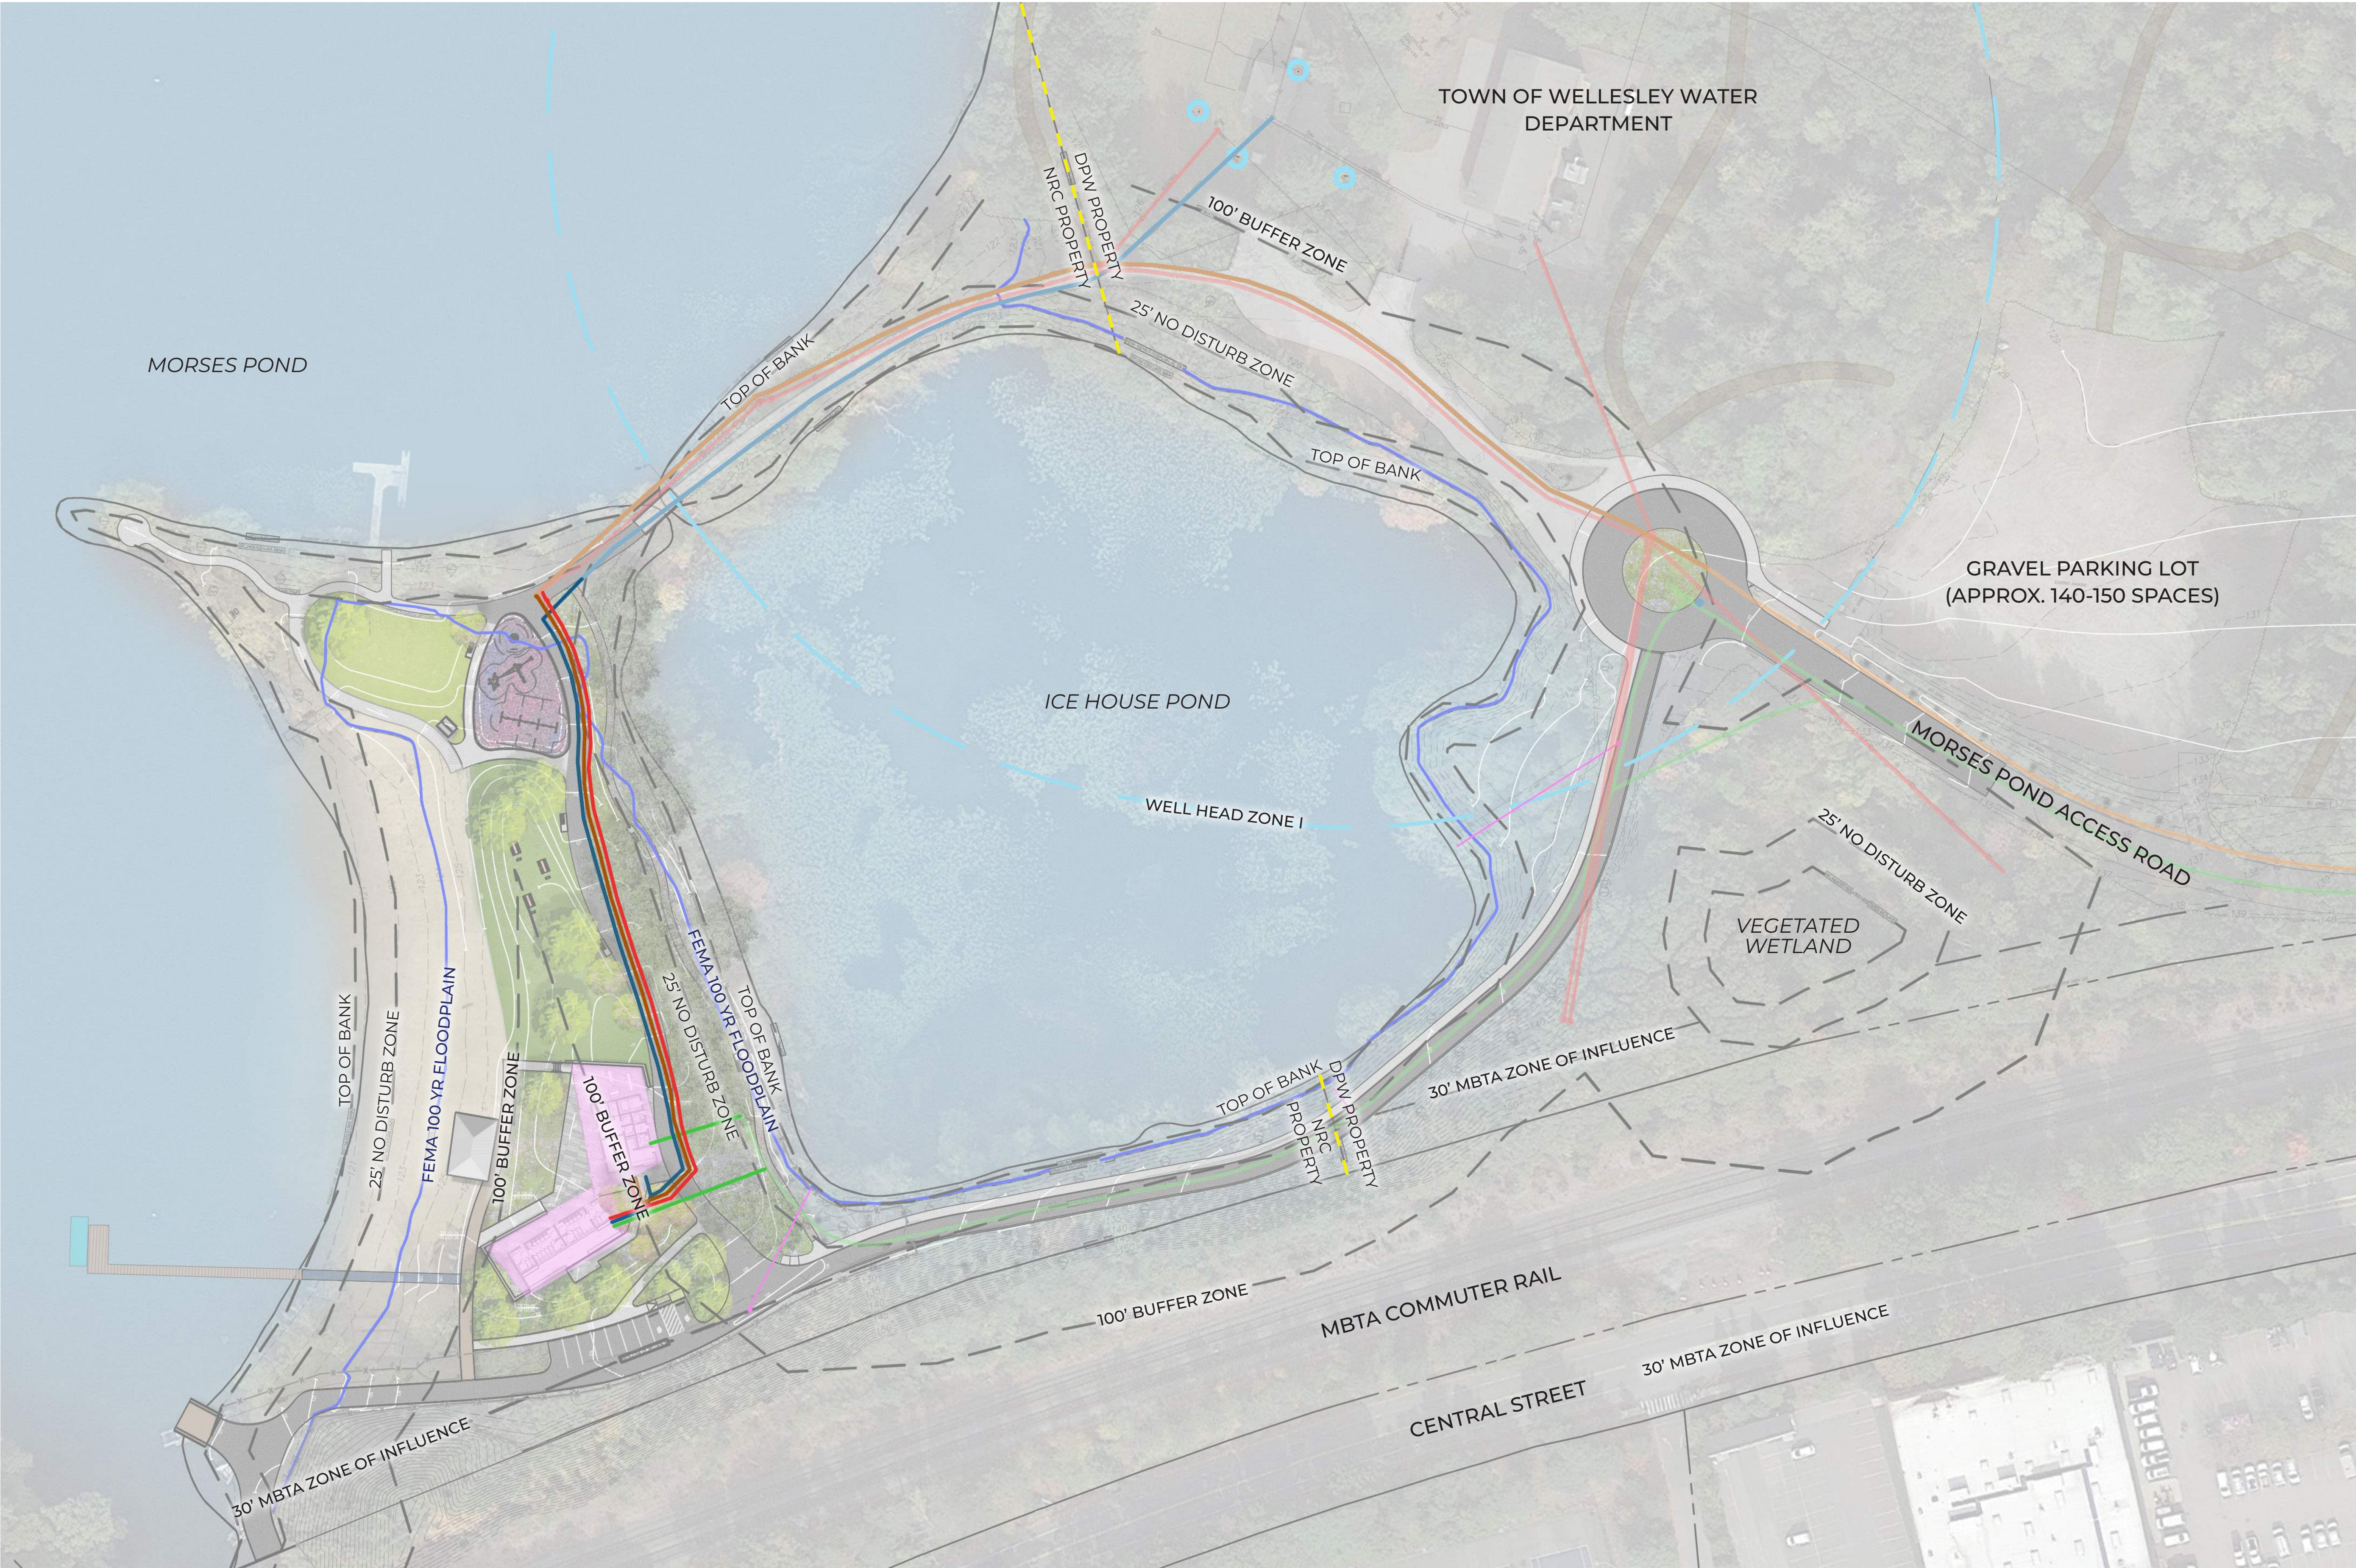
CURRENT MASTER PLAN: UTILITIES

LEGEND	
	EX. WATER LINE
	EX. SANITARY SEWER LINE
	EX. STORM DRAINAGE
	EX. ELECTRICAL CONDUIT
	EX. COMMUNICATIONS LINE
	EX. CABLE LINE FOR INTERNET
	PROPOSED WATER LINE
	PROPOSED SANITARY SEWER LINE
	PROPOSED ELECTRICAL CONDUIT
	PROPOSED CABLE LINE FOR INTERNET
