MORSES POND BEACH & BATHHOUSE IMPROVEMENTS
SUPPLEMENTARY FEASIBILITY STUDY
TASK 7: BUILDING LOCATION ANALYSIS

EXISTING CONDITIONS PLAN: **SITE HISTORY AS A TOWN BEACH**

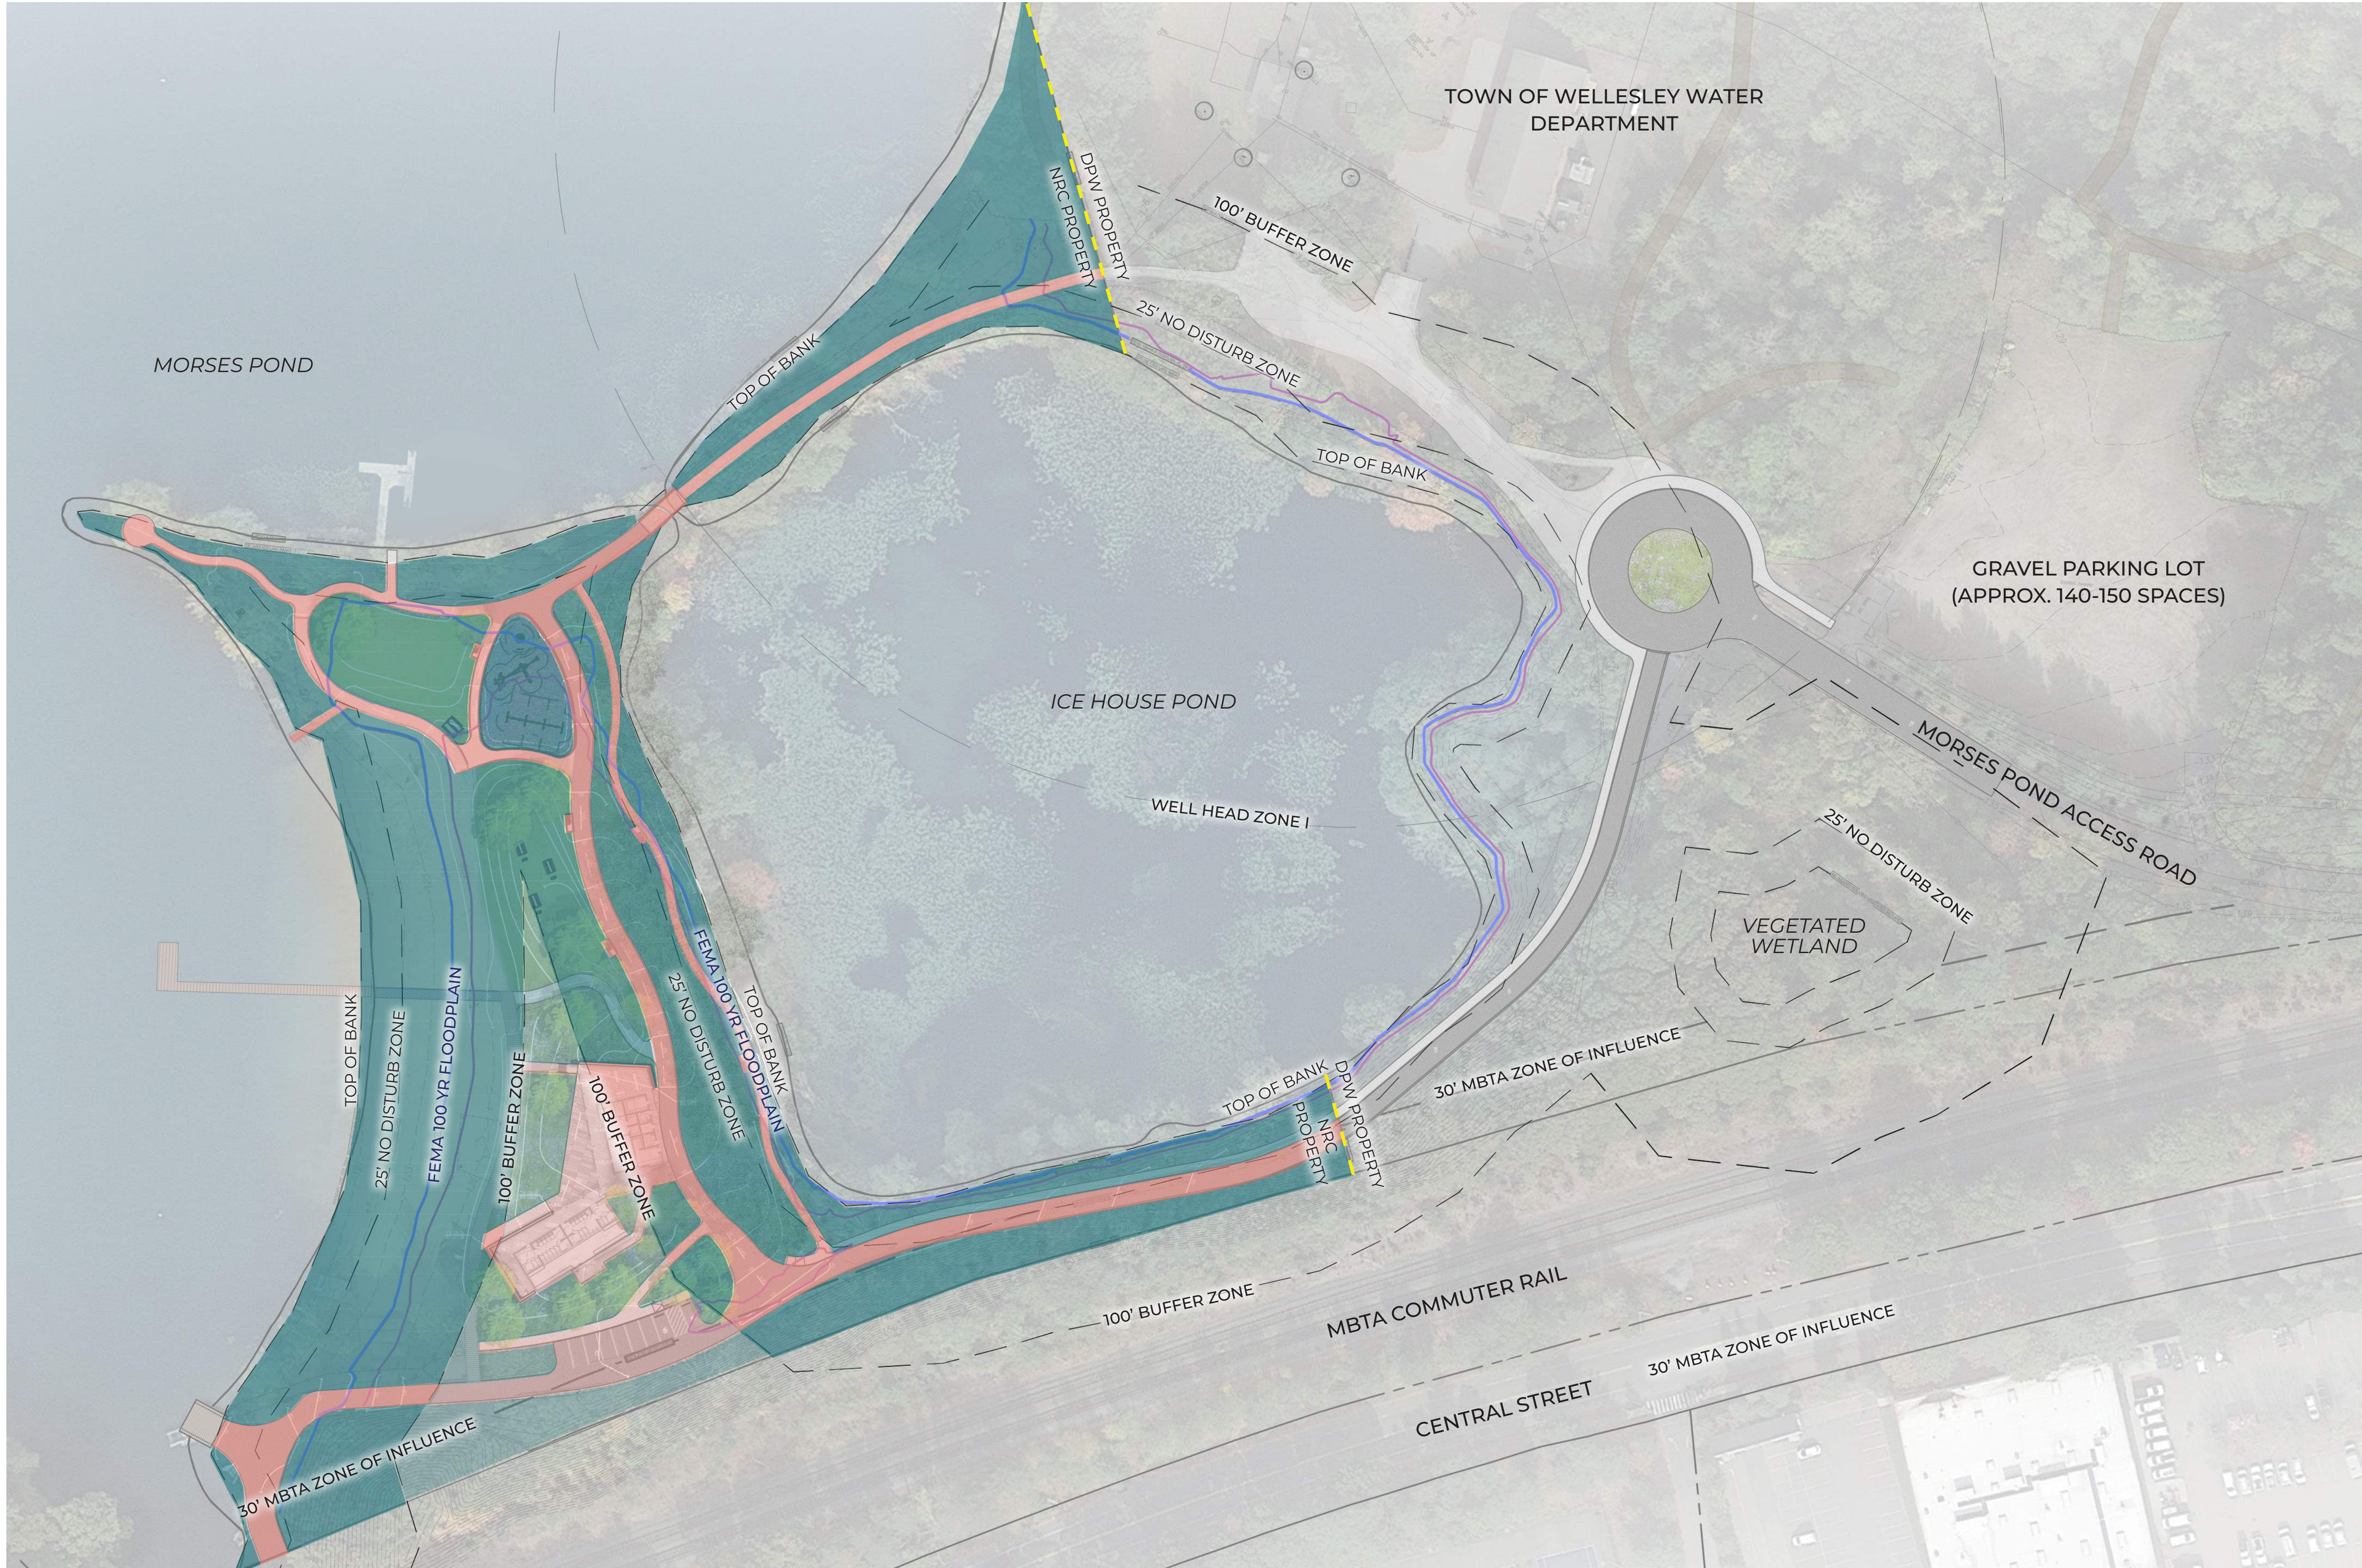
CURRENT MASTER PLAN: IMPERVIOUS / PERVIOUS COVER

LEGEND	
28,560 sf	IMPERVIOUS AREA - INSIDE 100' WETLAND BUFFER
11,280 sf	IMPERVIOUS AREA - OUTSIDE 100' WETLAND BUFFER
130,015 sf	PERVIOUS AREA - INSIDE 100' WETLAND BUFFER
17,505 sf	PERVIOUS AREA - OUTSIDE 100' WETLAND BUFFER

EXISTING CONDITIONS PLAN	CURRENT MASTER PLAN	NET CHANGE
IMPERVIOUS AREA - INSIDE 100' WET- LAND BUFFER	24,074 sf	28,560 sf	+4,486 sf
PERVIOUS AREA - INSIDE 100' WETLAND BUFFER	134,501 sf	130,015 sf	-4,486 sf
TOTAL IMPERVIOUS AREA	28,715 sf	39,840 sf	+11,125 sf
TOTAL PERVIOUS AREA	158,645 sf	147,520 sf	-11,125 sf
BUILDING SQUARE FOOTAGE	2,572 sf	3,191 sf	+619 sf
BUILDING LOCATION	North side	South side	N/A
OVERALL CUT / FILL	N/A	7,050.9 cy cut / 1,201.3 cy fill	5,849.6 cy net cut
CUT / FILL WITHIN THE 100 YR. FEMA FLOODPLAIN	N/A	458.8 cy cut / 68 cy fill	390.9 cy net cut
DEDICATED LAWN AREA	+/- 22,220 sf	+/- 17,730 sf	-4,490 sf
AMENITIES TO REMAIN	N/A	<ul style="list-style-type: none">• Beach pavilion• Floating docks	<ul style="list-style-type: none">• Beach pavilion• Floating docks
RELOCATED AMENITIES	N/A	N/A	N/A
REMOVED AMENITIES	N/A	<ul style="list-style-type: none">• Play structure• Swing Set• Both permanent pavilions• Volleyball court	<ul style="list-style-type: none">• Play structure• Swing Set• Both permanent pavilions• Volleyball court

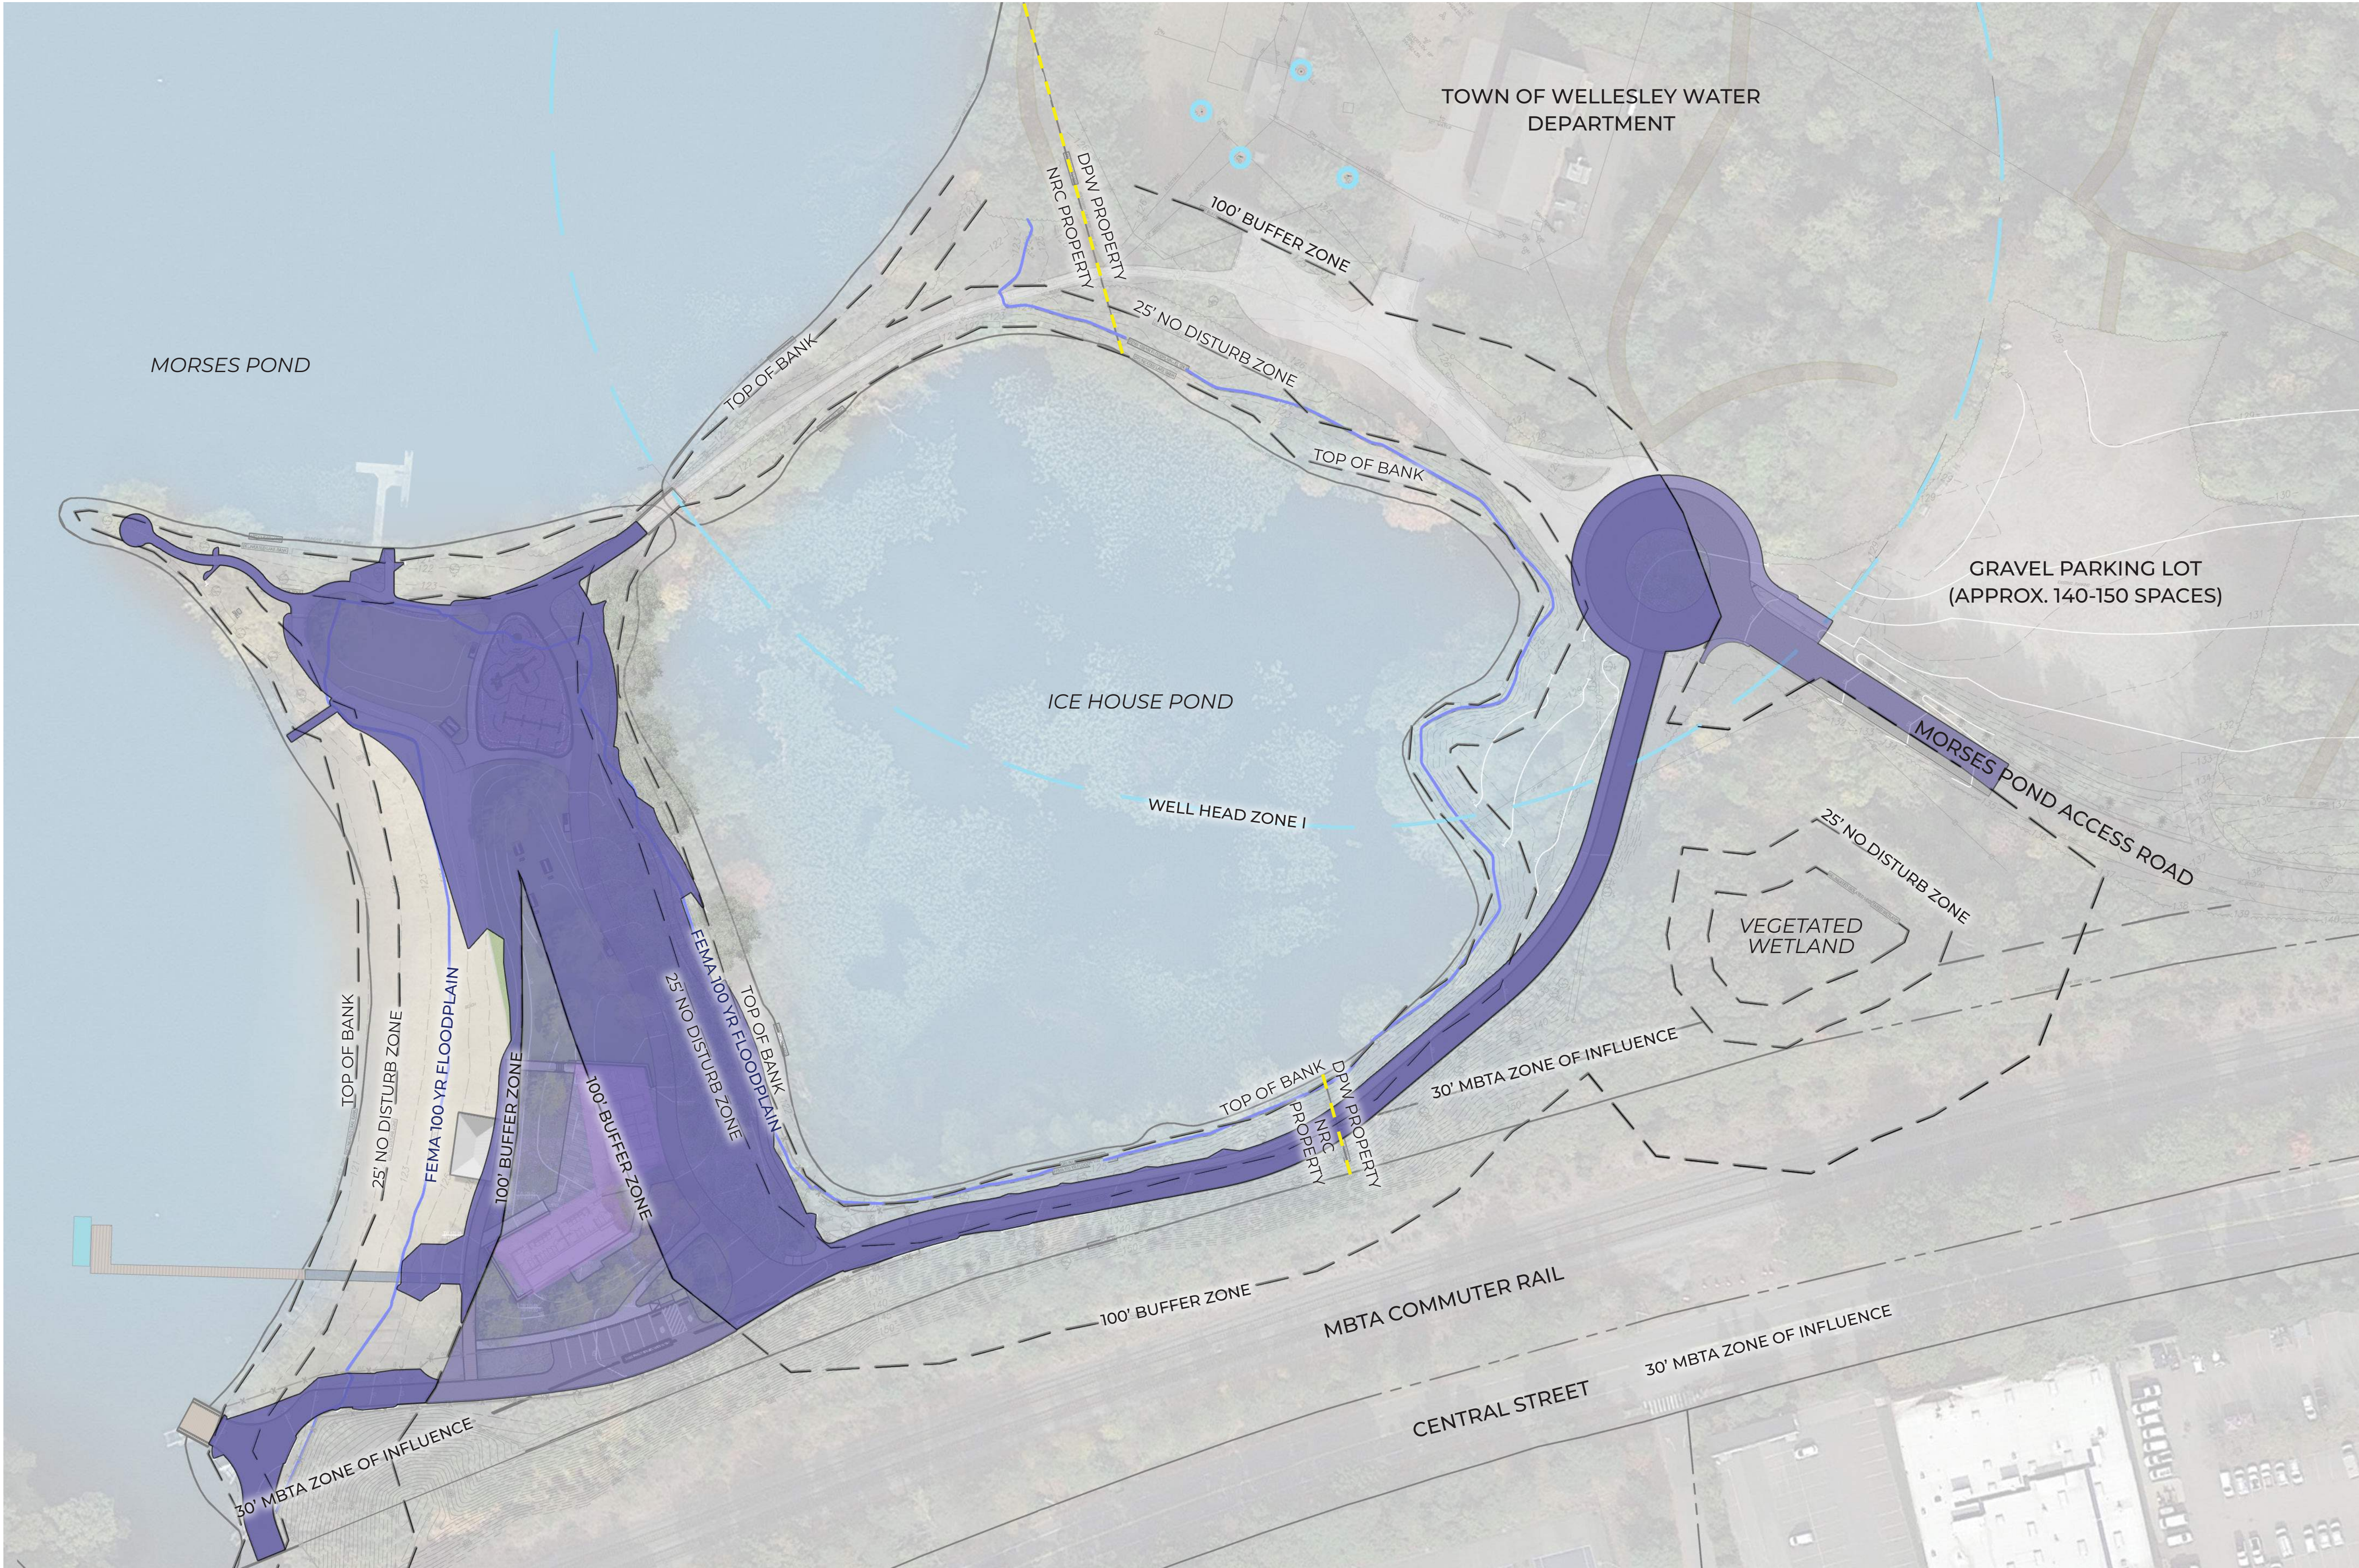
CURRENT MASTER PLAN: **DISTURBANCE**

- 87,764 sf** **DISTURBED AREA**
- INSIDE 100'
WETLAND BUFFER*
- 29,158 sf** **DISTURBED AREA**
- OUTSIDE 100'
WETLAND BUFFER

AREA OF DISTURBANCE	N/A	116,922 sf (87,764 sf inside 100' wetland buffer)	+116,922 sf
PERMITTING IMPACTS	N/A	<ul style="list-style-type: none">• Wildlife assessment is required (greater than 5,000 sf of alteration within the 100' wetland buffer)• A stormwater report is required (net increase in impervious within the 100' wetland buffer)• Minor compensatory storage is necessary within the 100 Yr. FEMA Floodplain (greater than 5,000 sf of alteration)• Planting one native replacement tree for each tree re-moved - 47 Native Trees Total• Zone of Influence permit required (project schedule to accomo-date review periods)	N/A

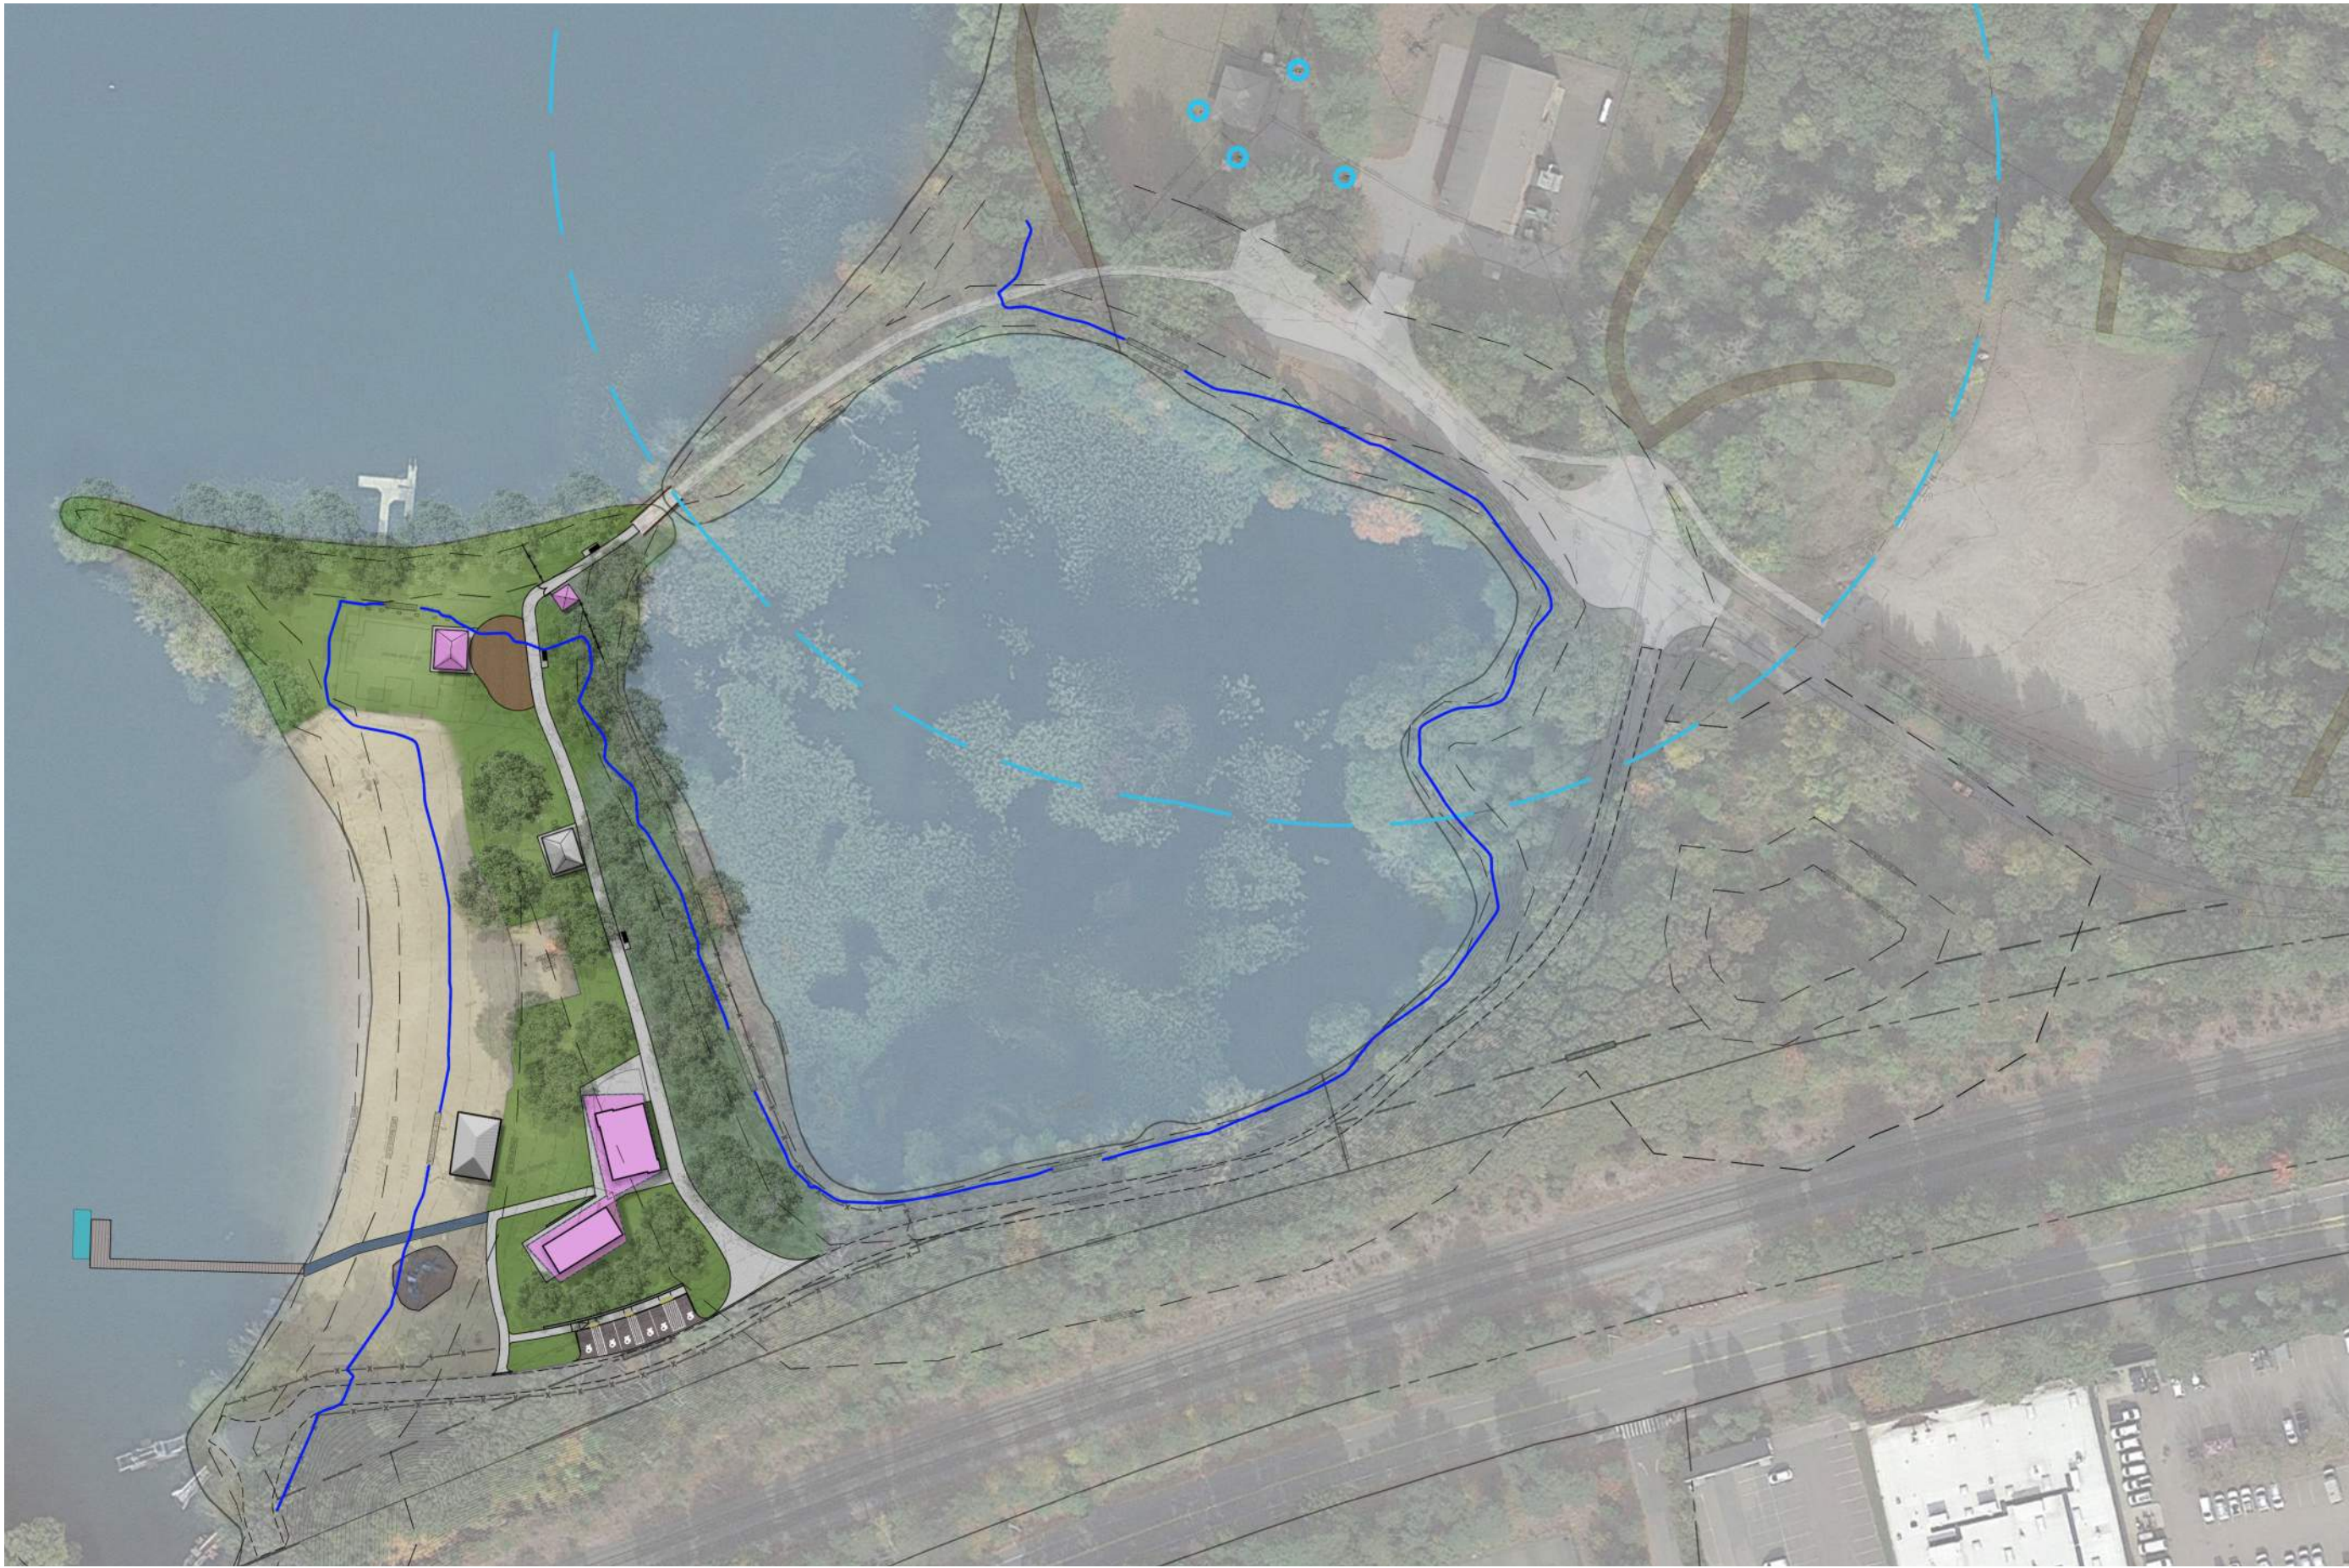
**ALTERNATIVE A: MODIFIED SOUTH
SIDE BUILDING DESIGN**

Reduced square footage buildings
located in the same orientation and
location (south side) as the Current
Master Plan

EXISTING CONDITIONS PLAN	ALTERNATIVE A: MODIFIED SOUTH SIDE BUILDING	NET CHANGE
IMPERVIOUS AREA - INSIDE 100' WETLAND BUFFER	24,074 sf	19,447 sf	-4,627 sf
PERVIOUS AREA - INSIDE 100' WETLAND BUFFER	134,501 sf	139,128 sf	+4,627 sf
TOTAL IMPERVIOUS AREA	28,715 sf	27,831 sf	-884 sf
TOTAL PERVIOUS AREA	158,645 sf	159,529 sf	+884 sf
BUILDING SQUARE FOOTAGE	2,572 sf	2,230 sf	-342 sf
BUILDING LOCATION	North side	South side	N/A
OVERALL CUT / FILL	N/A	835 cy cut / 31 cy fill	803 cy net cut
CUT / FILL WITHIN THE 100 YR. FEMA FLOODPLAIN	N/A	10 cy cut/ 24 cy fill	14 cy net fill
DEDICATED LAWN AREA	+/- 22,220 sf	+/- 26,250 sf	+4,030 sf
AMENITIES TO REMAIN	N/A	<ul style="list-style-type: none">• Beach pavilion• Floating docks• Play structure• Volleyball court• Northern permanent pavilion	<ul style="list-style-type: none">• Beach pavilion• Floating docks• Play structure• Volleyball court• Northern permanent pavilion

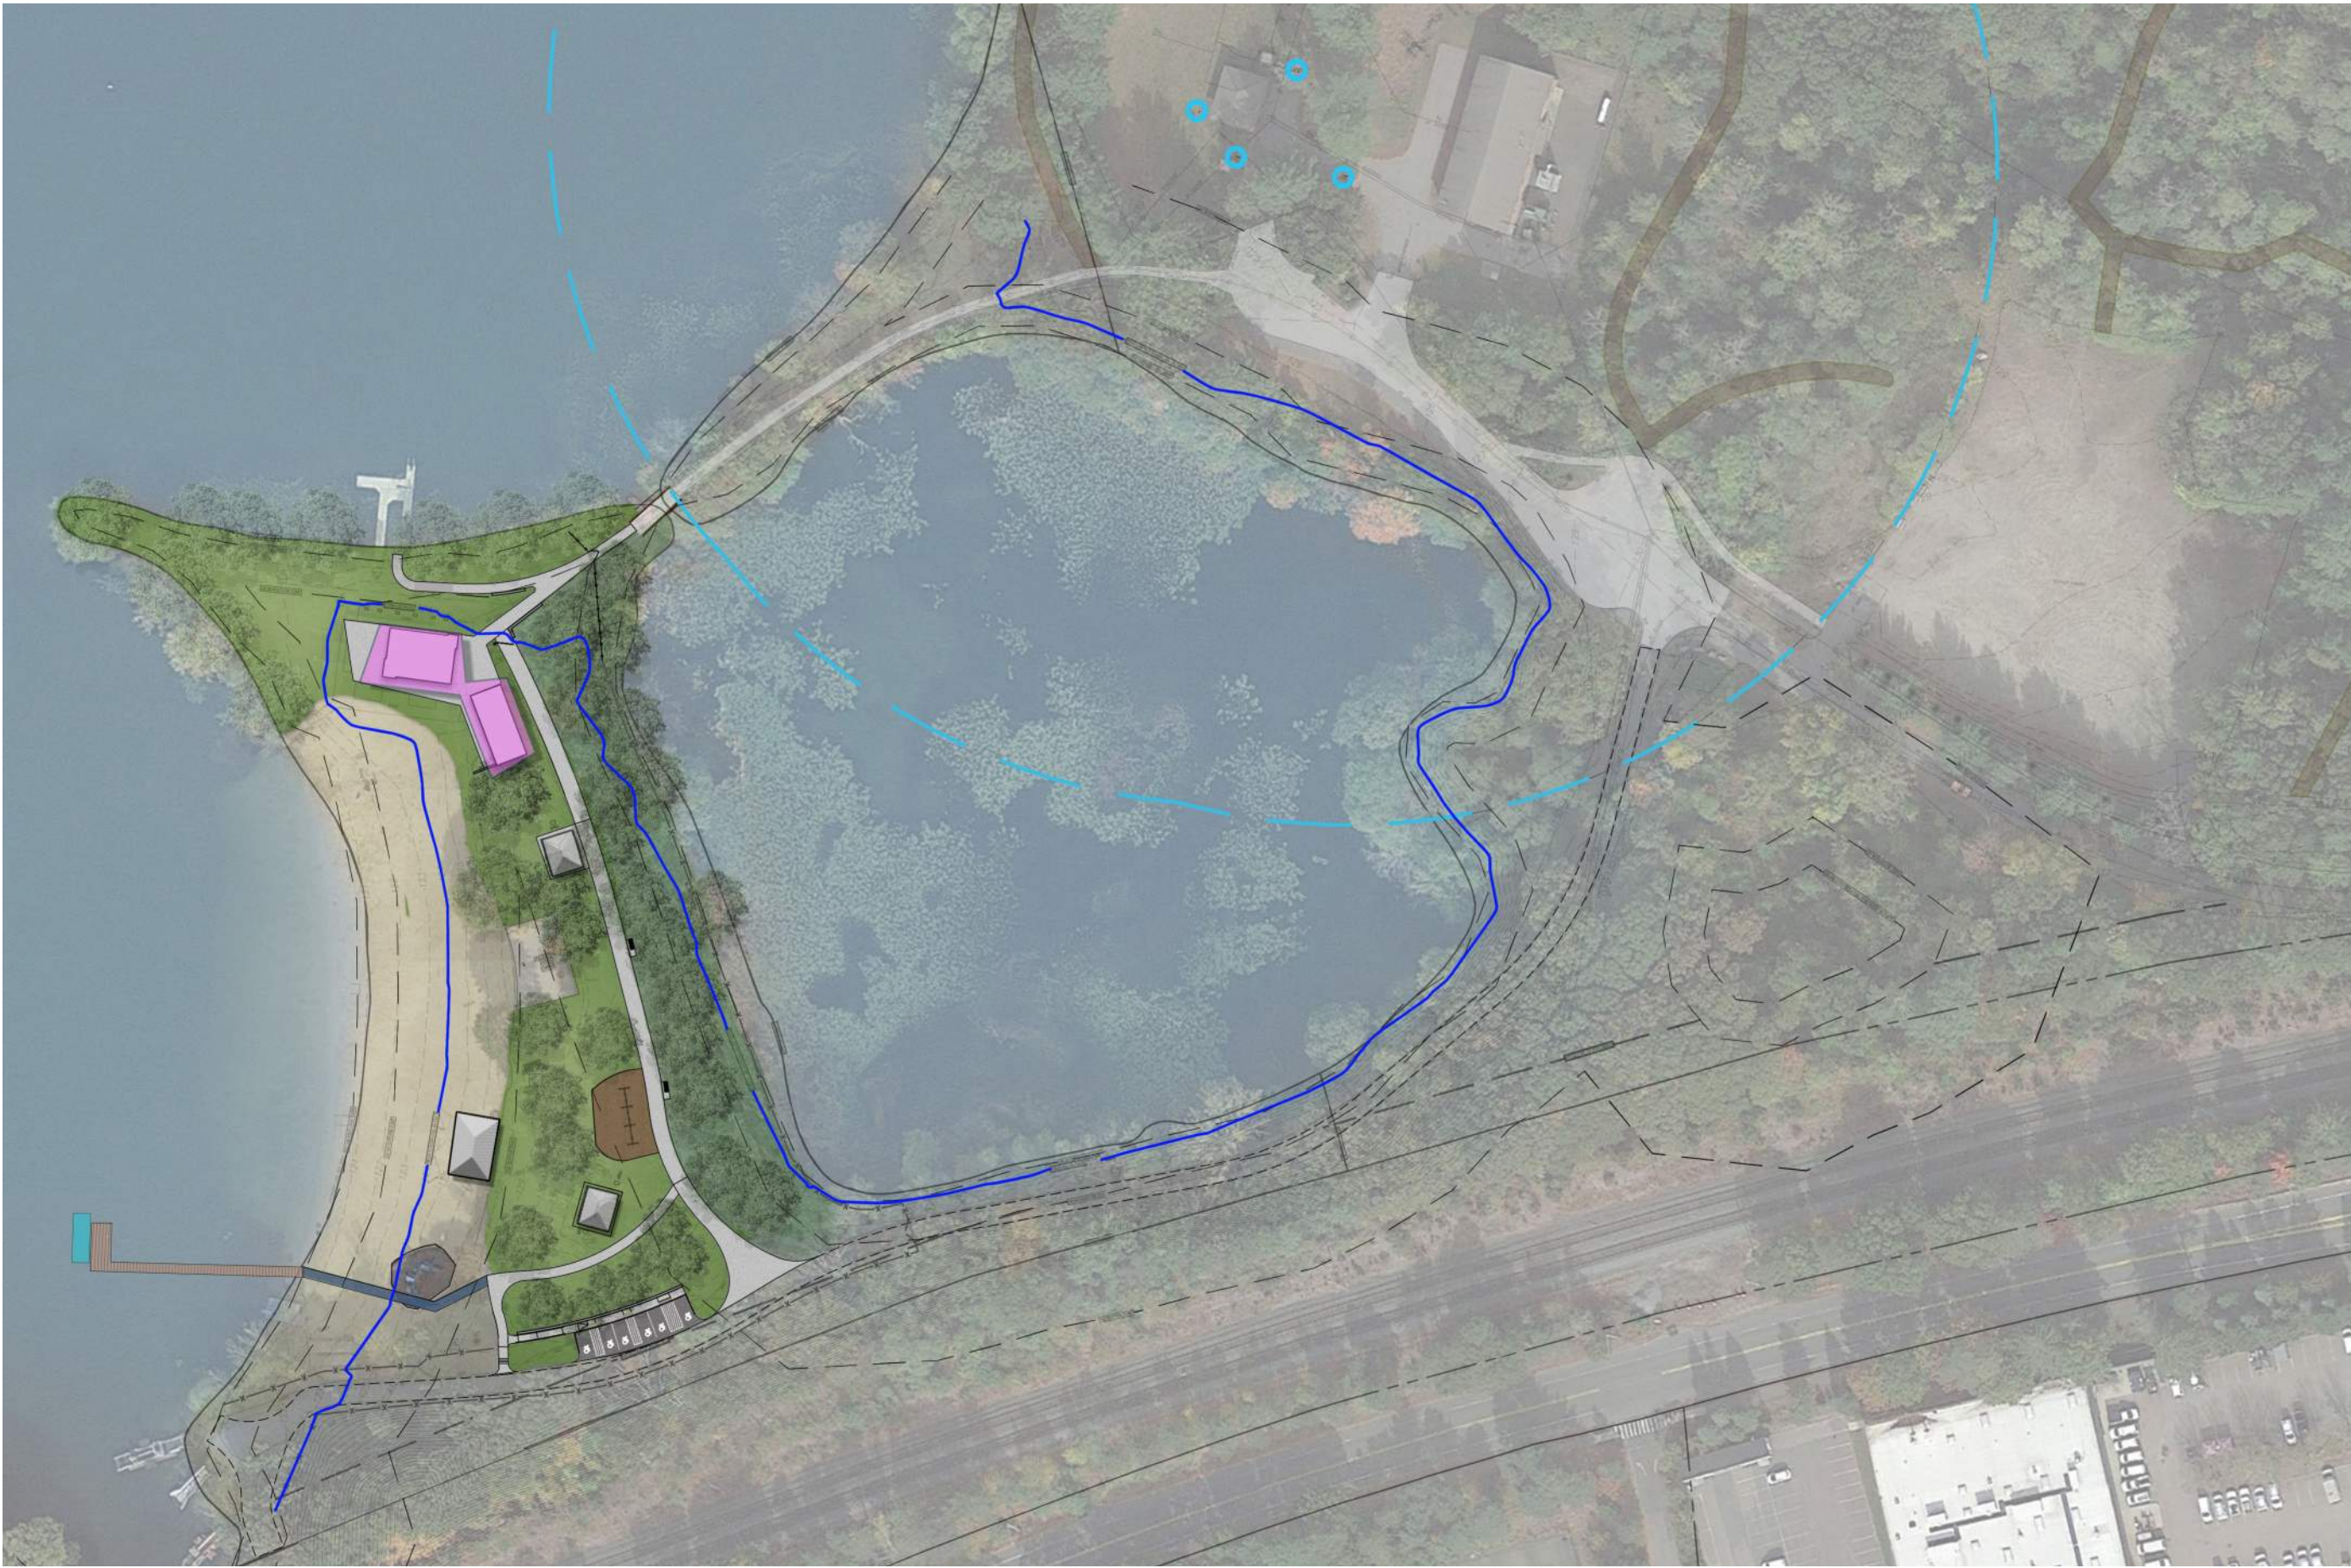
**ALTERNATIVE B: NEW NORTH SIDE
BUILDING DESIGN**

Reduced square footage buildings
located generally in the same
location as the existing bathhouse
building (north side)

EXISTING CONDITIONS PLAN	ALTERNATIVE B: NEW NORTH SIDE BUILDING	NET CHANGE
IMPERVIOUS AREA - INSIDE 100' WET-LAND BUFFER	24,074 sf	22,881 sf	-1,193 sf
PERVIOUS AREA - INSIDE 100' WETLAND BUFFER	134,501 sf	135,694 sf	+1,193 sf
TOTAL IMPERVIOUS AREA	28,715 sf	29,399 sf	+684 sf
TOTAL PERVIOUS AREA	158,645 sf	157,961 sf	-684 sf
BUILDING SQUARE FOOTAGE	2,572 sf	2,230 sf	-342 sf
BUILDING LOCATION	North side	North side	N/A
OVERALL CUT / FILL	N/A	438 cy cut / 82 cy fill	356 cy net cut
CUT / FILL WITHIN THE 100 YR. FEMA FLOODPLAIN	N/A	54 cy cut, 13 cy fill	41 cy net fill
DEDICATED LAWN AREA	+/- 22,220 sf	+/- 21,328 sf	-892 sf
AMENITIES TO REMAIN	N/A	<ul style="list-style-type: none">• Beach pavilion• Both permanent pavilions• Floating docks• Play structure• Swing Set• Volleyball court	6
RELOCATED AMENITIES	N/A	N/A	N/A
REMOVED AMENITIES	N/A	N/A	N/A
ADDED AMENTIES	N/A	<ul style="list-style-type: none">• Accessible beach mats	<ul style="list-style-type: none">• Accessible beach mats

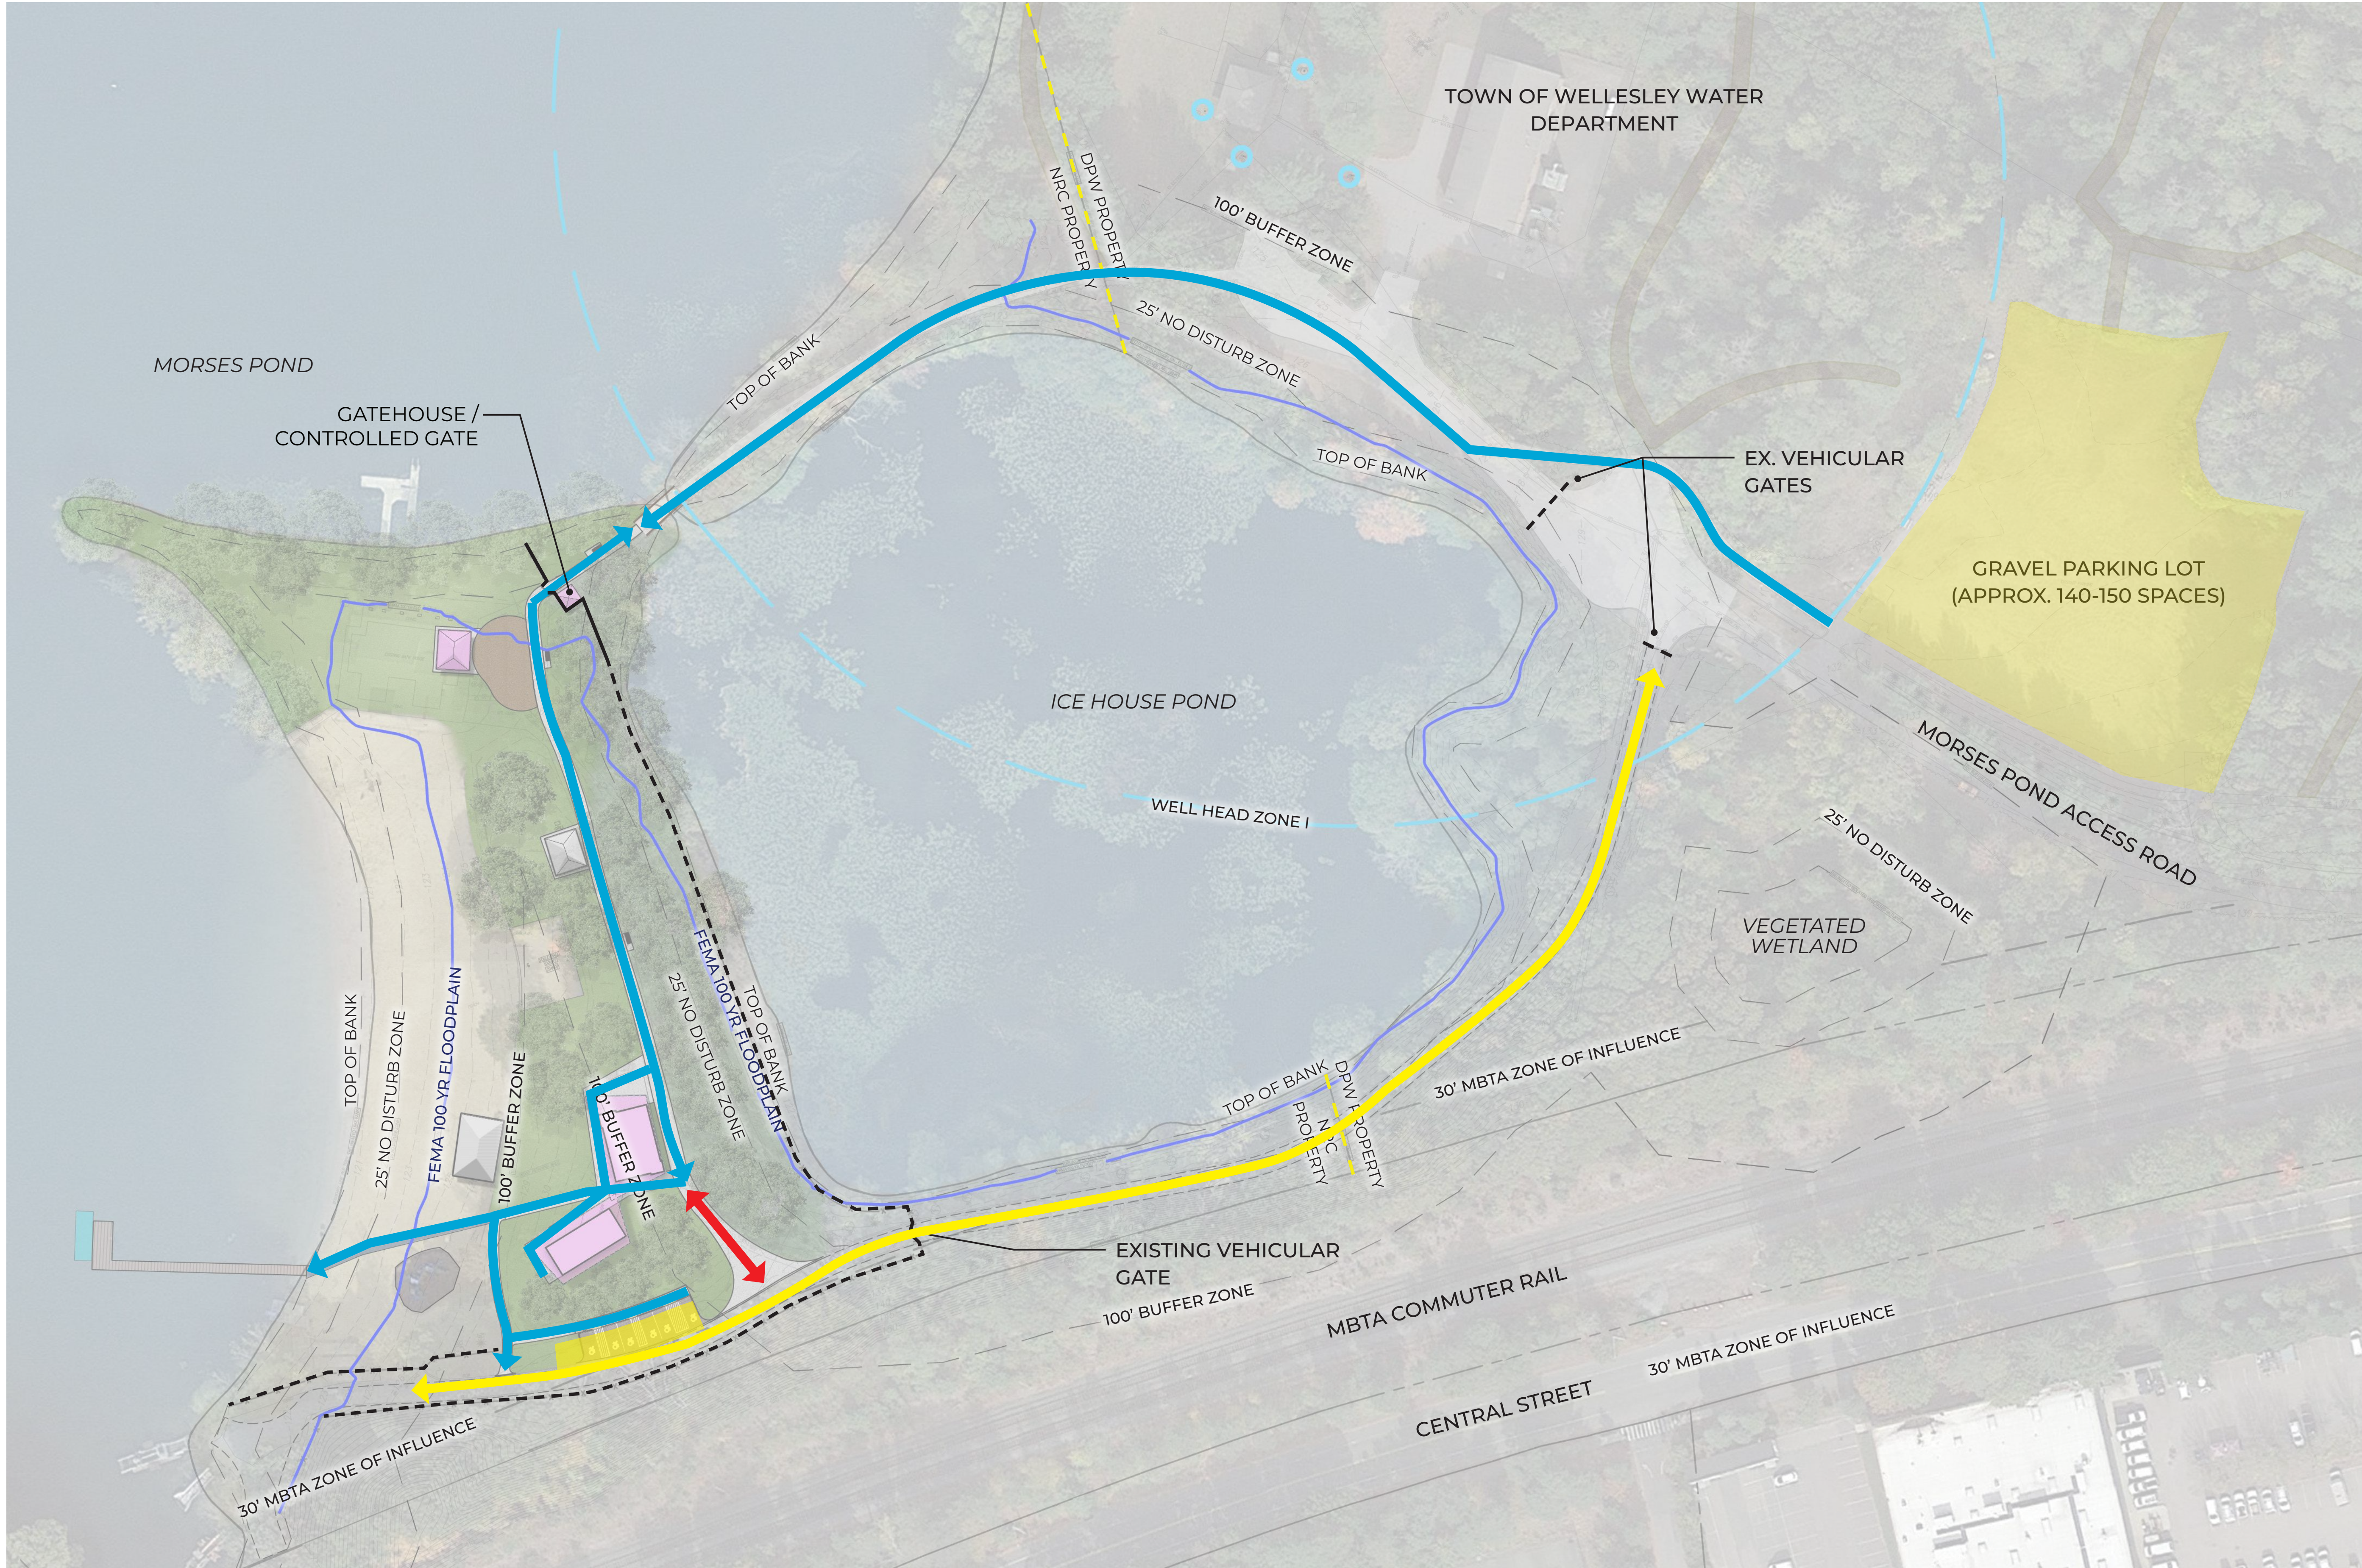
ALTERNATIVE A: PEDESTRIAN AND VEHICULAR CIRCULATION

- EX. FENCE LINE
- ACCESSIBLE PEDESTRIAN ROUTE (< 5%)
- NON-ACCESSIBLE PEDESTRIAN ROUTE (> 5%)
- VEHICULAR ROUTE
- EX. PARKING AREA
- PROPOSED ACCESSIBLE PARKING
- PR. FENCELINE
