MORSES POND BEACH & BATHHOUSE IMPROVEMENTS
SUPPLEMENTARY FEASIBILITY STUDY
TASK 7: BUILDING LOCATION ANALYSIS

EXISTING CONDITIONS PLAN: **SITE HISTORY AS A TOWN BEACH**

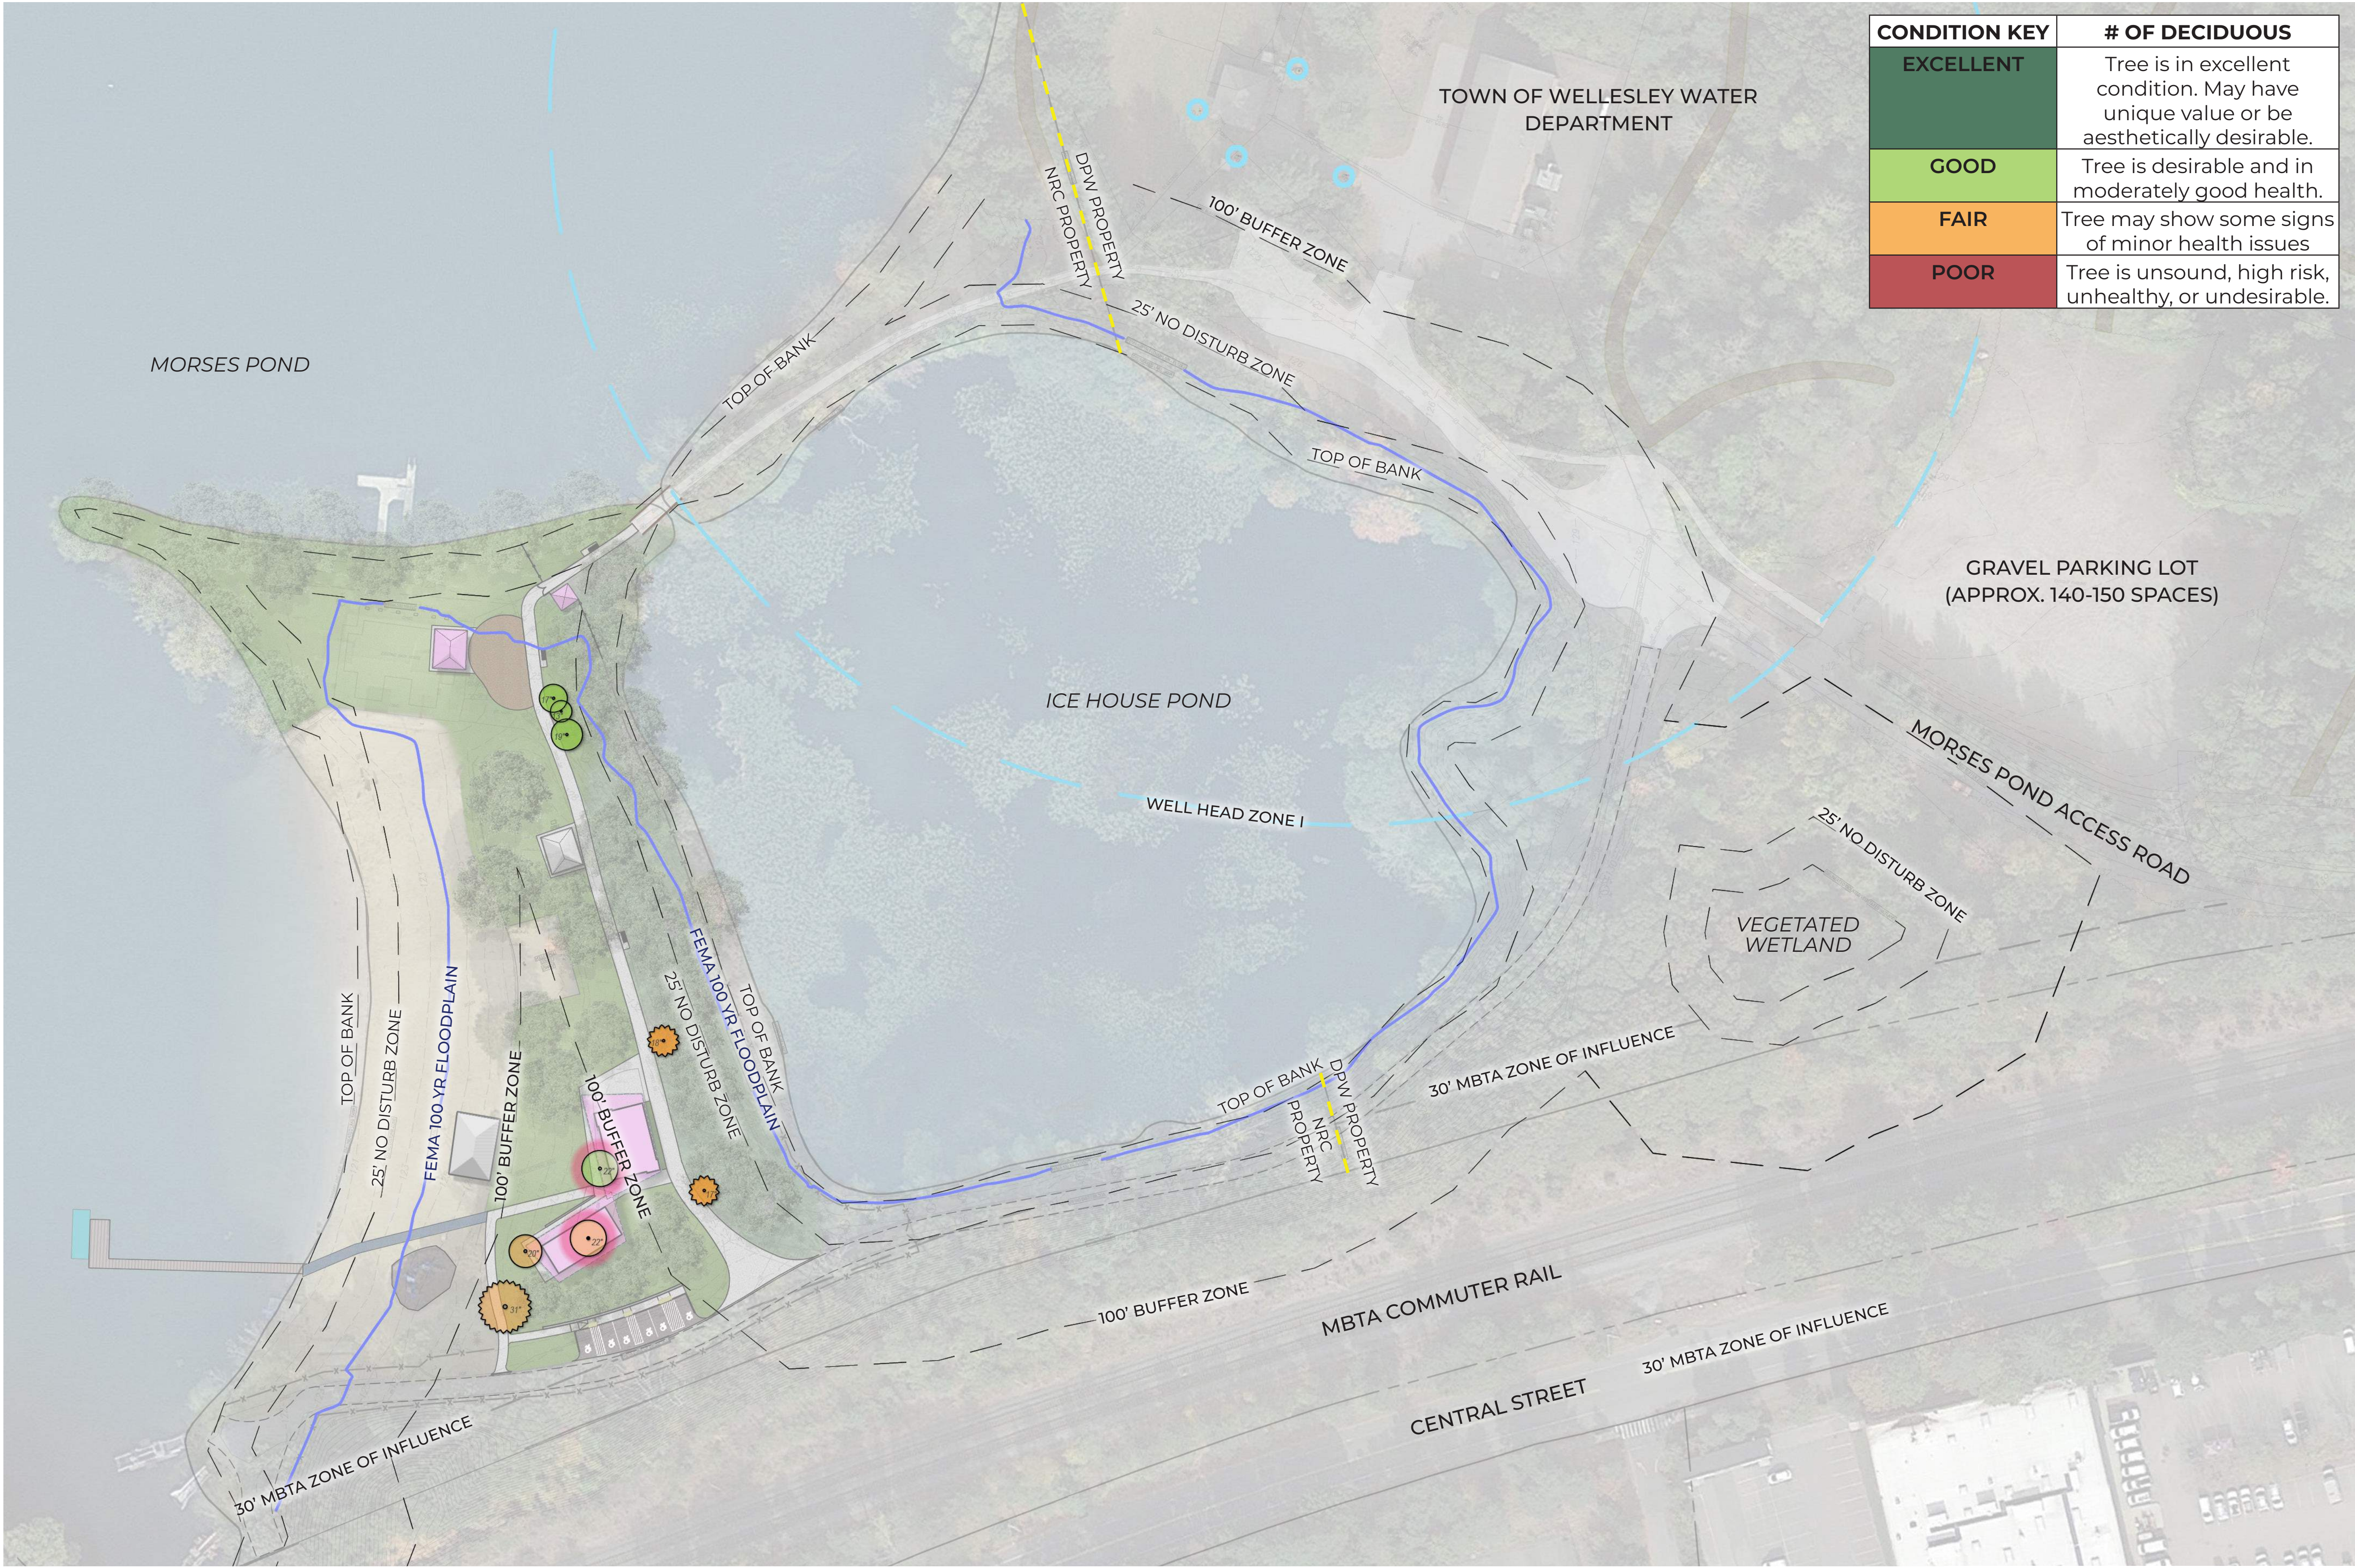
ALTERNATIVE A: TREE IMPACTS

CONDITION KEY	# OF DECIDUOUS
EXCELLENT	Tree is in excellent condition. May have unique value or be aesthetically desirable.
GOOD	Tree is desirable and in moderately good health.
FAIR	Tree may show some signs of minor health issues.
POOR	Tree is unsound, high risk, unhealthy, or undesirable.

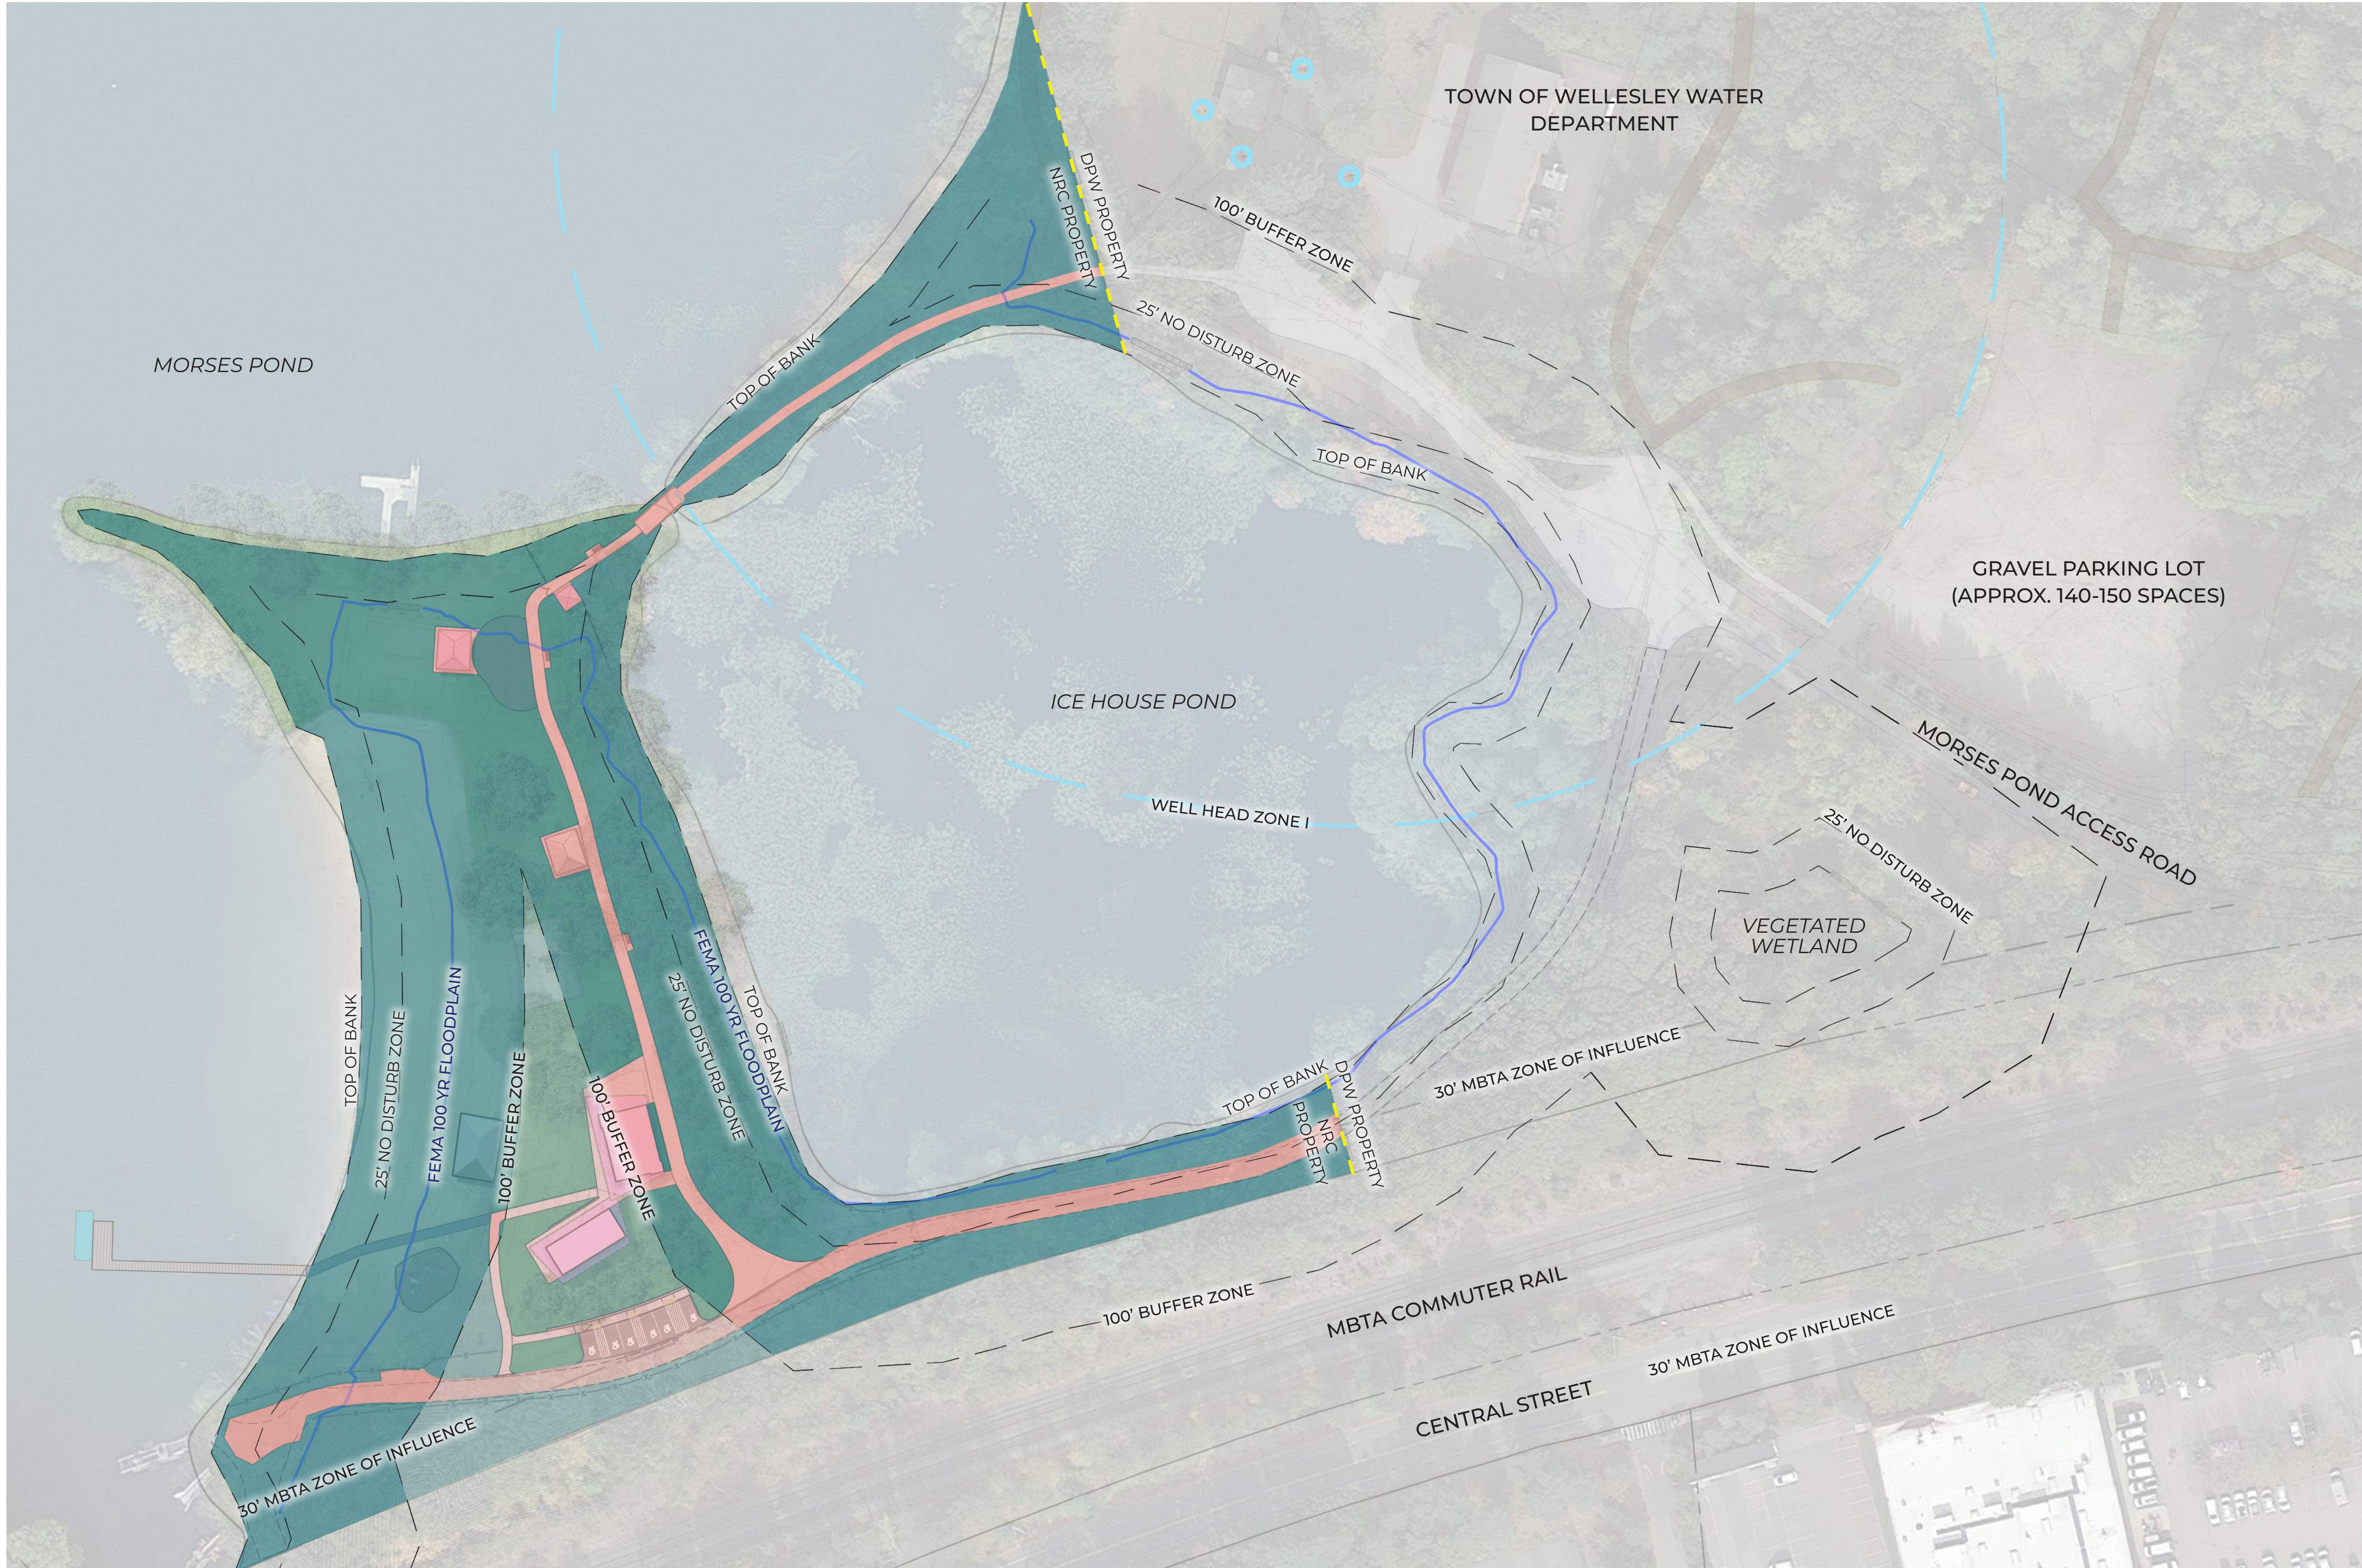
ALTERNATIVE A: IMPERVIOUS / PERVIOUS COVER

LEGEND	
19,447 sf	IMPERVIOUS AREA - INSIDE 100' WETLAND BUFFER
8,384 sf	IMPERVIOUS AREA - OUTSIDE 100' WETLAND BUFFER
139,128 sf	PERVIOUS AREA - INSIDE 100' WETLAND BUFFER
20,401 sf	PERVIOUS AREA - OUTSIDE 100' WETLAND BUFFER

EXISTING CONDITIONS PLAN	ALTERNATIVE A: MODIFIED SOUTH SIDE BUILDING	NET CHANGE
IMPERVIOUS AREA - INSIDE 100' WETLAND BUFFER	24,074 sf	19,447 sf	-4,627 sf
PERVIOUS AREA - INSIDE 100' WETLAND BUFFER	134,501 sf	139,128 sf	+4,627 sf
TOTAL IMPERVIOUS AREA	28,715 sf	27,831 sf	-884 sf
TOTAL PERVIOUS AREA	158,645 sf	159,529 sf	+884 sf
BUILDING SQUARE FOOTAGE	2,572 sf	2,230 sf	-342 sf
BUILDING LOCATION	North side	South side	N/A
OVERALL CUT / FILL	N/A	835 cy cut / 31 cy fill	803 cy net cut
CUT / FILL WITHIN THE 100 YR. FEMA FLOODPLAIN	N/A	10 cy cut/ 24 cy fill	14 cy net fill
DEDICATED LAWN AREA	+/- 22,220 sf	+/- 26,250 sf	+4,030 sf
AMENITIES TO REMAIN	N/A	<ul style="list-style-type: none">• Beach pavilion• Floating docks• Play structure• Volleyball court• Northern permanent pavilion	<ul style="list-style-type: none">• Beach pavilion• Floating docks• Play structure• Volleyball court• Northern permanent pavilion

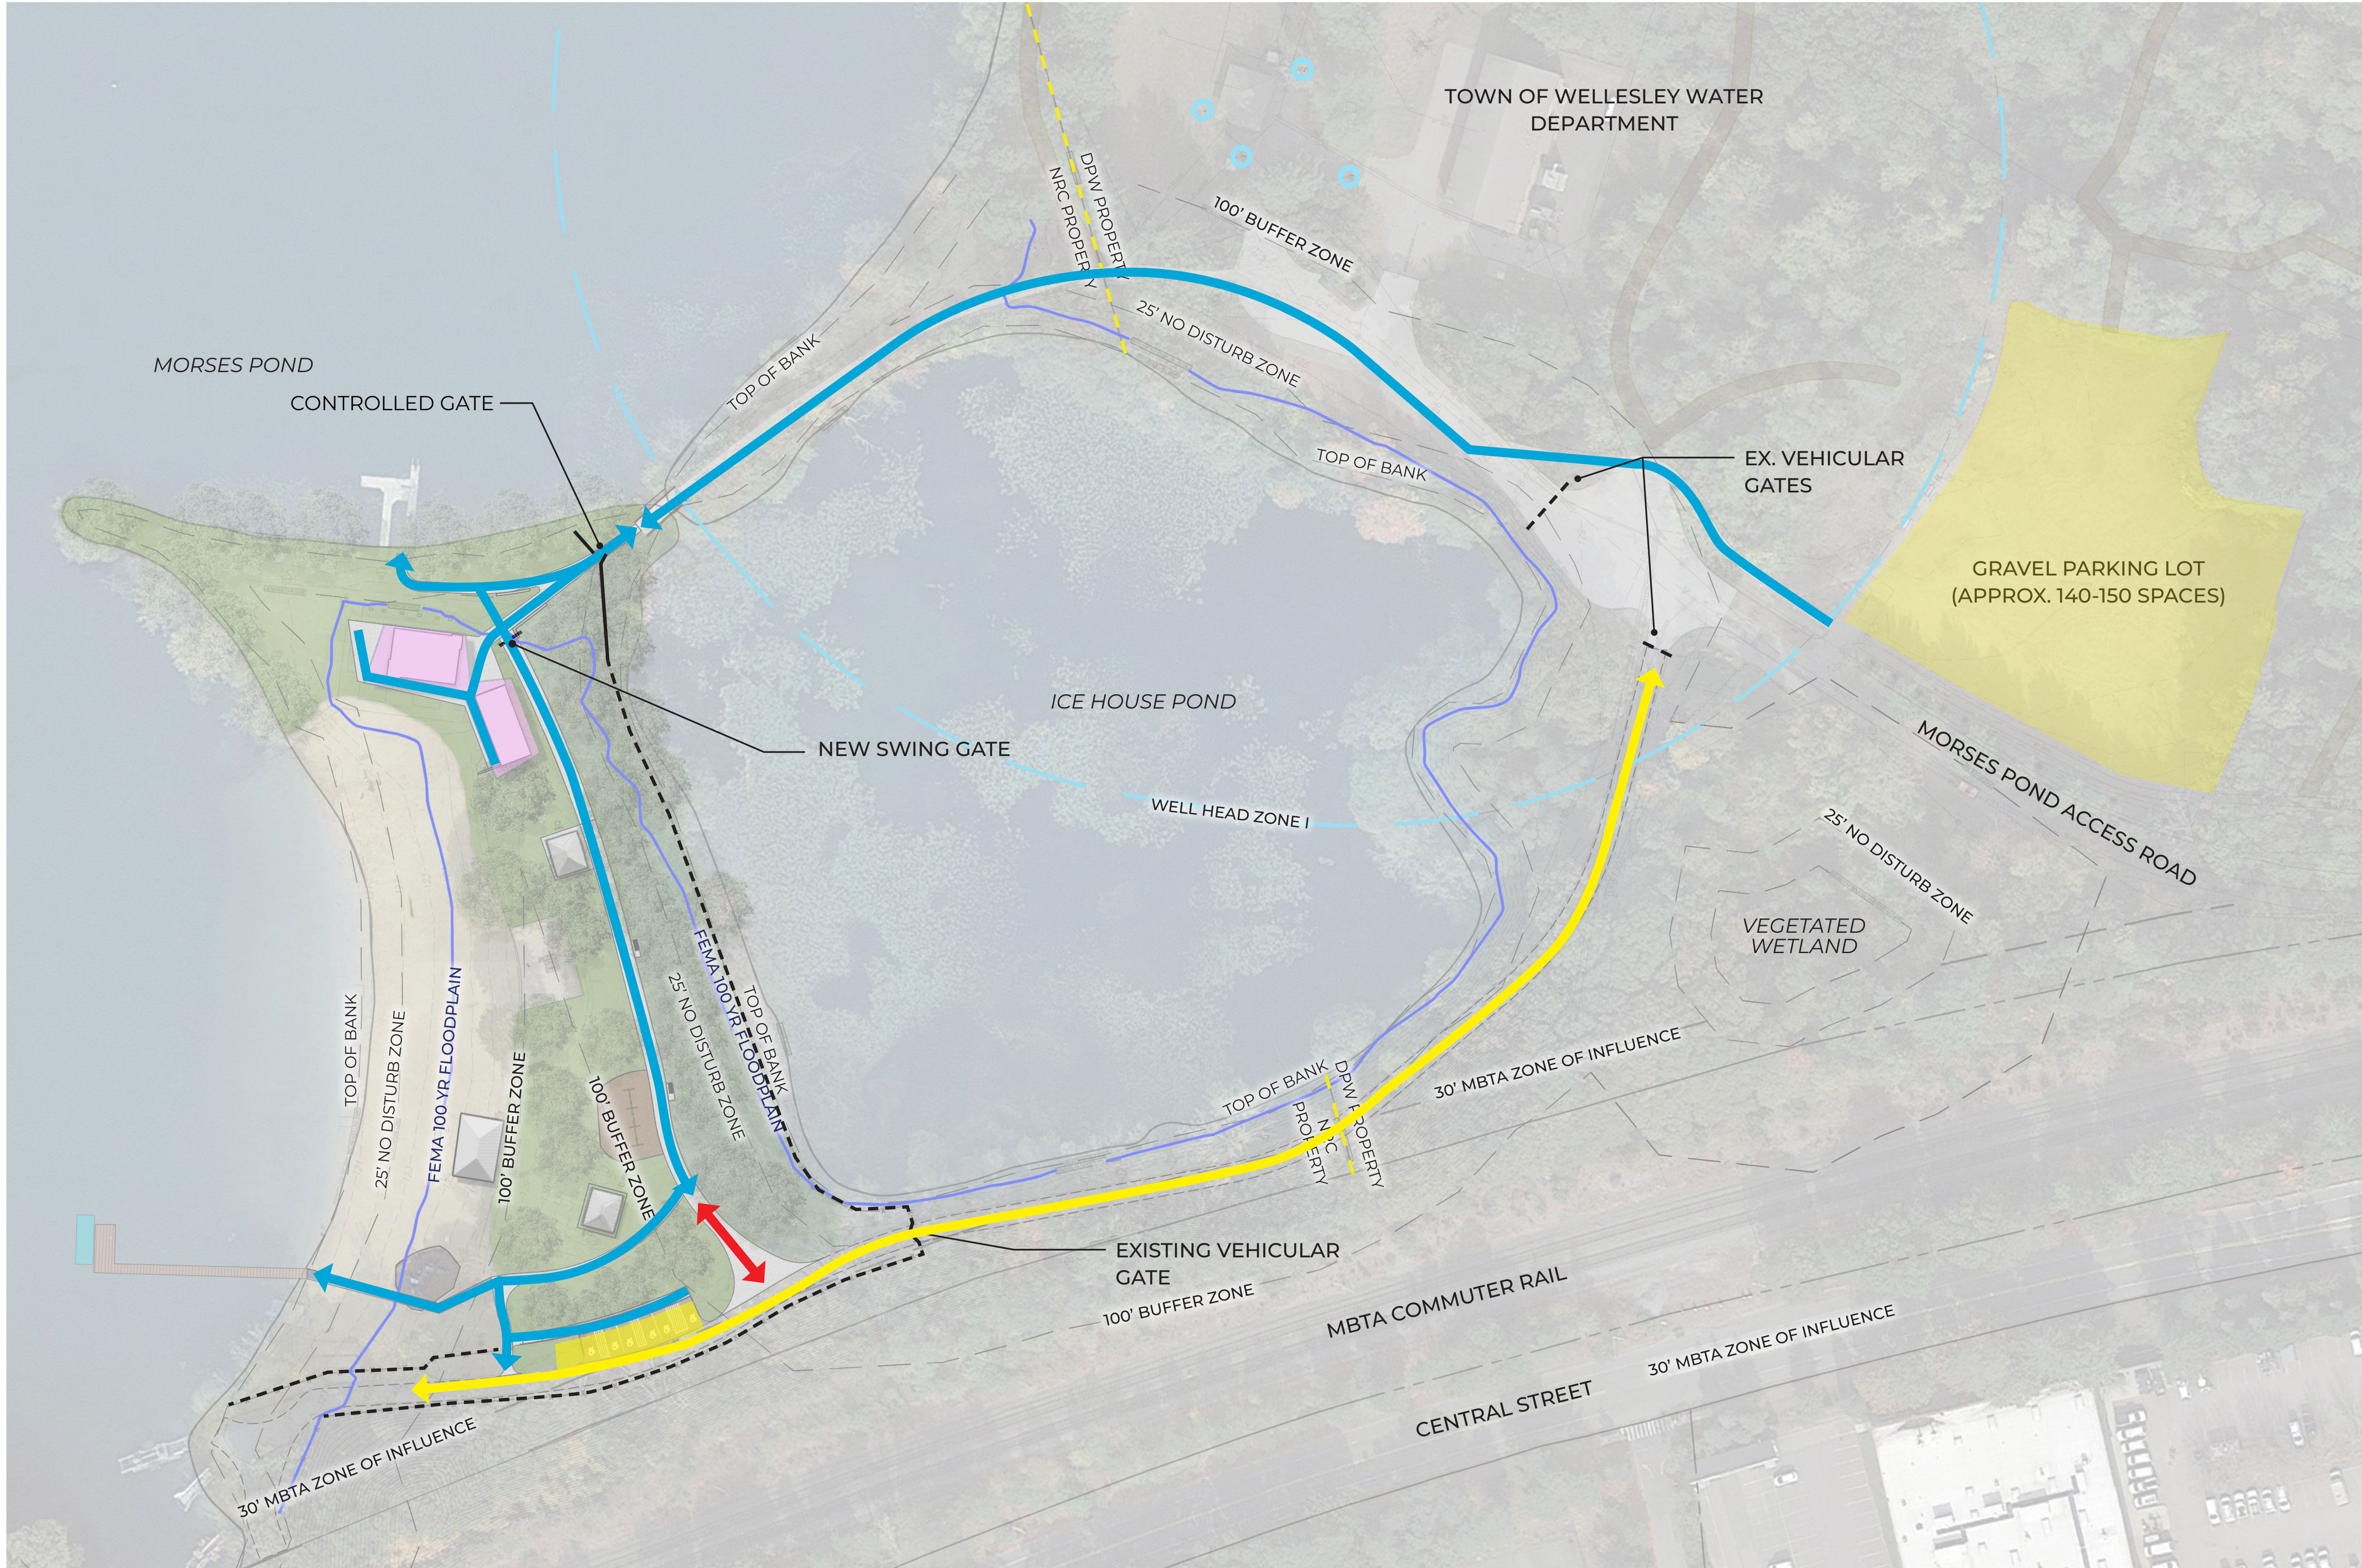
ALTERNATIVE B: PEDESTRIAN AND VEHICULAR CIRCULATION

- EX. FENCE LINE
- ↔ ACCESSIBLE PEDESTRIAN ROUTE (< 5%)
- ↔ NON-ACCESSIBLE PEDESTRIAN ROUTE (> 5%)
- ↔ VEHICULAR ROUTE
- EX. PARKING AREA
- PROPOSED ACCESSIBLE PARKING
- PR. FENCELINE

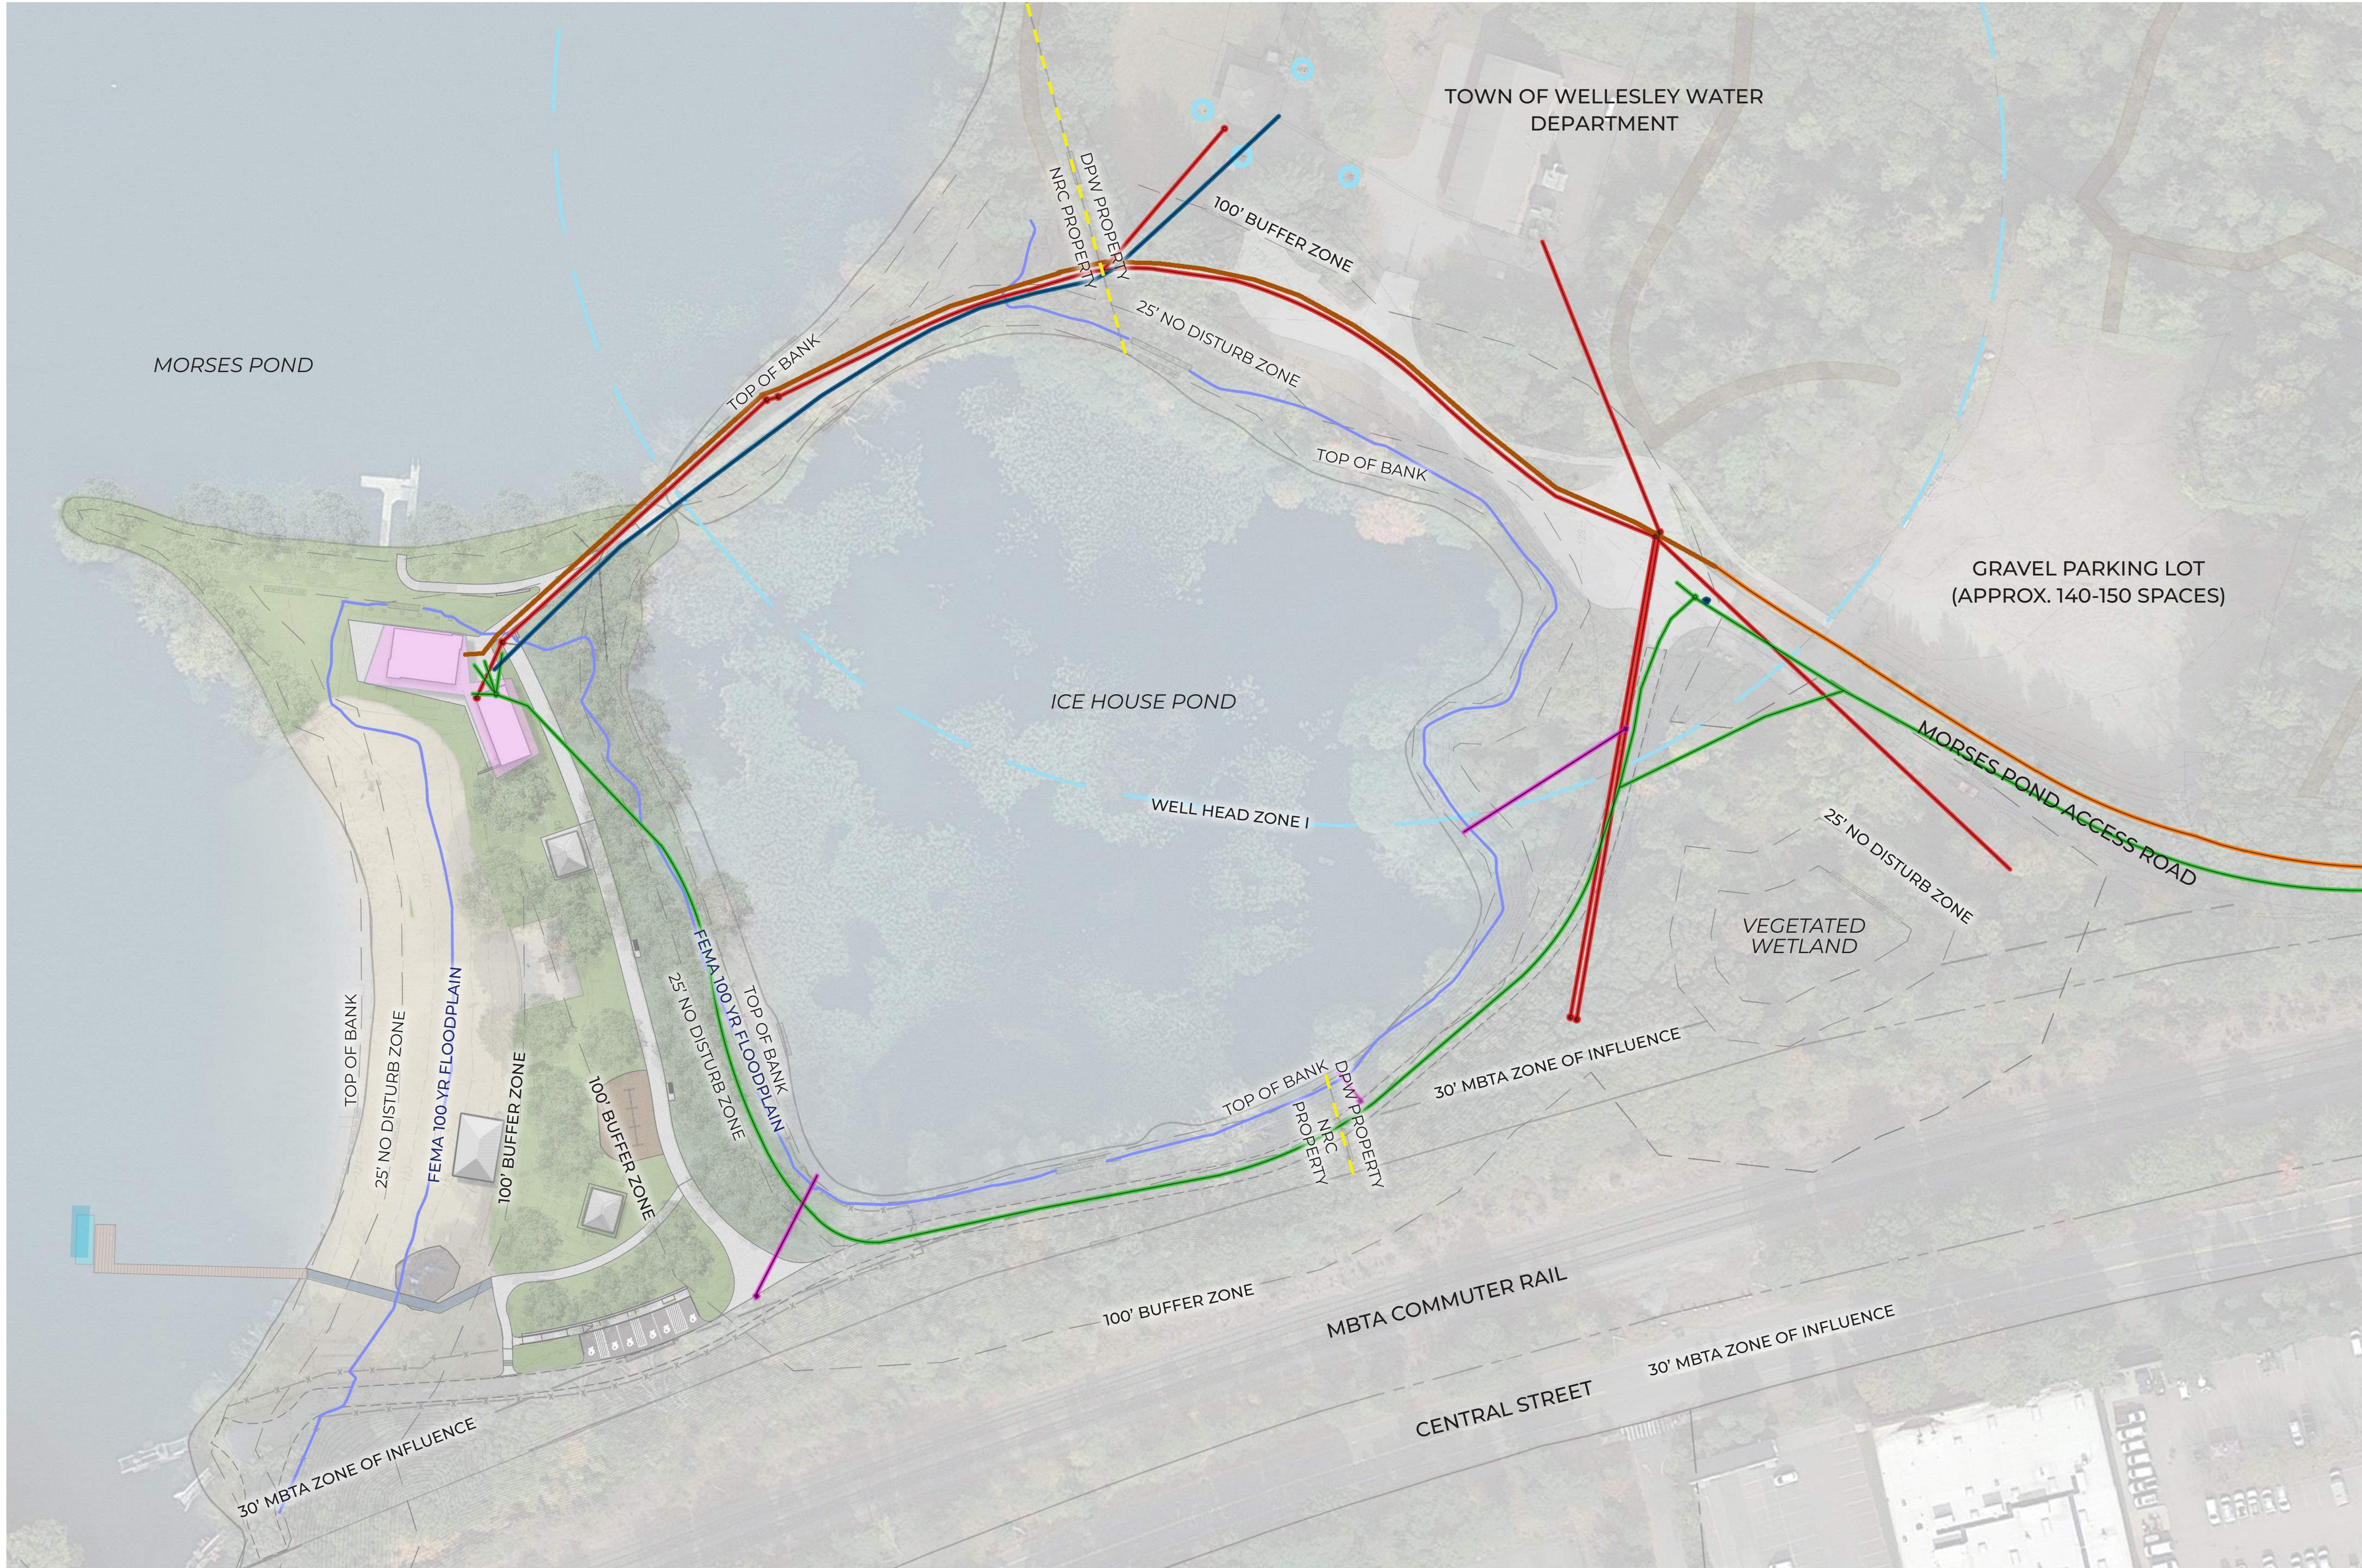
ALTERNATIVE B: UTILITIES

WATER	EX. WATER LINE
SEWER	EX. SANITARY SEWER LINE
STORM	EX. STORM DRAINAGE
ELECTRICAL	EX. ELECTRICAL CONDUIT
COMMUNICATIONS	EX. COMMUNICATIONS LINE
CABLE	EX. CABLE LINE FOR INTERNET

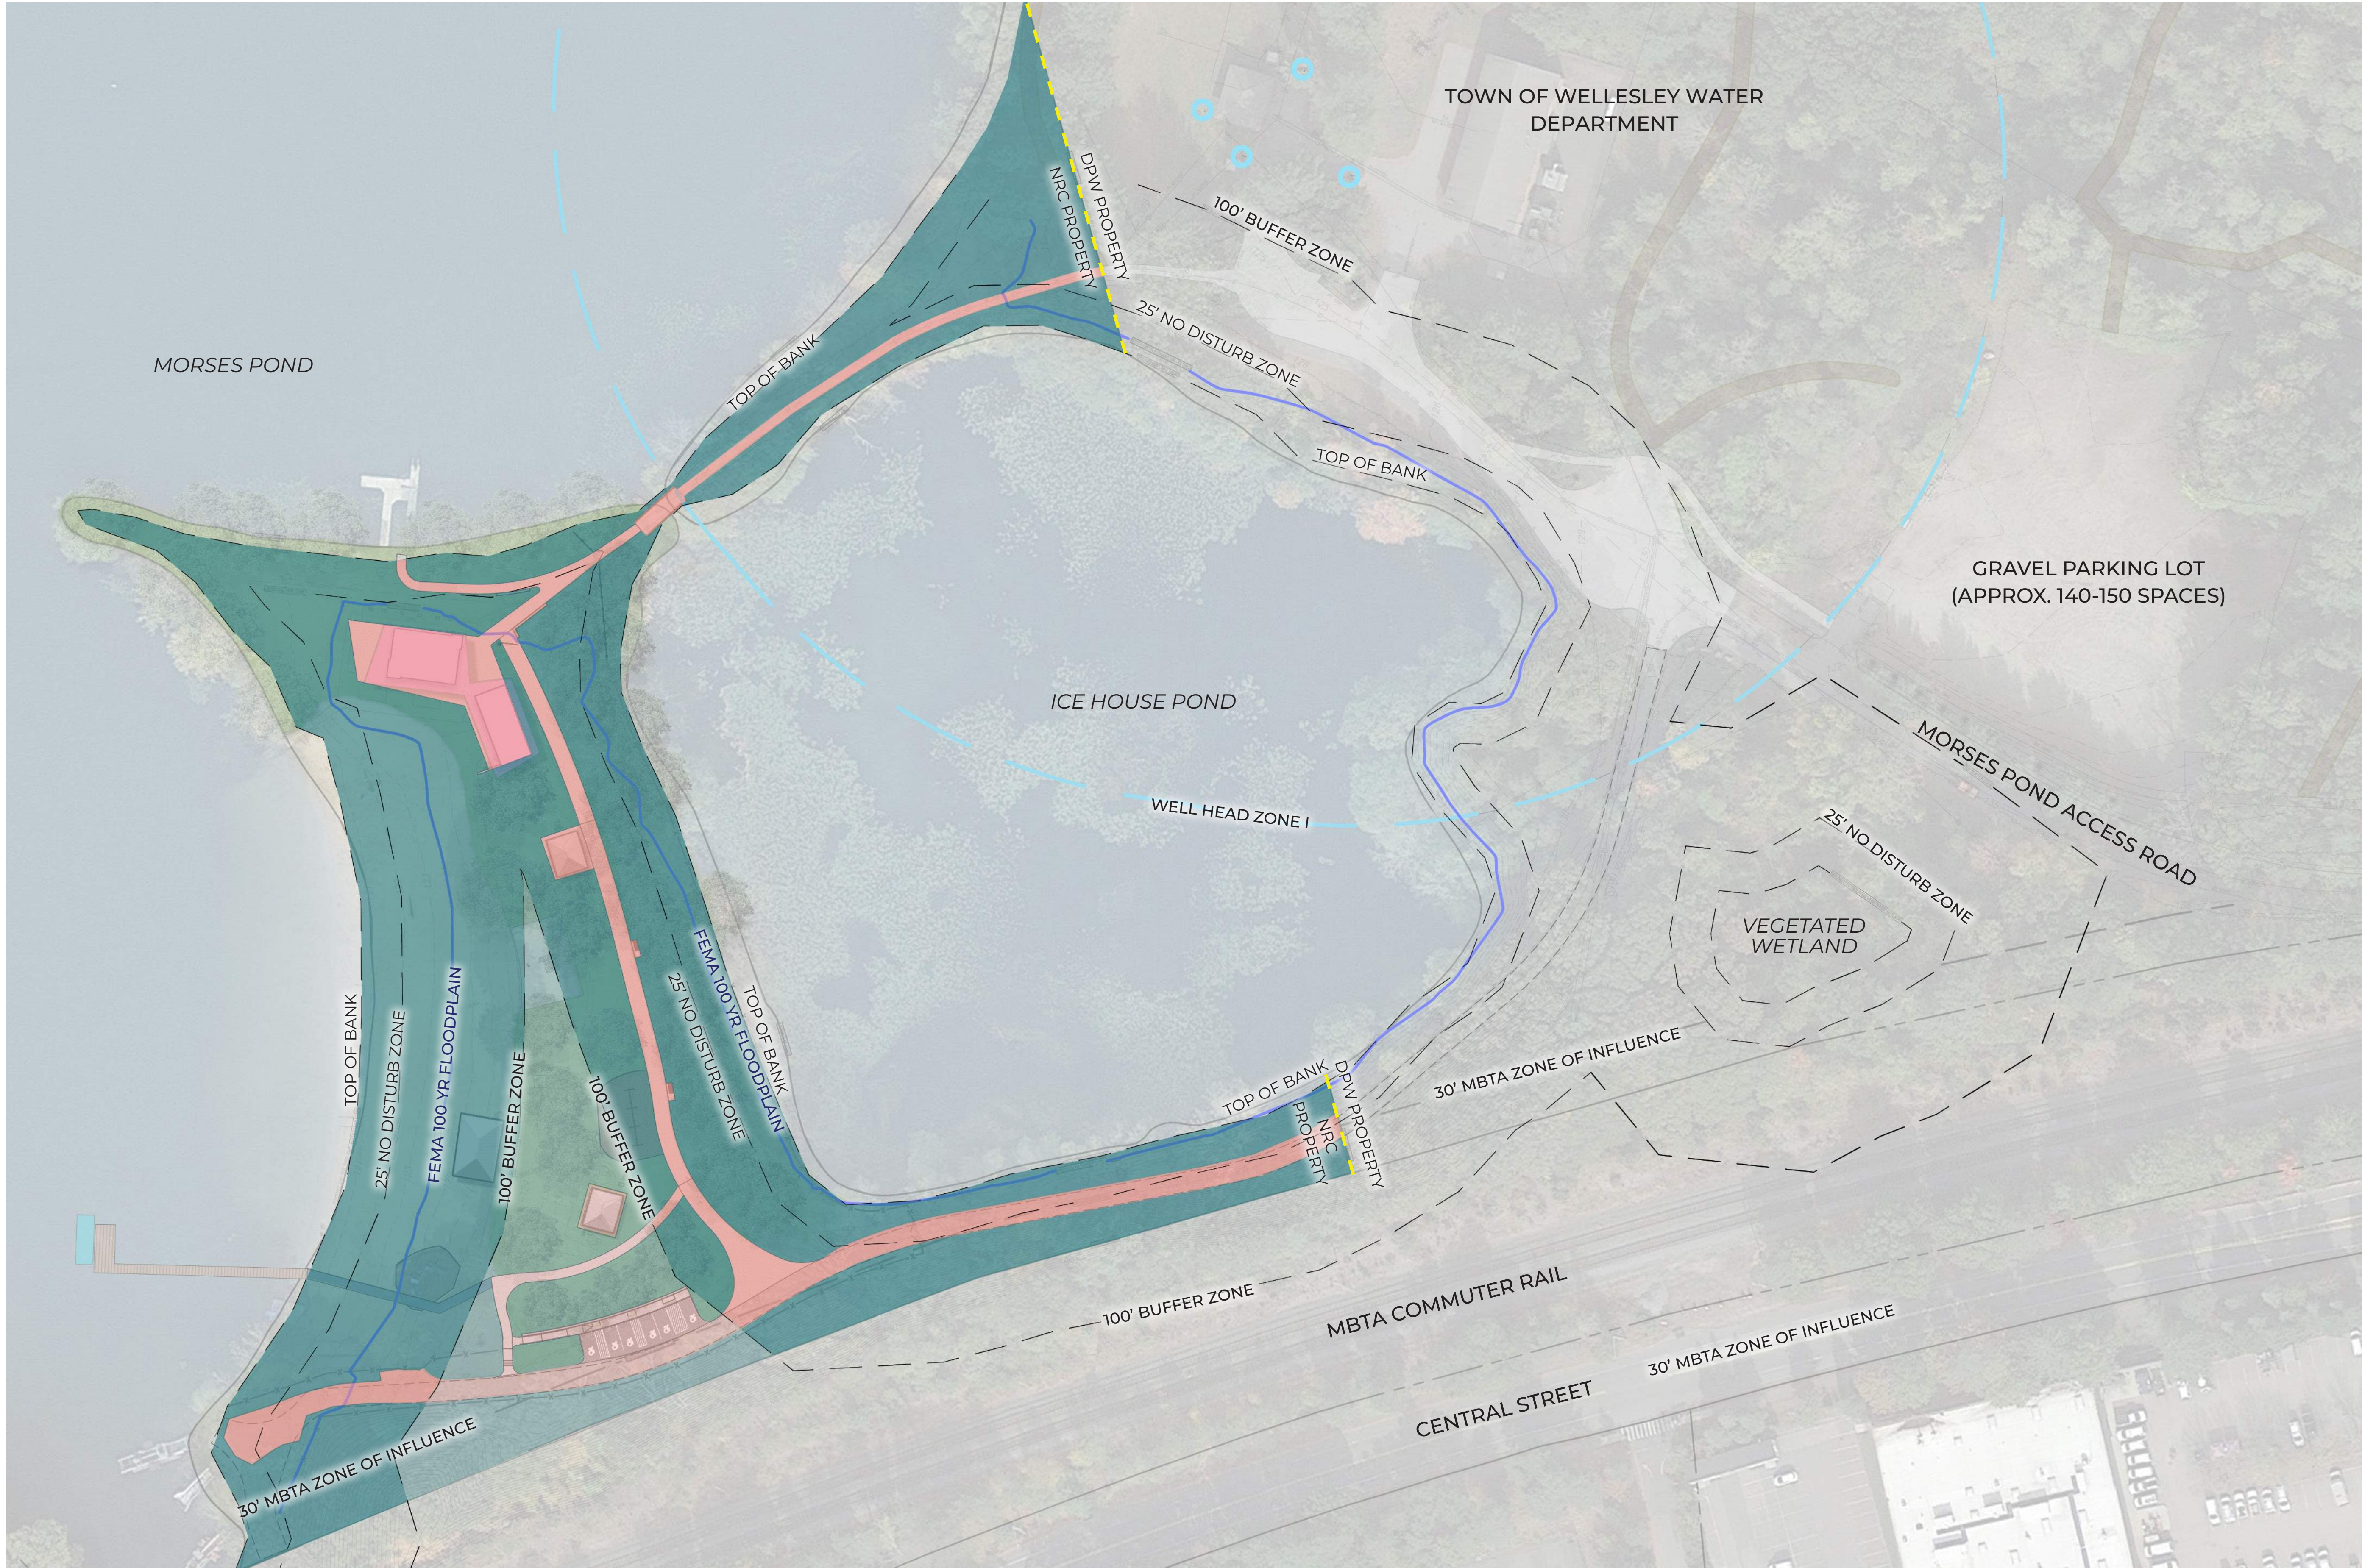
ALTERNATIVE B: IMPERVIOUS / PERVIOUS COVER

LEGEND	
22,881 sf	IMPERVIOUS AREA - INSIDE 100' WETLAND BUFFER
6,518 sf	IMPERVIOUS AREA - OUTSIDE 100' WETLAND BUFFER
135,694 sf	PERVIOUS AREA - INSIDE 100' WETLAND BUFFER
22,267 sf	PERVIOUS AREA - OUTSIDE 100' WETLAND BUFFER

EXISTING CONDITIONS PLAN	ALTERNATIVE B: NEW NORTH SIDE BUILDING	NET CHANGE
IMPERVIOUS AREA - INSIDE 100' WET-LAND BUFFER	24,074 sf	22,881 sf	-1,193 sf
PERVIOUS AREA - INSIDE 100' WETLAND BUFFER	134,501 sf	135,694 sf	+1,193 sf
TOTAL IMPERVIOUS AREA	28,715 sf	29,399 sf	+684 sf
TOTAL PERVIOUS AREA	158,645 sf	157,961 sf	-684 sf
BUILDING SQUARE FOOTAGE	2,572 sf	2,230 sf	-342 sf
BUILDING LOCATION	North side	North side	N/A
OVERALL CUT / FILL	N/A	438 cy cut / 82 cy fill	356 cy net cut
CUT / FILL WITHIN THE 100 YR. FEMA FLOODPLAIN	N/A	54 cy cut, 13 cy fill	41 cy net fill
DEDICATED LAWN AREA	+/- 22,220 sf	+/- 21,328 sf	-892 sf
AMENITIES TO REMAIN	N/A	<ul style="list-style-type: none">• Beach pavilion• Both permanent pavilions• Floating docks• Play structure• Swing Set• Volleyball court	6
RELOCATED AMENITIES	N/A	N/A	N/A
REMOVED AMENITIES	N/A	N/A	N/A
ADDED AMENTIES	N/A	<ul style="list-style-type: none">• Accessible beach mats	<ul style="list-style-type: none">• Accessible beach mats
