MORSES POND BEACH & BATHHOUSE IMPROVEMENTS
SUPPLEMENTARY FEASIBILITY STUDY
TASK 7: BUILDING LOCATION ANALYSIS

EXISTING CONDITIONS PLAN: **SITE HISTORY AS A TOWN BEACH**

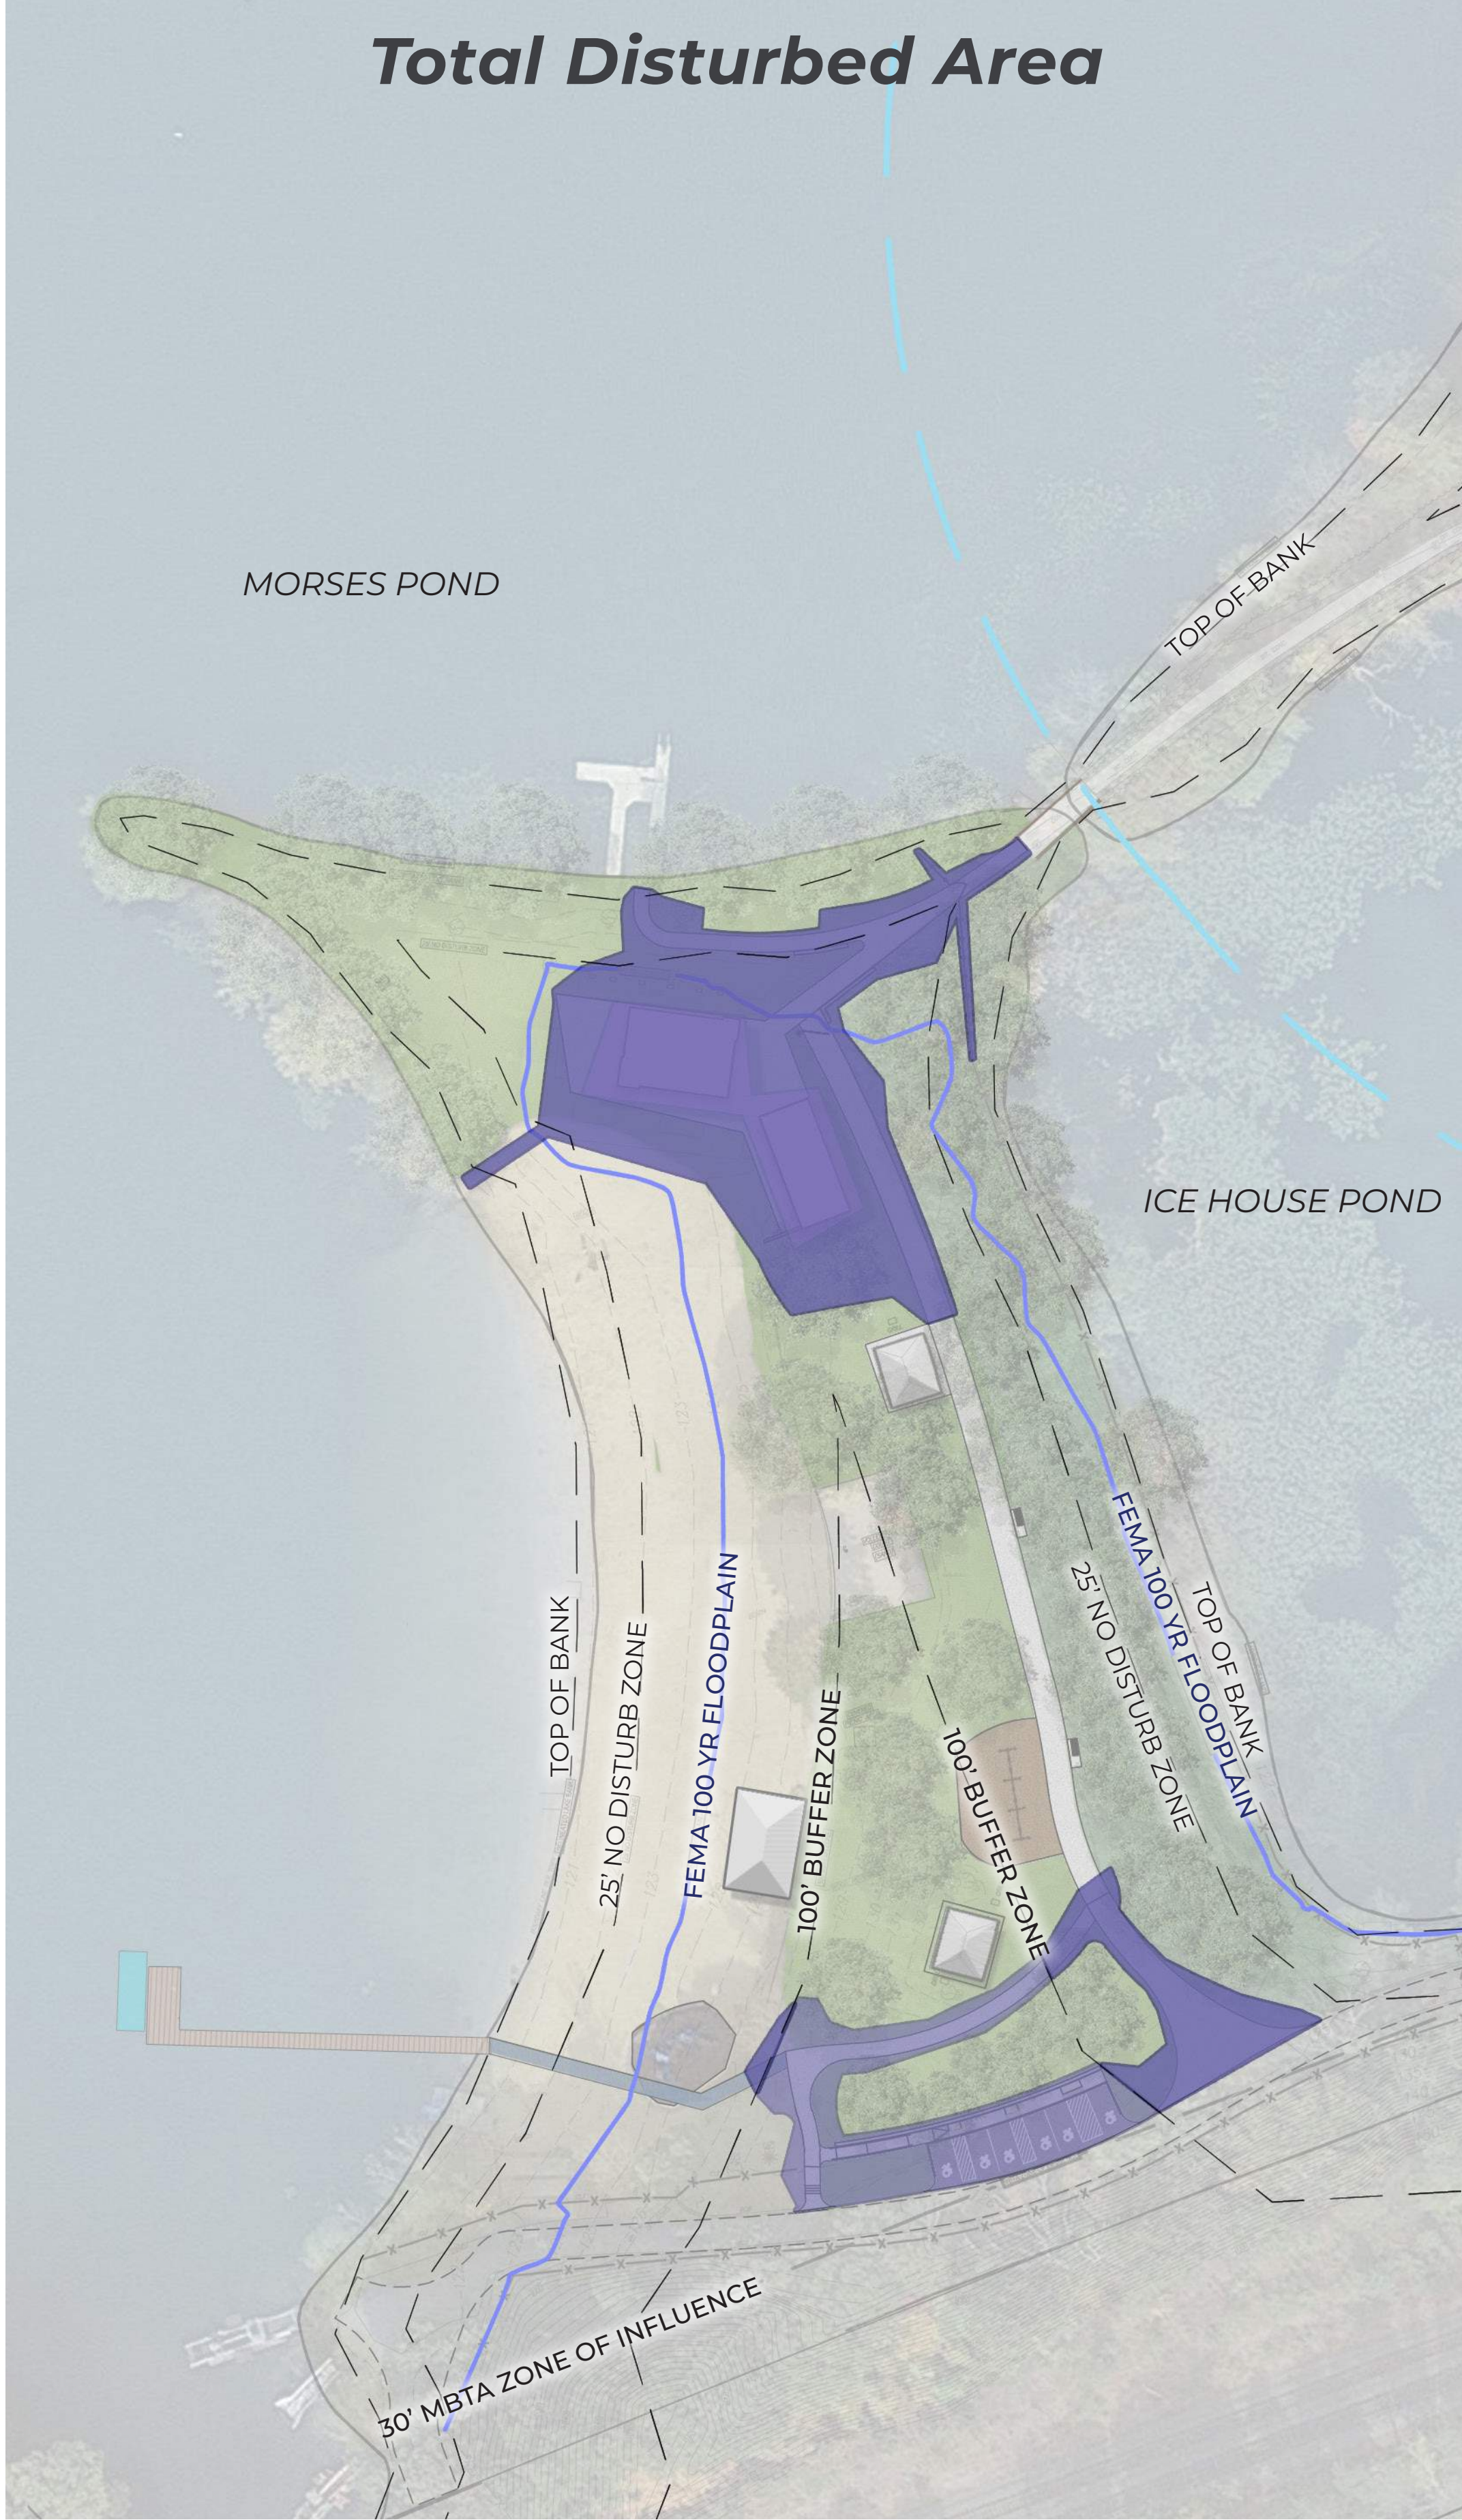
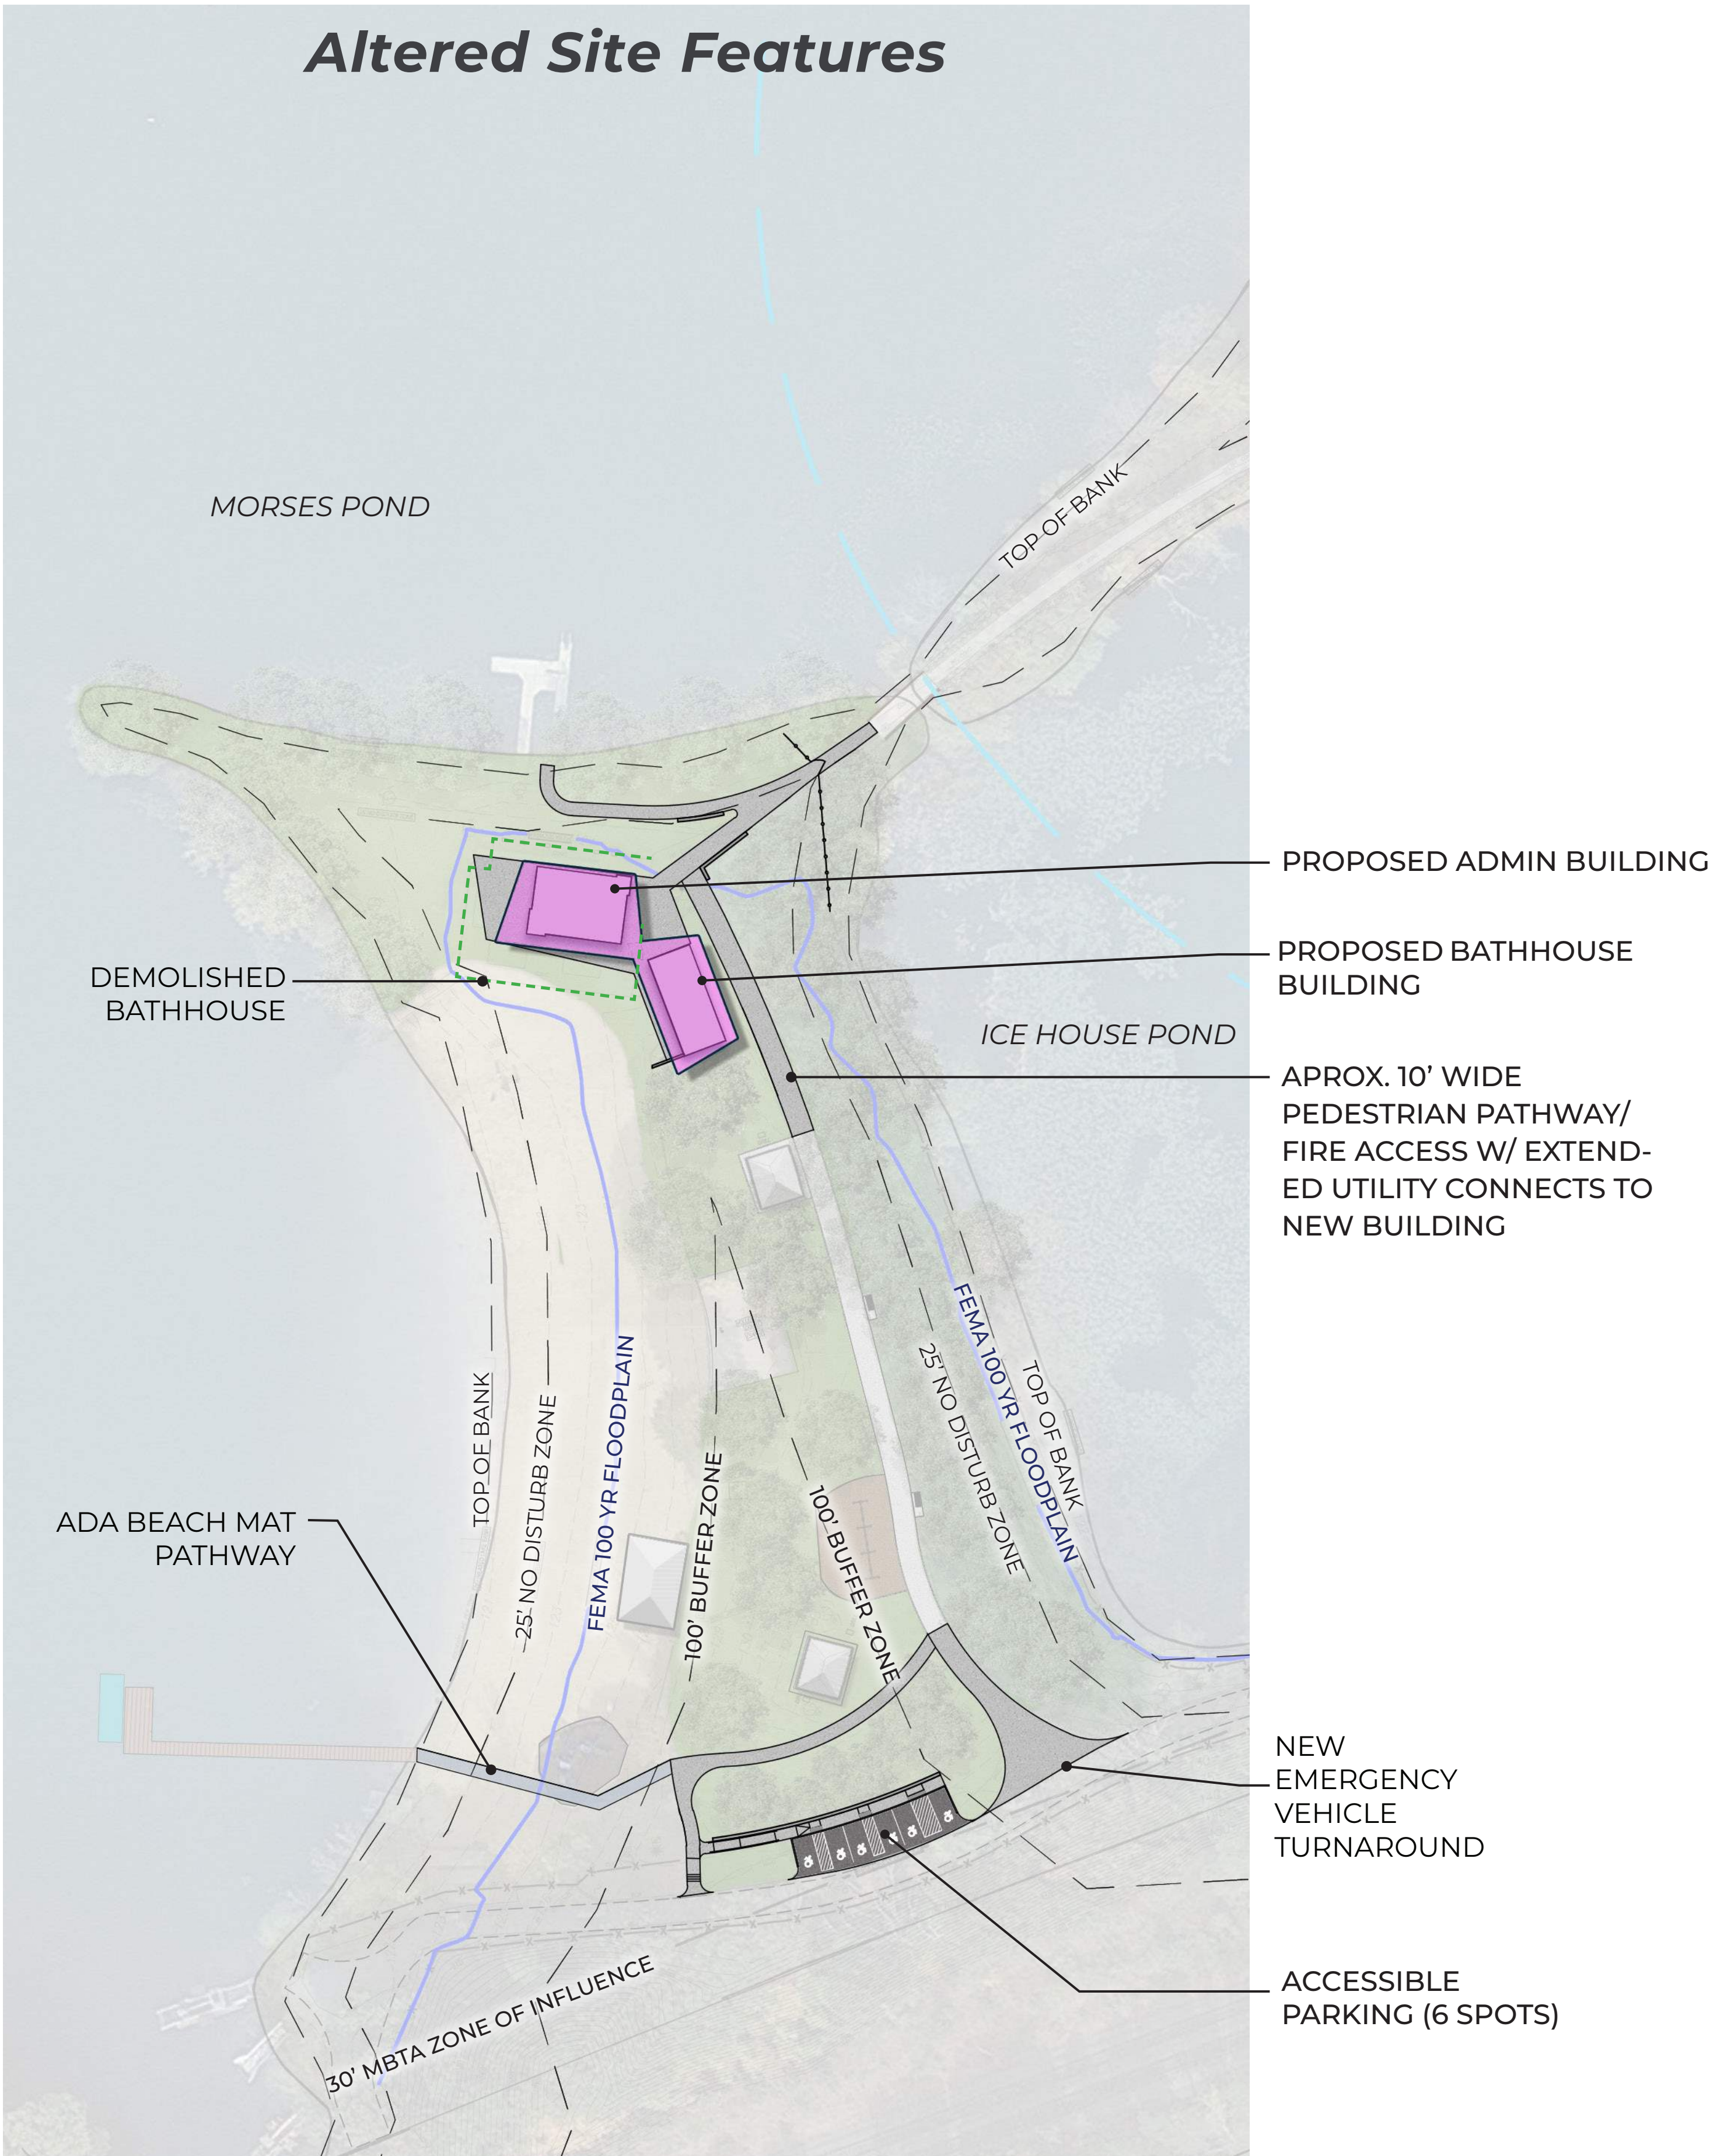
ALTERNATIVE B: OVERALL DISTURBANCE SUMMARY

19,638 sf	DISTURBED AREA - INSIDE 100' WETLAND BUFFER	5,877 sf	DISTURBED AREA - OUTSIDE 100' WETLAND BUFFER
------------------	--	-----------------	---

AREA OF DISTURBANCE	N/A	25,515 sf (19,638 inside 100' wetland buffer)	+25,515 sf
PERMITTING IMPACTS	N/A	<ul style="list-style-type: none">• Wildlife assessment is required (greater than 5,000 sf of alteration within the 100' wetland buffer)• A stormwater report may not be needed (net decrease in impervious within the 100' wetland buffer)• Minor compensatory storage is necessary within the 100 Yr. FEMA Floodplain (greater than 5,000 sf of alteration)• Planting one native replacement tree for each tree removed - 1 Native Trees Total	N/A

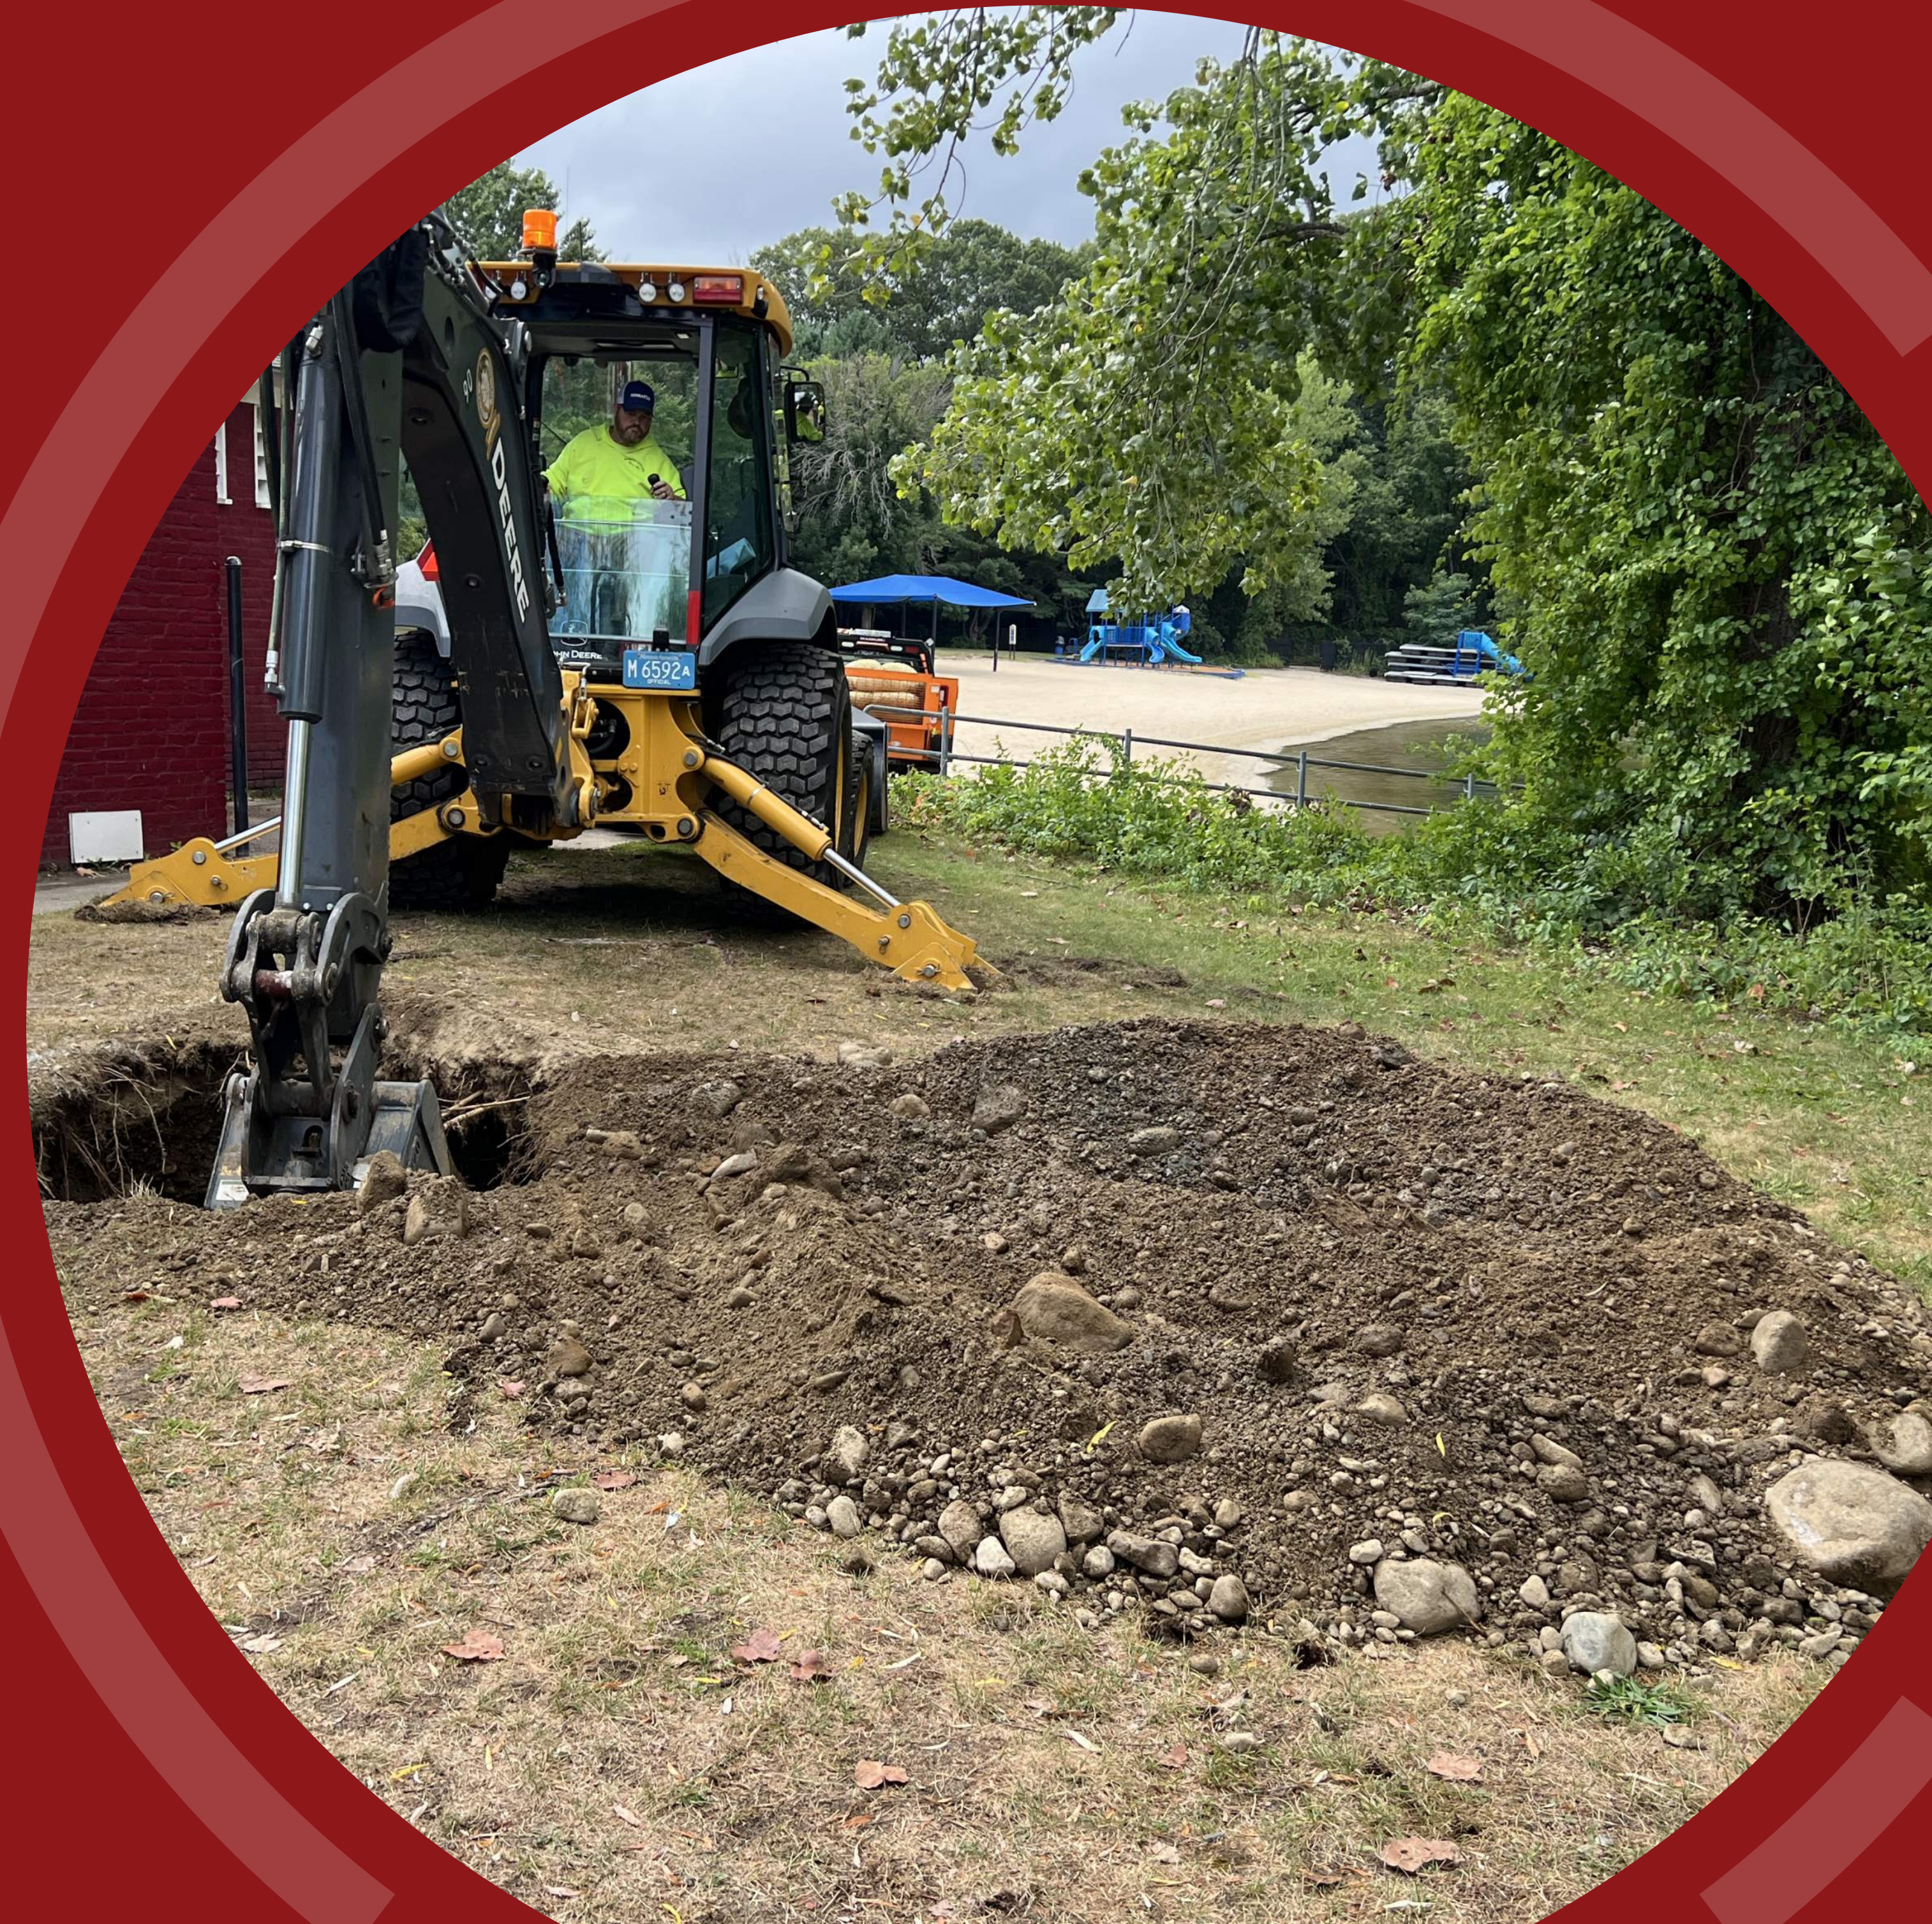
*Test pits performed in
August 2025*

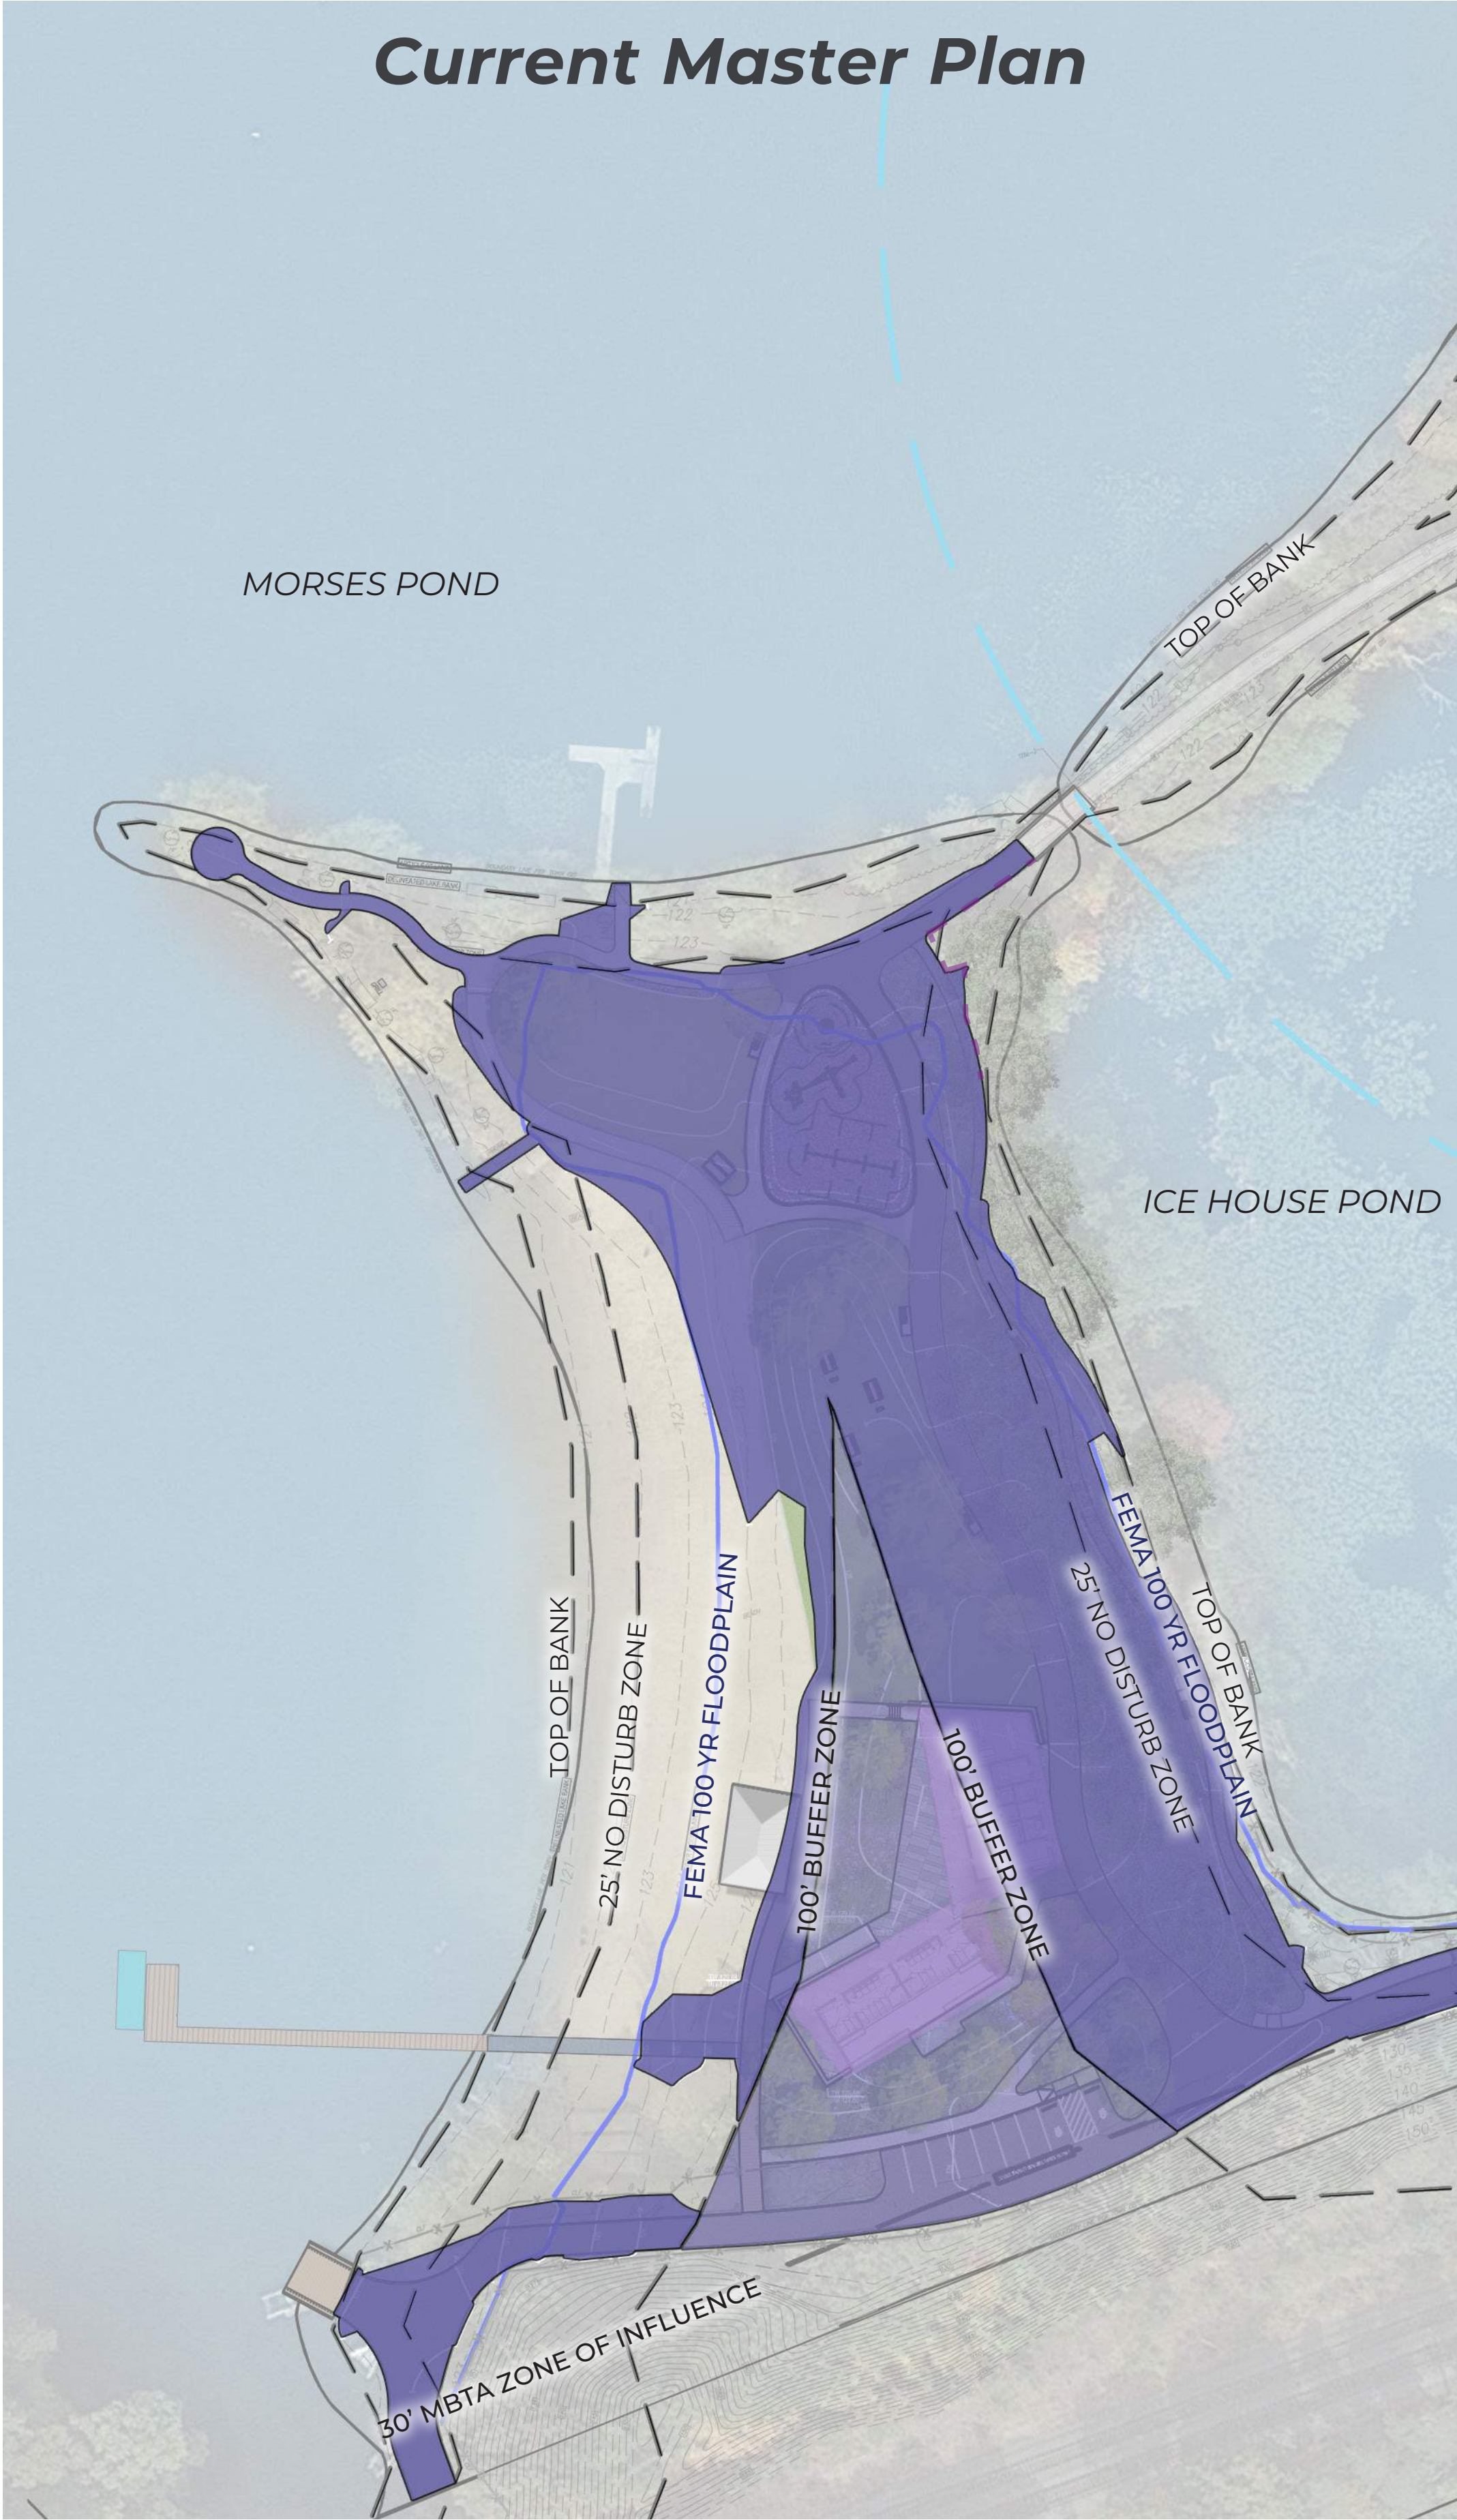
ALTERNATES COMPARISON: **OVERALL SITE DISTURBANCE**

87,764 sf	DISTURBED AREA - INSIDE 100' WETLAND BUFFER*	29,158 sf	DISTURBED AREA - OUTSIDE 100' WETLAND BUFFER
------------------	---	------------------	---

* INCLUDES DISTURBANCE AREAS OF VEHICULAR DROP OFF AND ACCESS ROAD

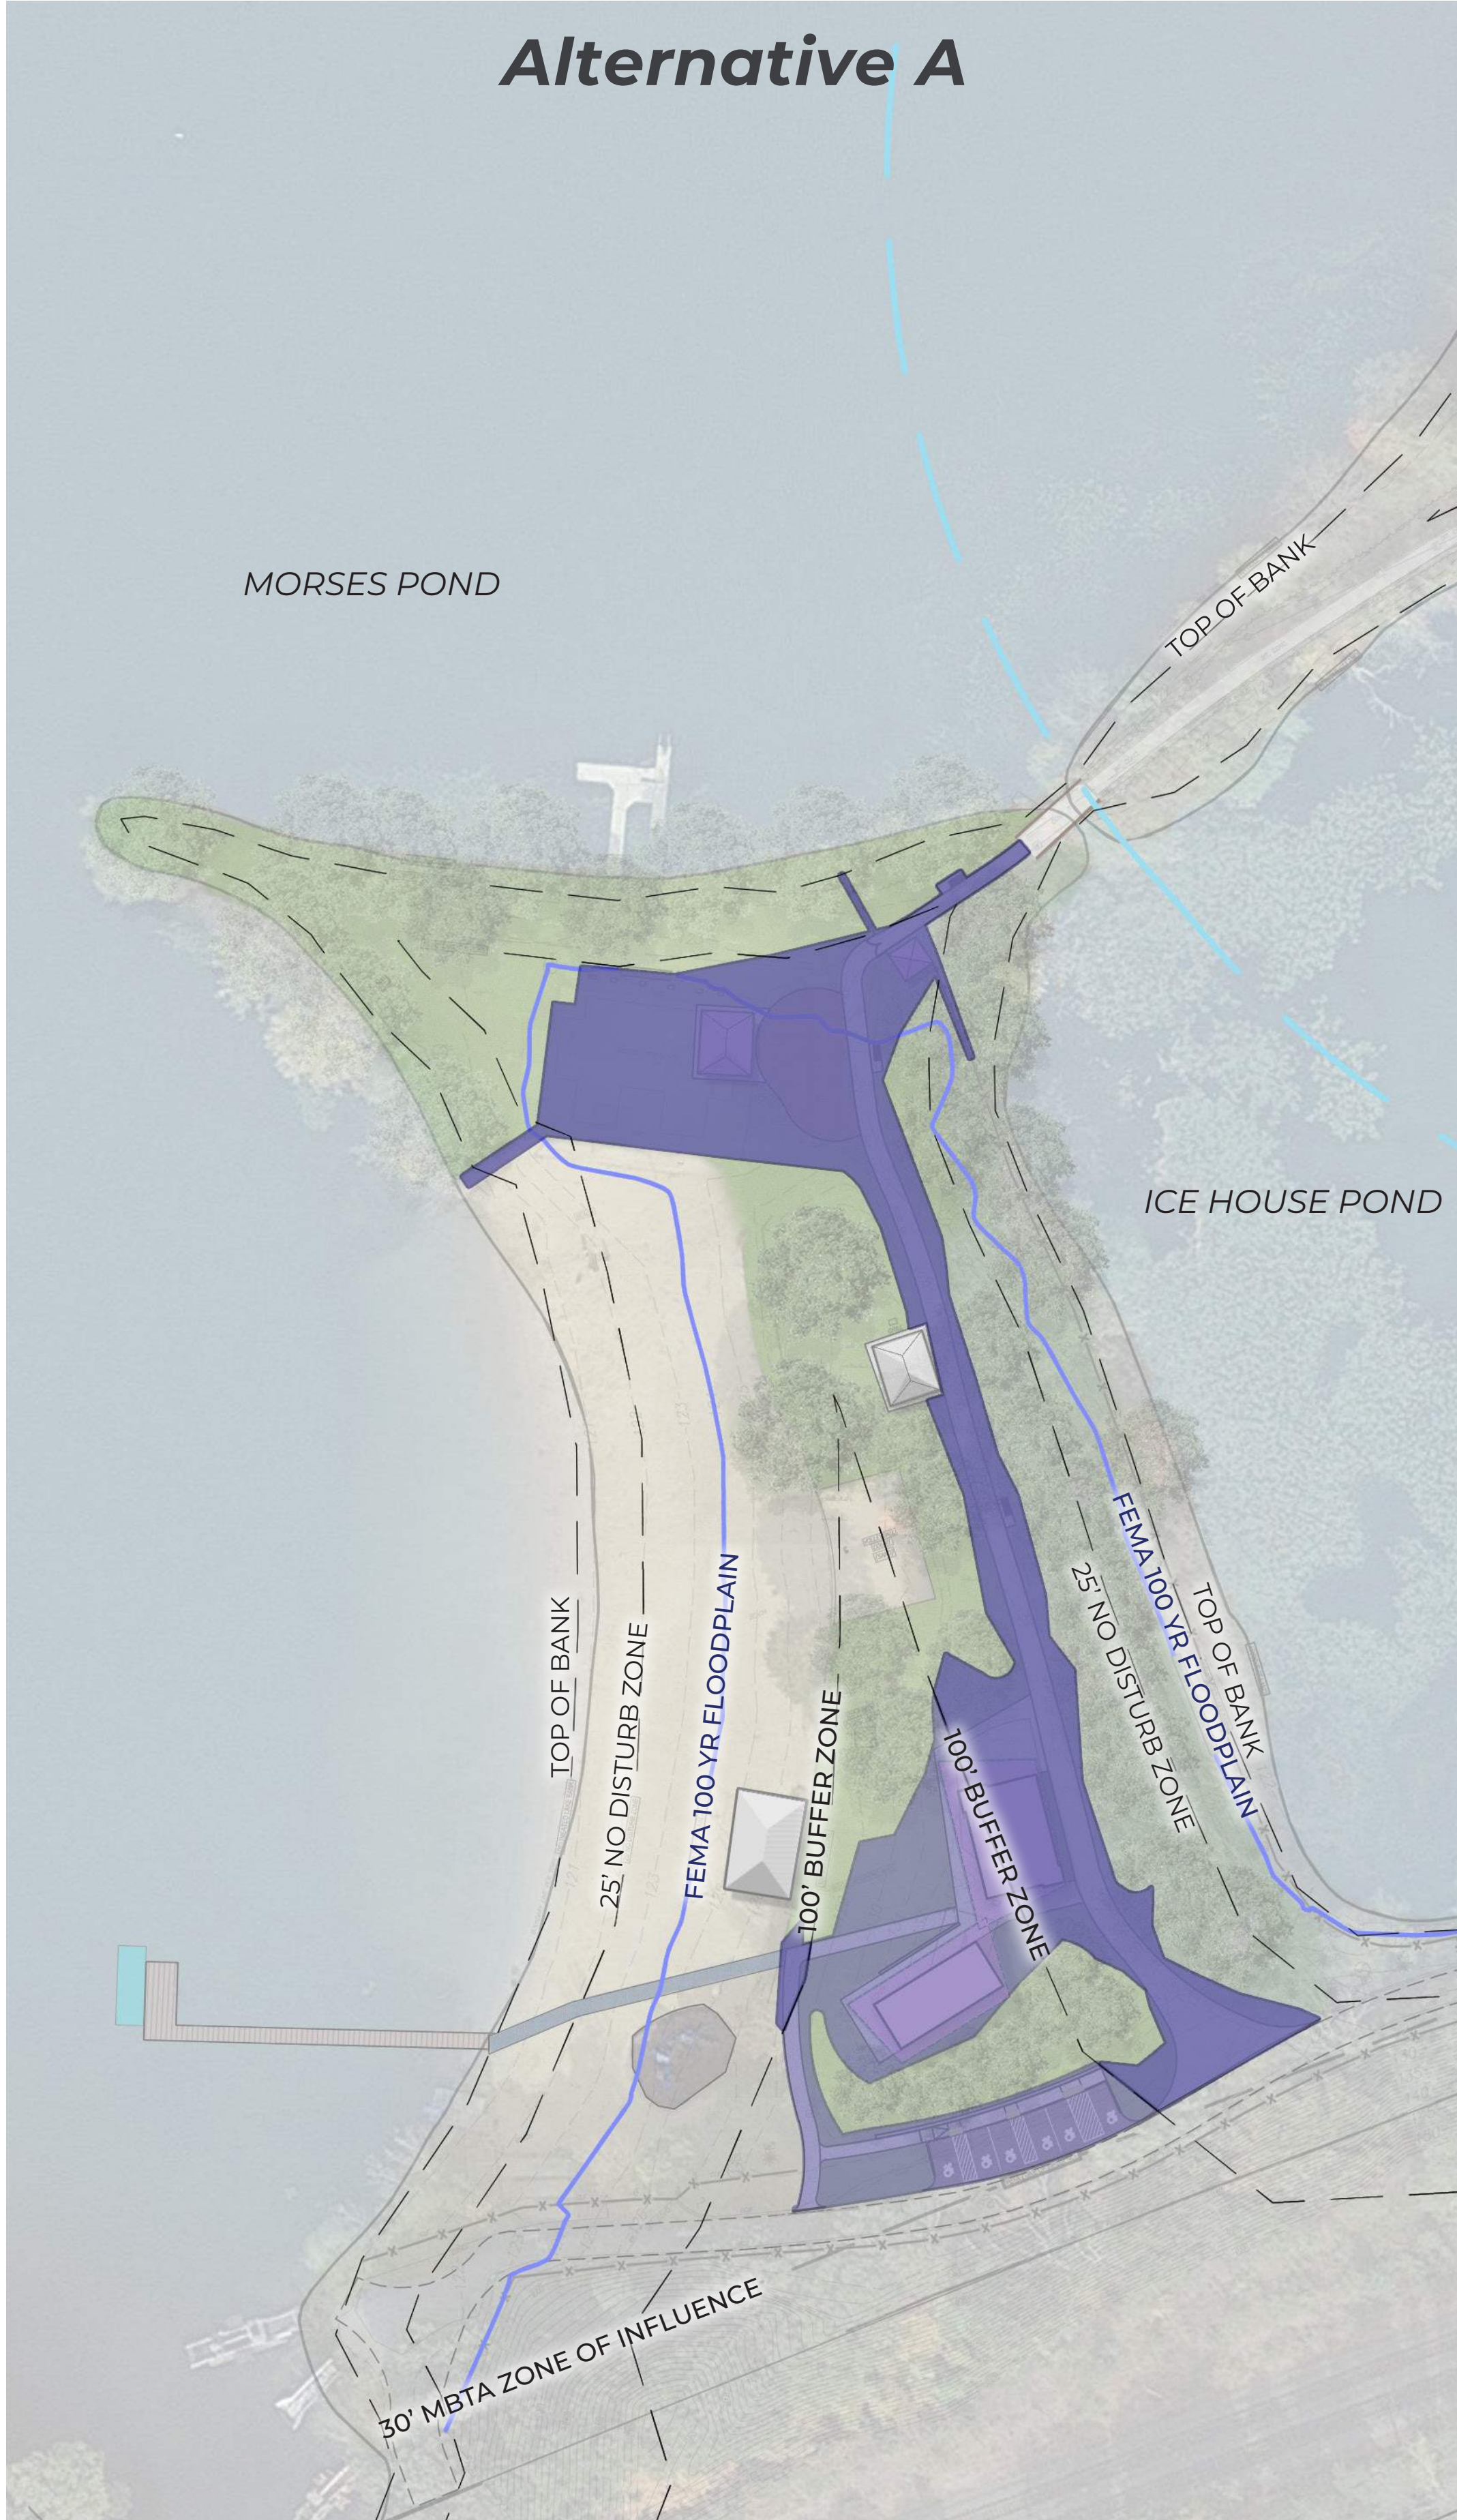
22,258 sf	DISTURBED AREA - INSIDE 100' WETLAND BUFFER	10,668 sf	DISTURBED AREA - OUTSIDE 100' WETLAND BUFFER
------------------	--	------------------	---

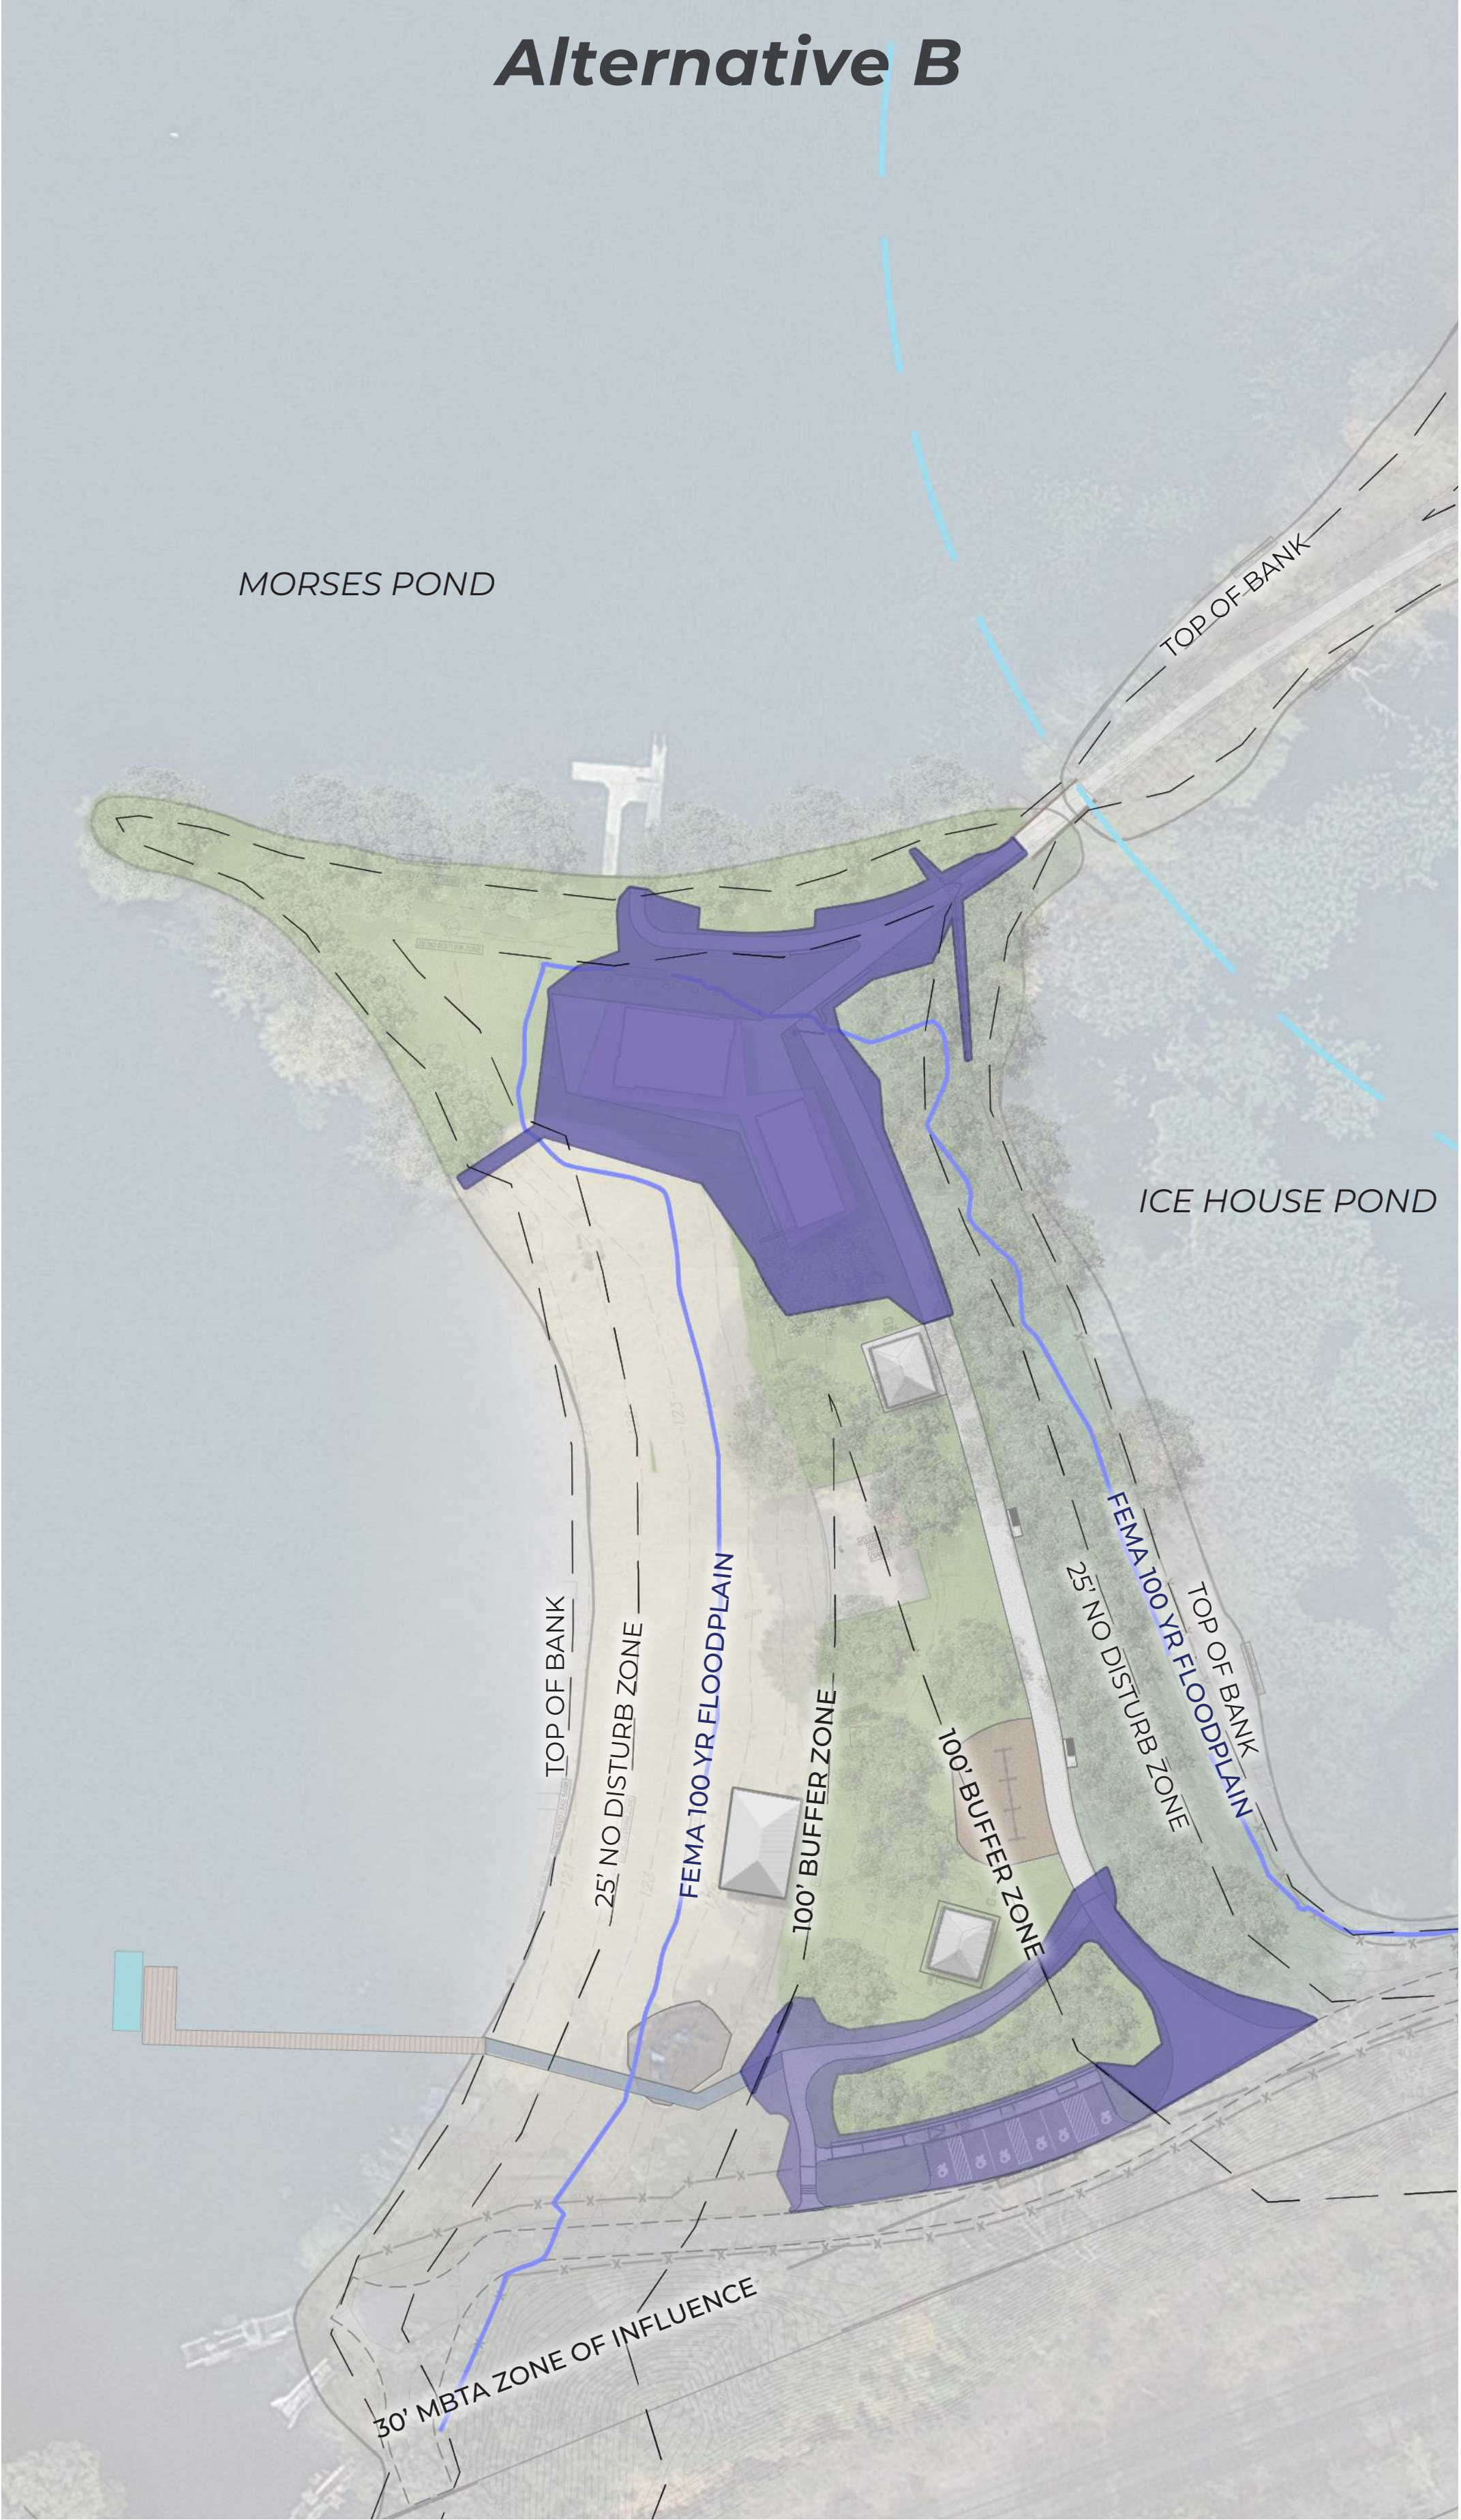
19,638 sf	DISTURBED AREA - INSIDE 100' WETLAND BUFFER	5,877 sf	DISTURBED AREA - OUTSIDE 100' WETLAND BUFFER
------------------	--	-----------------	---
